Proposed Redevelopment at Nos. 43-50 Dolphins Barn Street
Dublin 8

ARCHITECTURE
CONSERVATION
ARCHITECTS

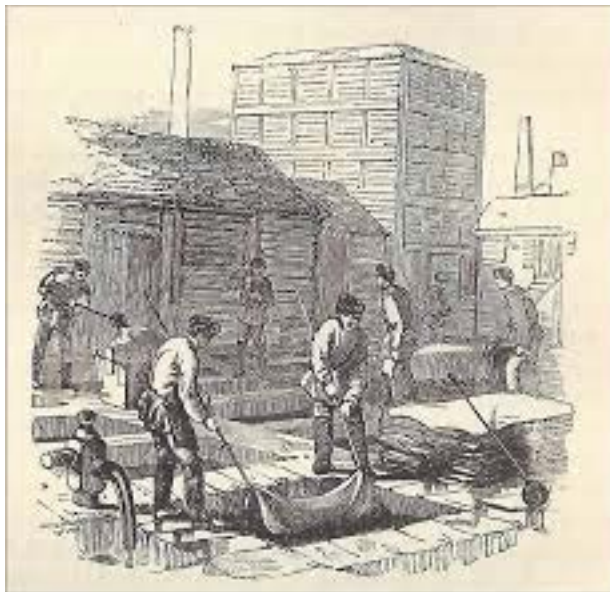
Plate No. 1. Drawing of an early 20th century tannery in Litherland, circa 1920, showing the large animal hides were soaked in rectangular pits, filled with water and lime. Similar pits can be seen in the mid-9th century Ordnance Survey maps of the subject area, included below. (Image Tan Yar Messrs Walker Ltd, Litherland, circa 1920, from J Hewitt & Sons: A Company History)

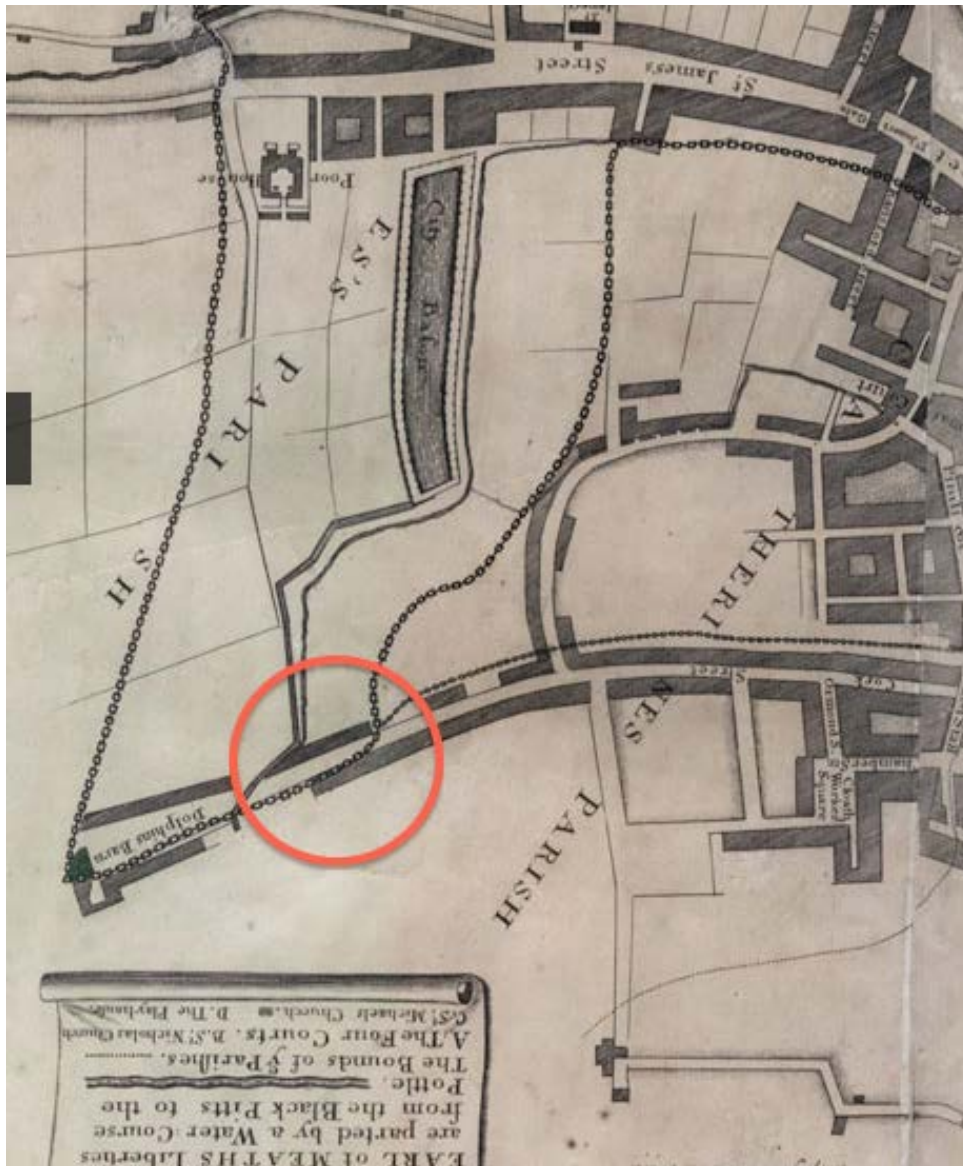
Plate No. 2. Detail from Charles Brookings **A Map of the City and Suburbs of Dublin**, 1728, showing the location of the subject site in the red circle. This map does not show individual structures, but is a relatively reliable record of where structures existed along Dublin's streets at that time. This map was drawn with the north arrow pointing down, so this image shows the subject portion of the map inverted to show north oriented to the top of the page.

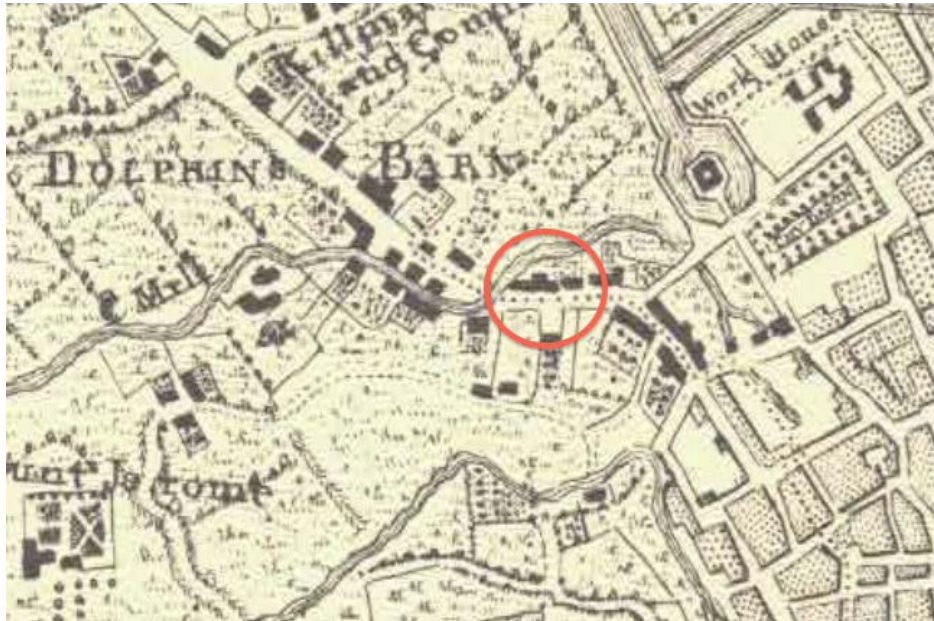
Plate No. 3. Detail from John Rocque's **An Actual Survey of the County of Dublin (1760)**, showing the area of the proposed development. The small terrace of houses can be seen, with one of the houses projecting beyond its neighbours to the rear. That is likely to be No. 47 Dolphins Barn Street, which is a few metres deeper in plan than the other adjacent houses. North is to the right in this map, which shows how rural and undeveloped the land in the edge of Dublin remained as of 1760. Note the proximity of the water course to the rear gardens of the subject terrace of houses. The presence of running water was crucial to the operation of the small scale tanneries that were common in the area during the 18th and 19th centuries.

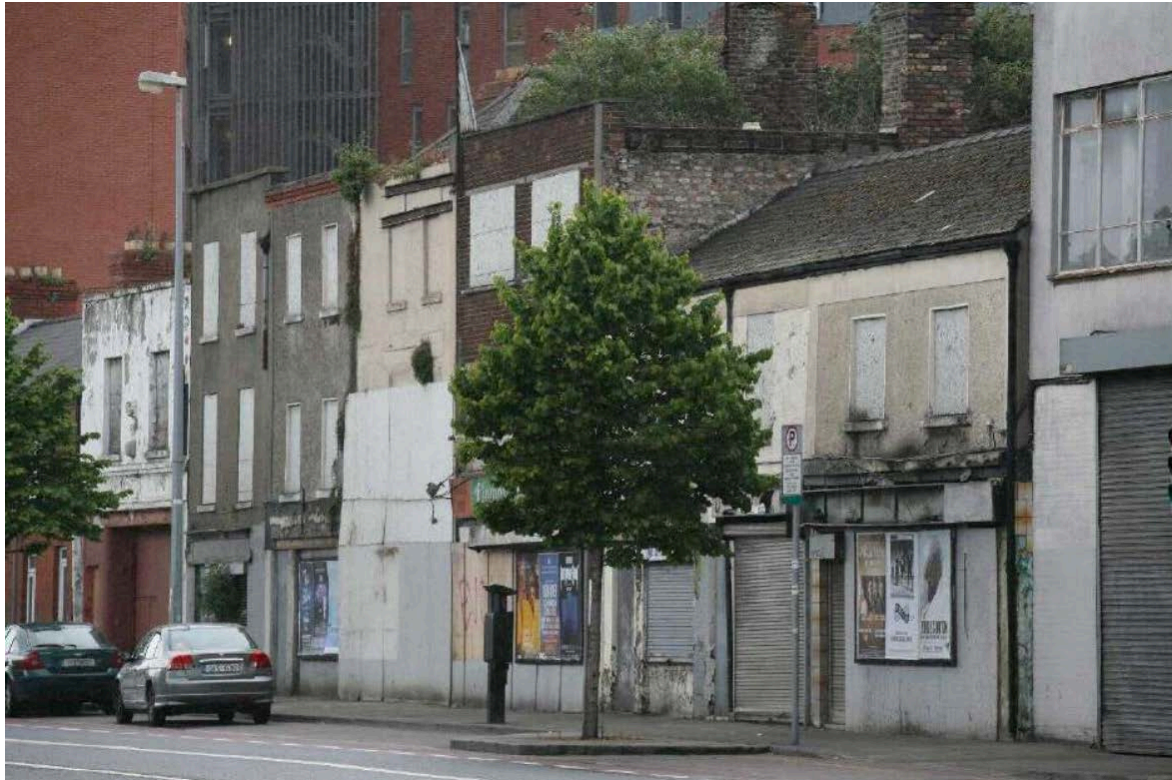
Plate No. 11. Record photo from 2017, showing Nos. 43-49 Dolphins Barn Street from across the road. This photo shows the extent to which the former houses have been modified over the last three centuries, and how they have become dangerously derelict over the last few decades. (Photo by Stephen Farrell, 2017)

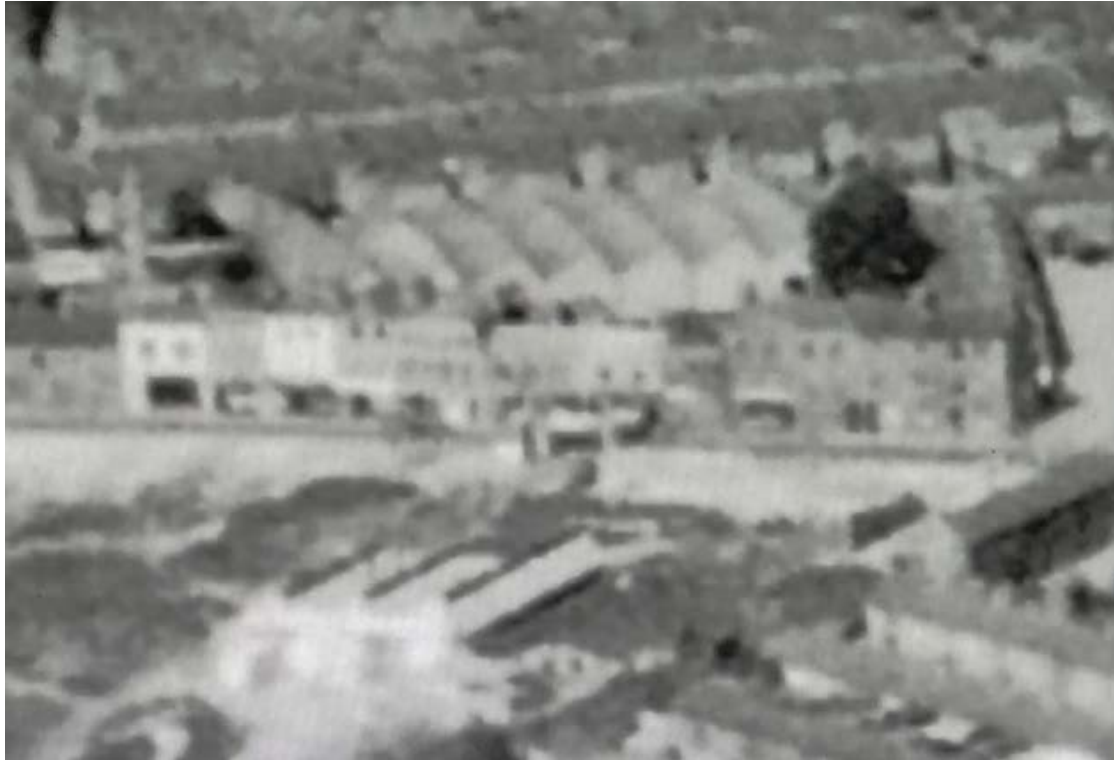
The subject terrace of former houses are believed to represent a group of single family houses with original construction dates from the second quarter of the 18th century. In their currently decayed condition, it is unsafe to fully access all areas of any of the house, with some of them being virtually collapsed within the perimeter walls. The author of this report was able to enter all of the structures with the exception of No. 46, and to assess the general extent of survival of significant historic building fabric. Photo surveys from 2017 and early 2024 provided additional invaluable documentation of the structures, internally and externally, to allow for fuller appreciation of the house's physical conditions, the extent of modifications that were carried over the last three centuries, and the extent of survival of significant historic building fabric.

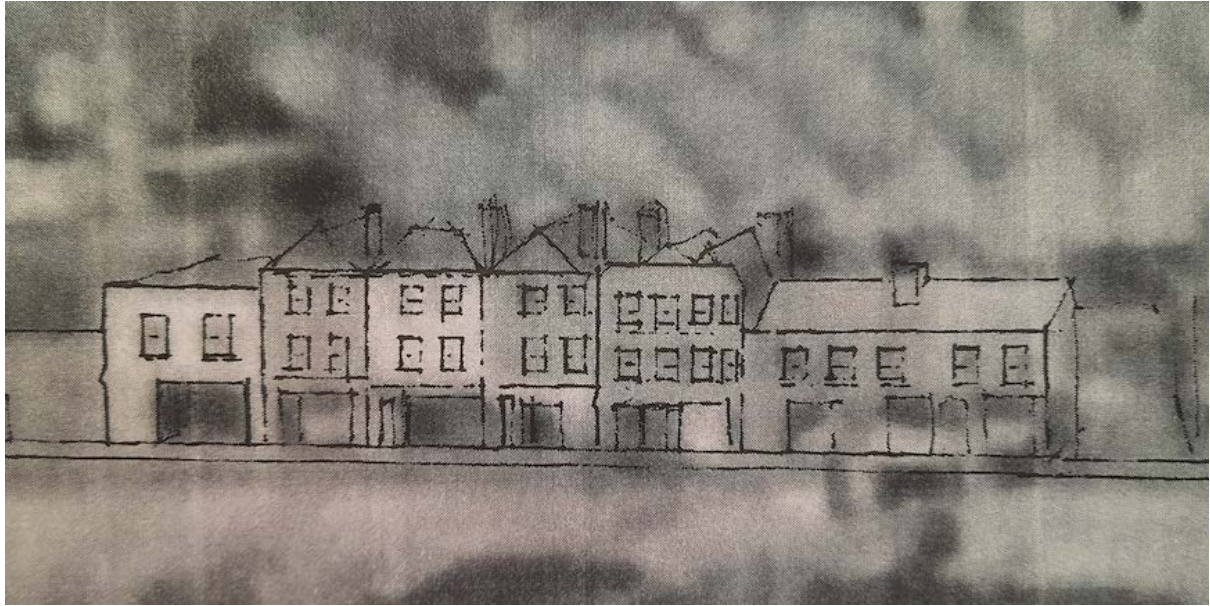
Plate No. 13. Enlarged detail from the ca. 1960 aerial photo of Dublin, with the image enhanced by the author, to show how the structures appear to have existed around 1960. No. 43 is at the left end of the terrace, with No. 48 and 49 at the right. The structure with four bays of windows is No. 47, at the centre of the image.

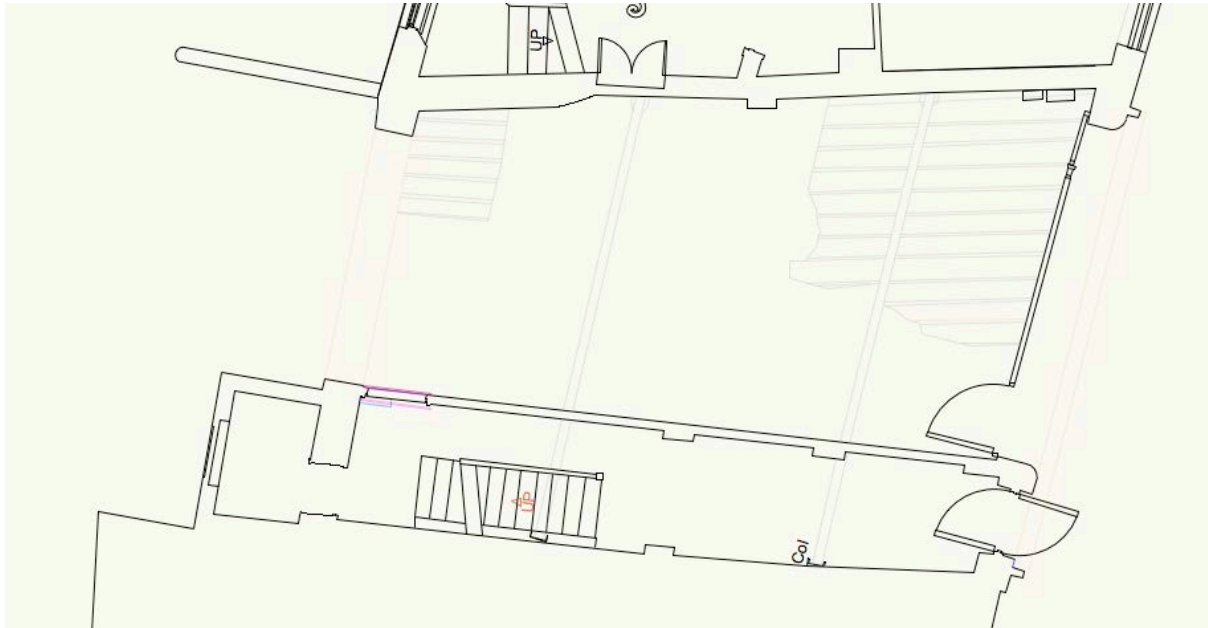
Plate No. 15. Measured survey showing the ground floor to No. 43 Dolphins Barn Street as it currently exists. Dolphins Barn Street is to the right, and most of the ground floor is taken up by a wide vehicular laneway running through to the large factory to the rear of all of the houses. It is clear from this survey that virtually nothing remains from the early 18th or 19th centuries in this property at the ground floor..

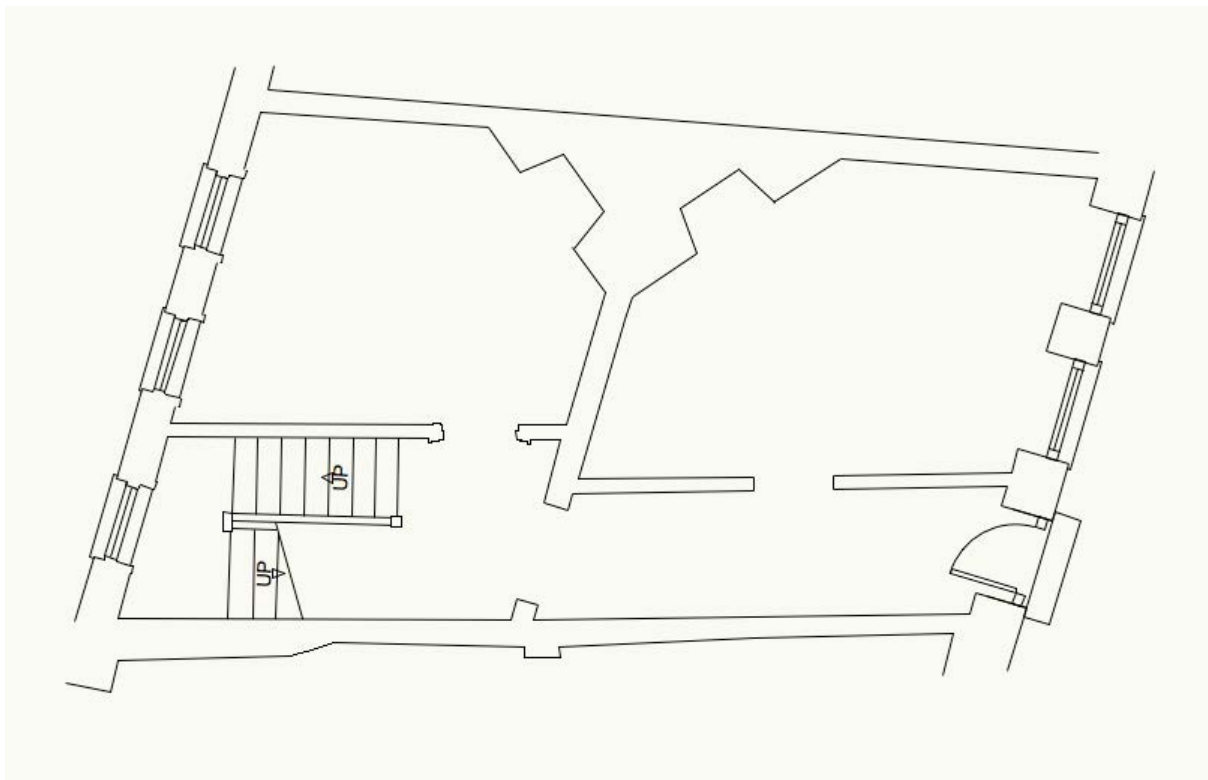
Plate No. 24. Conjectural ground floor plan of No. 44 Dolphins Barn Street, drawn by the author. This drawing shows the basic footprint of the house on the ground floor, most of which still exists in situ. The stairs and all joinery have been replaced in the early 19th century, and there is now a shopfront in place of the original door and ground floor windows. The first floor is currently not safe to enter, so the measured survey was not carried out in those areas.

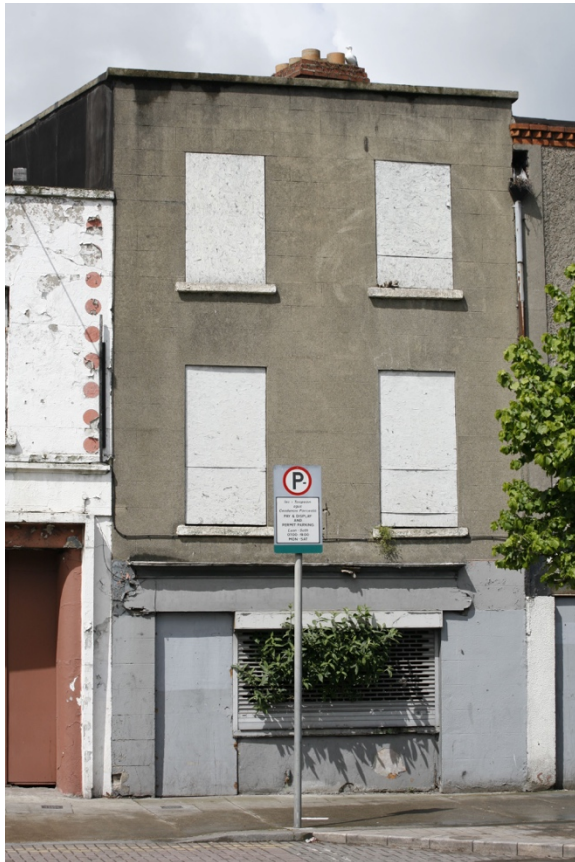
Plate No. 25. General view showing the front elevation to No. 44 Dolphins Barn Street. Note the flat roof, early 20th century shopfront signboard, and sand and cement render. (Photo by Stephen Farrell, 2017)

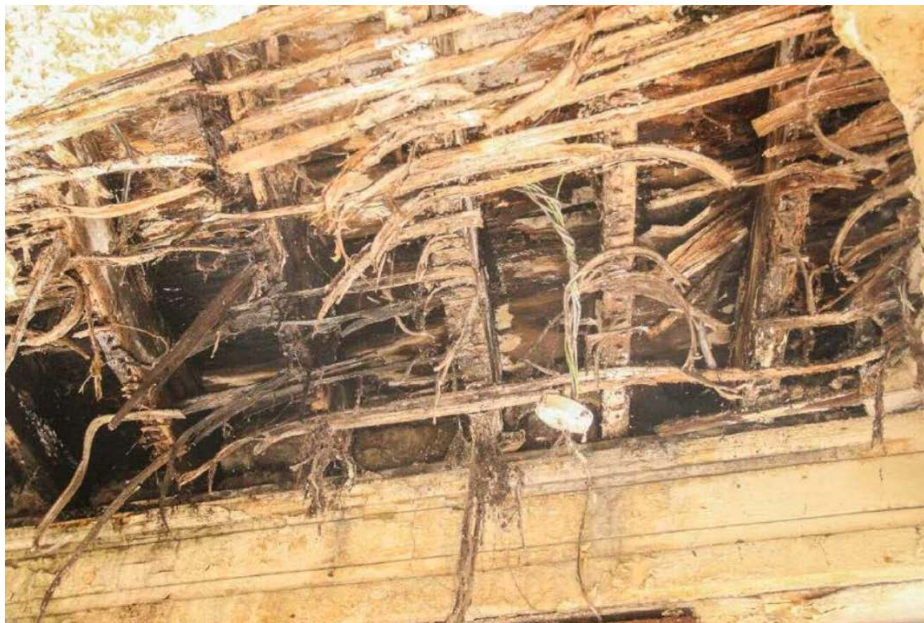
Plate No. 32. Detail view showing the extensive dry rot and damp rot damage to the ceiling and first floor joists in the front wall to No. 44 Dolphins Barn Street. This photo dates from 2017, and the damage is now significantly greater. (Photo by Stephen Farrell, 2017)

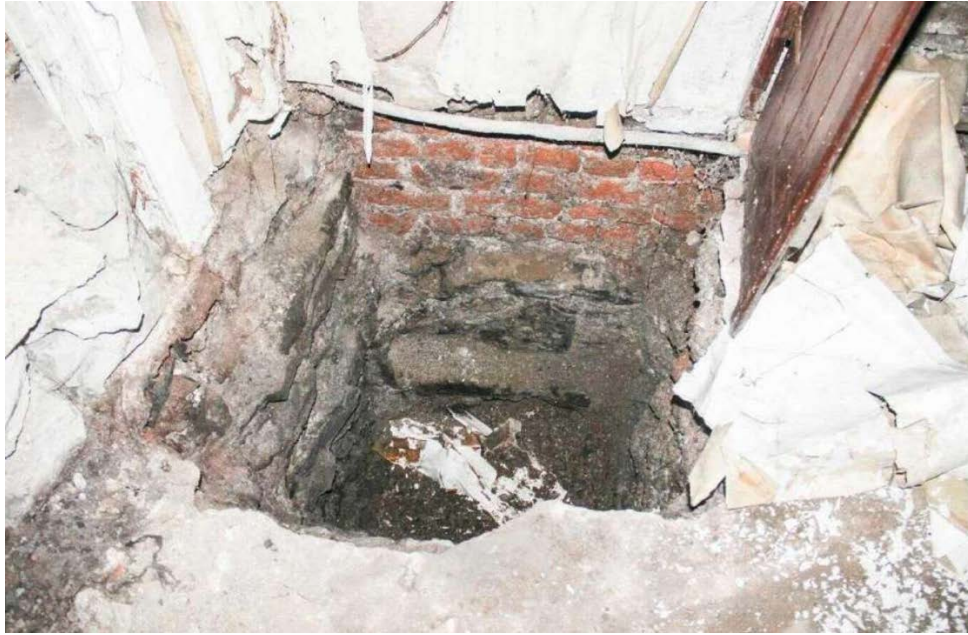
Plate No. 33. Detail view showing the test hole in the ground floor slab to No. 44 Dolphins Barn Street. This excavate reveals that foundation consists of handmade red brick on a rubble stone foundation. (Photo by Stephen Farrell, 2017)

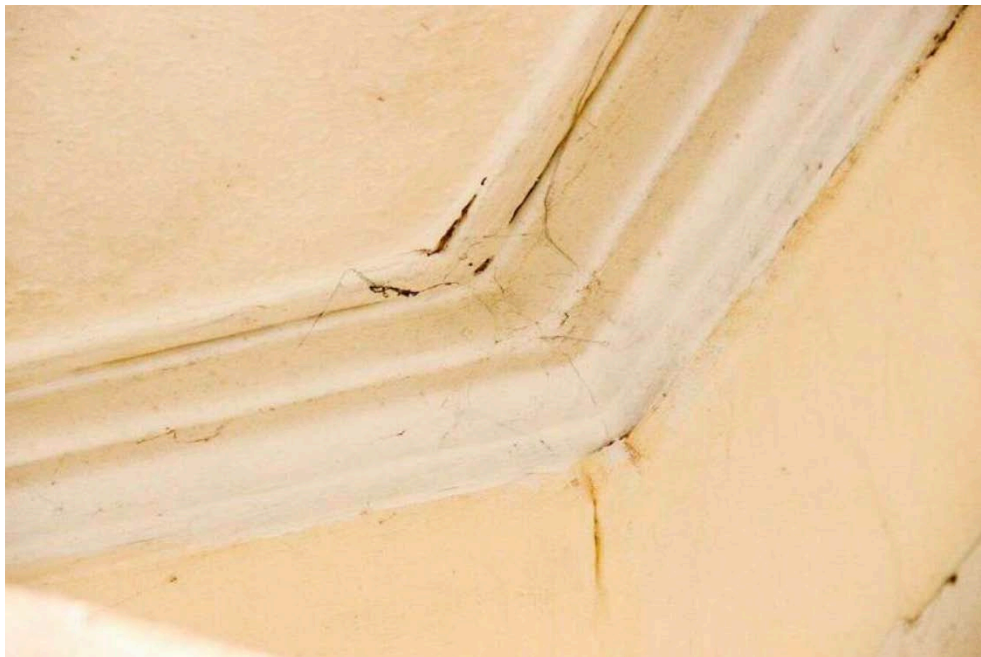
Plate No. 34. Detail view showing the early 19th century plaster coving in the ground floor rear room at No. 44 Dolphins Barn Street, as it appeared in 2017. (Photo by Stephen Farrell, 2017)

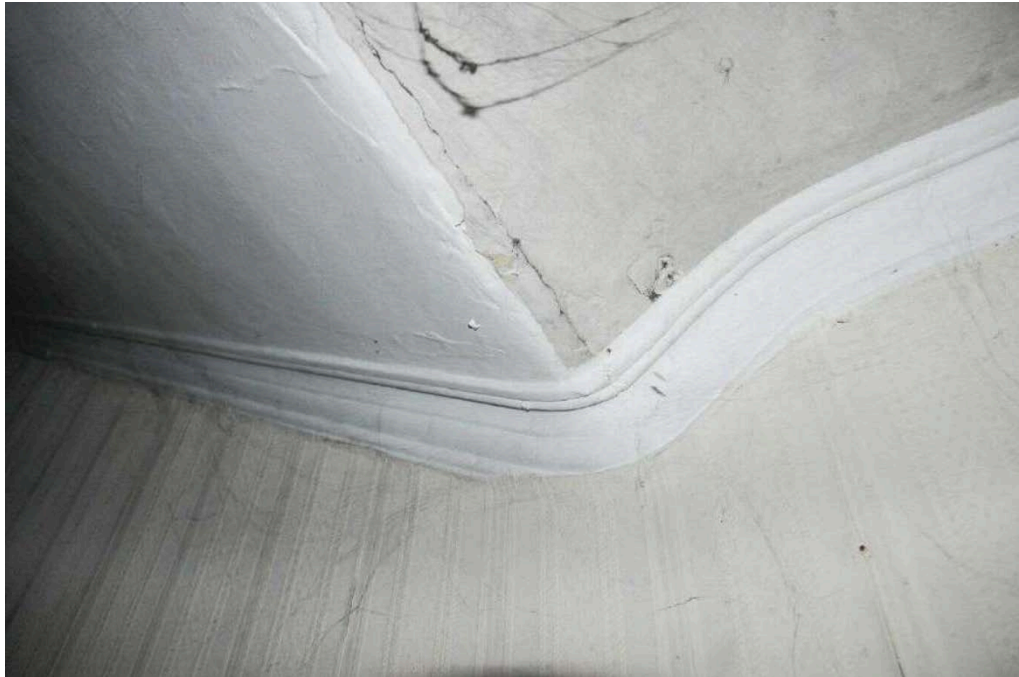
Plate No. 35. Detail view showing the early 19th century plaster coving to the stairwell in No. 44 Dolphins Barn Street as it appeared in 2017. That area has since been heavily damaged by damp rot and dry rot fungus. (Photo by Stephen Farrell, 2017)

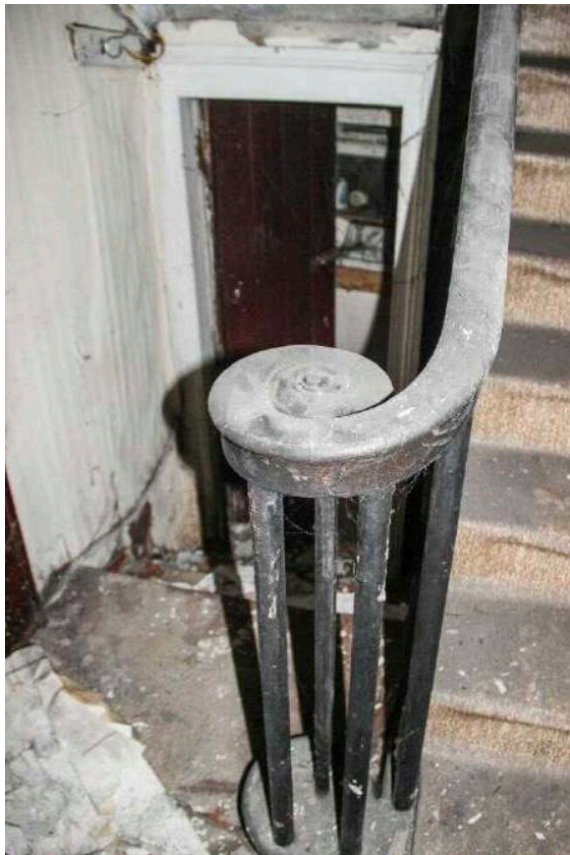
Plate No. 36. Detail view showing the early 19th century rondel to the handrail in the stairwell in No. 44 Dolphins Barn Street as it appeared in 2017. (Photo by Stephen Farrell, 2017)

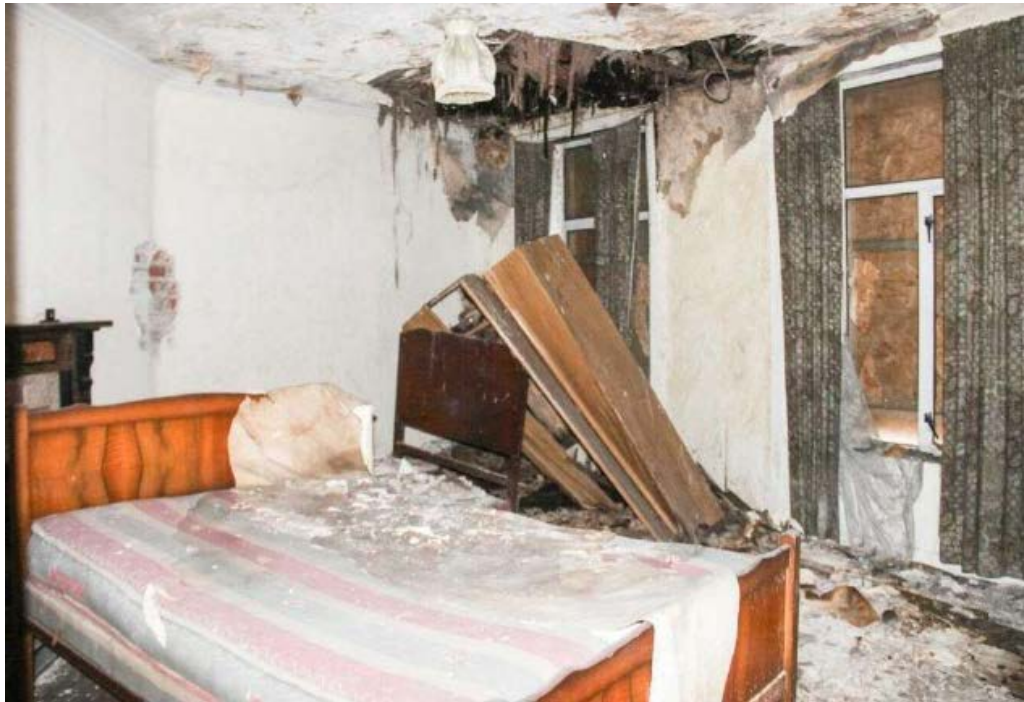
Plate No. 37. General view showing the first floor front room in No. 44 Dolphins Barn Street, in 2017. Note the late 19th or early 20th century fireplace in the angled chimney breast at left. Also note the extensive damage caused by unchecked roof leaks in the front roof. (Photo by Stephen Farrell, 2017)

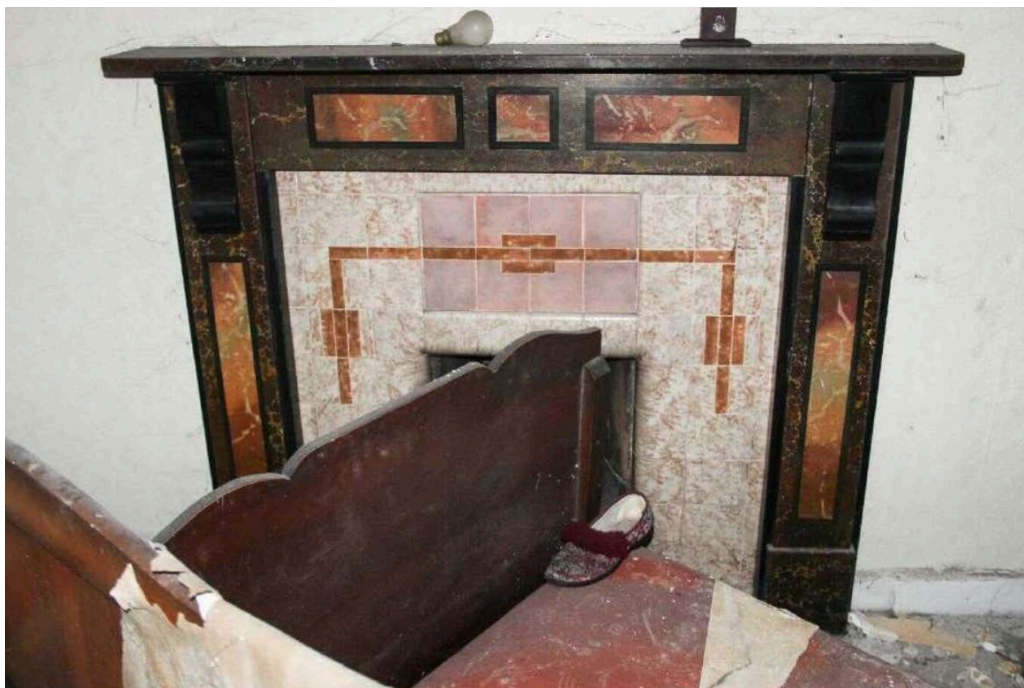
Plate No. 38. Detail view showing the late 19th or early 20th century marbled slate fire surround in the first floor front room in No. 44. This fireplace could have been installed at any time by owners or occupants, and does not necessarily provide evidence of the property's construction or redevelopment. (Photo by Stephen Farrell, 2017)

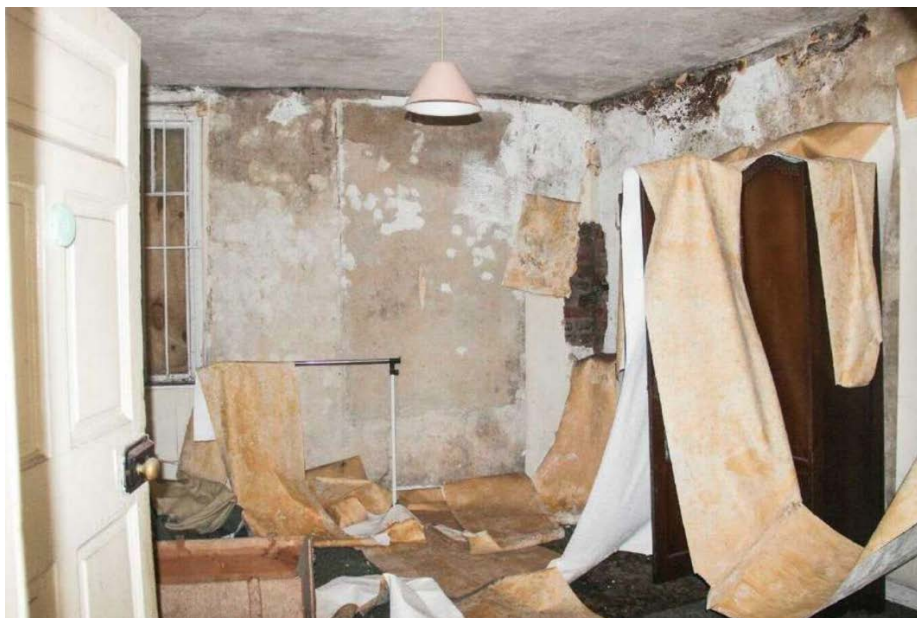
Plate No. 42. General view showing the rear first floor room in No. 44 Dolphins Barn Street as it appeared in 2017. That area has since been more heavily damaged by damp rot and dry rot fungus. There is an angled corner chimney breast at the right, out of the view. (Photo by Stephen Farrell, 2017)

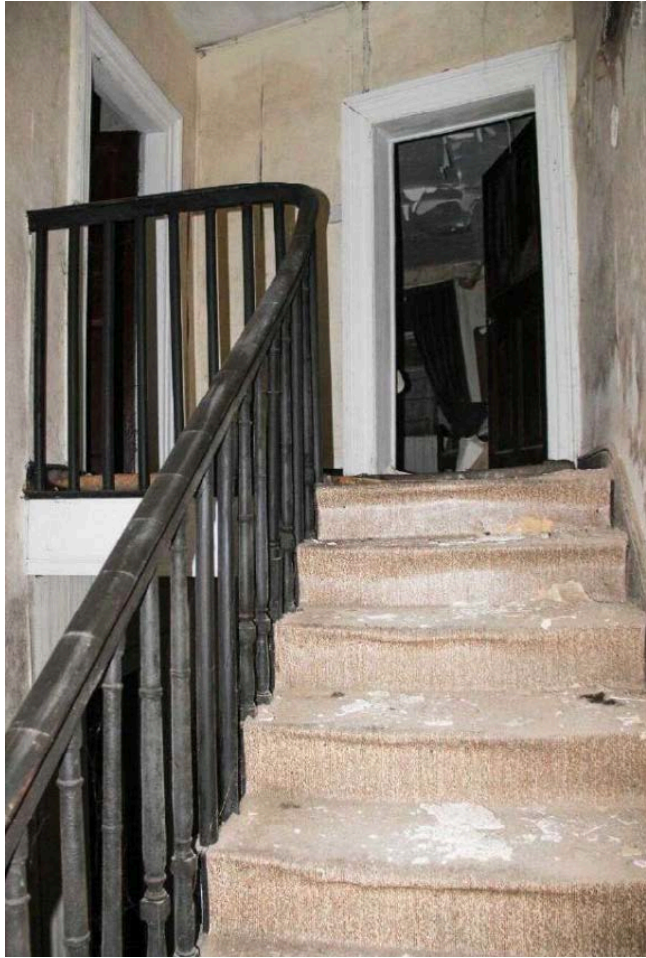
Plate No. 43. Detail view showing the early 19th century handrail to the stairwell in No. 44 Dolphins Barn Street as it appeared in 2017. That area has since been heavily damaged by damp rot and dry rot fungus. (Photo by Stephen Farrell, 2017)

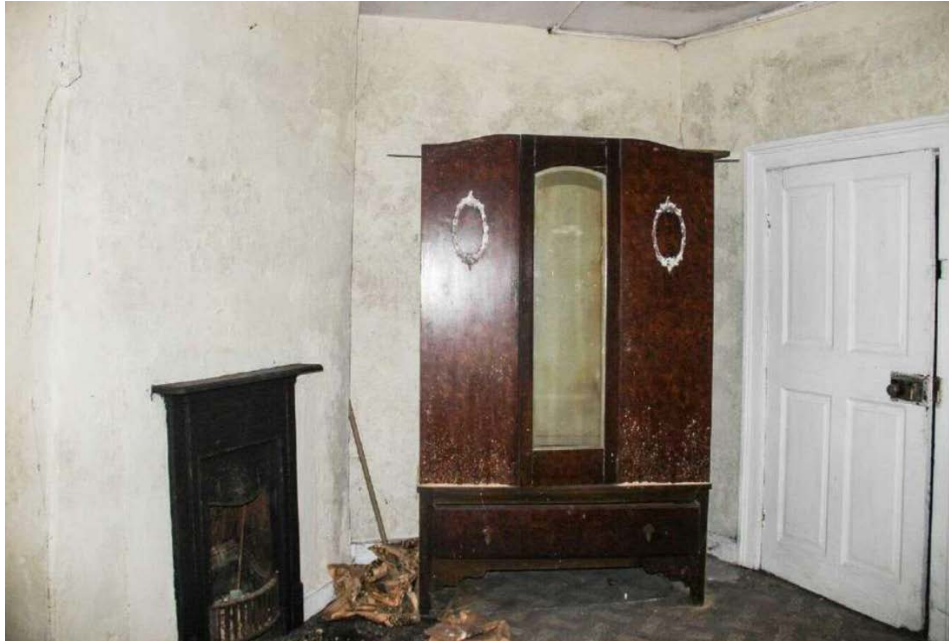
Plate No. 44. Detail view showing the 18th century four panel door and angled fireplace in the second floor rear room, in No. 44 Dolphins Barn Street as it appeared in 2017. The cast iron fire surround dates from the late 19th or early 20th century. (Photo by Stephen Farrell, 2017)

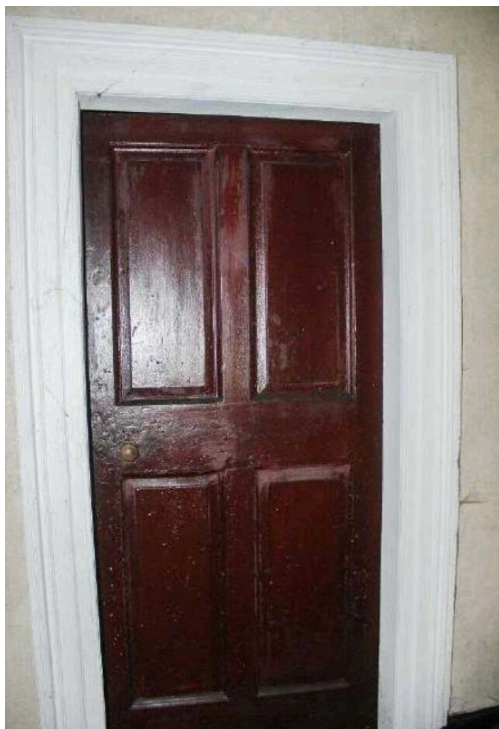
Plate No. 45. Detail view showing one of the four-panel, raised panel doors in the second floor in No. 44 Dolphins Barn Street as it appeared in 2017. These doors most likely date from around 1725 to 1750, and are interesting survivors. That area has since been heavily damaged rainwater leaks into the roof and floor structure. (Photo by Stephen Farrell, 2017)

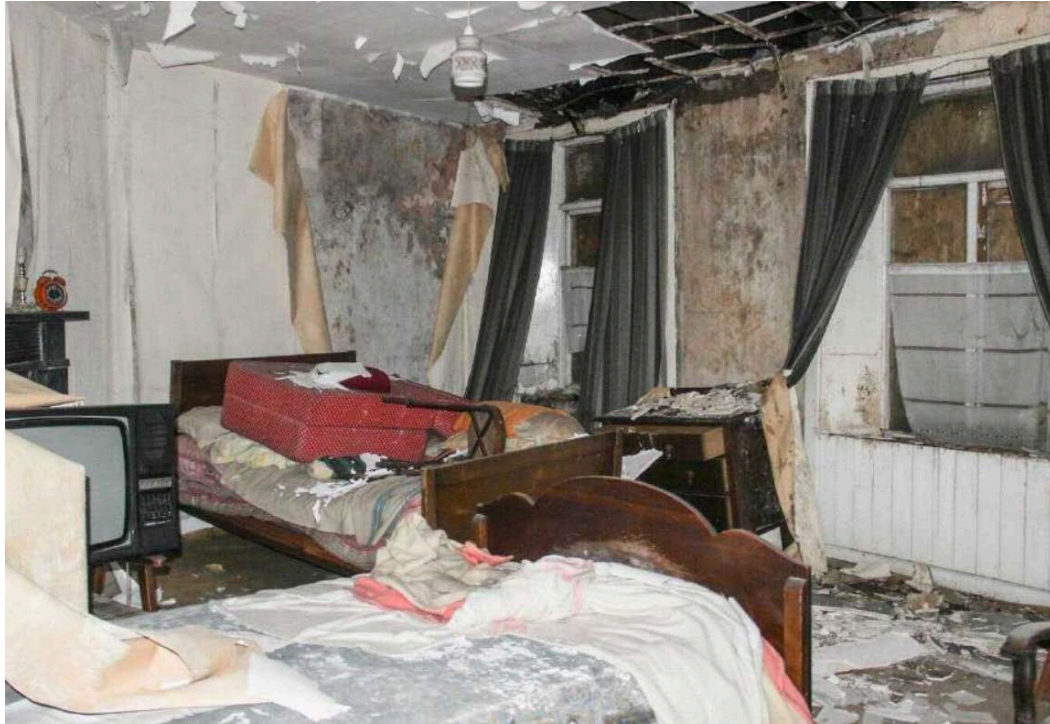
Plate No. 46. Detail view showing the second floor front bedroom in No. 44 Dolphins Barn Street as it appeared in 2017. The corner chimney breast is at the left, with a good quality slate fire surround. That area has been heavily damaged by damp rot and dry rot fungus. (Photo by Stephen Farrell, 2017)

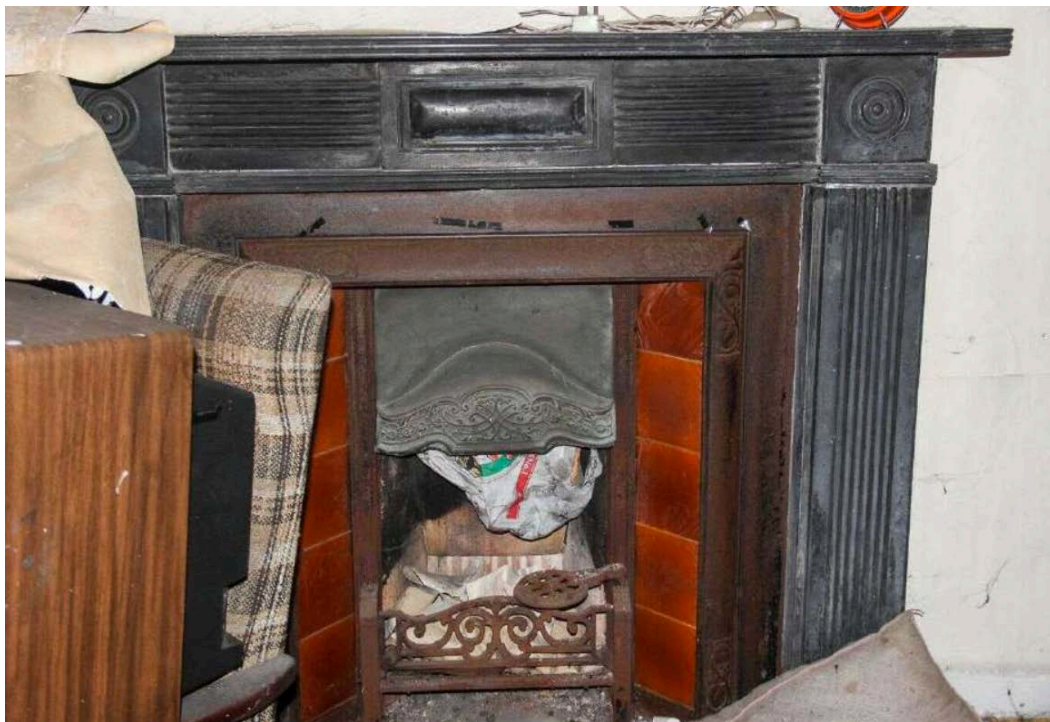
Plate No. 47. Detail view showing the fine early 19th century fire surround, currently in the second floor front bedroom in No. 44. This fireplace could have been used in the ground floor front room, when the house was likely renovated and updated around 1825. That area has since been heavily damaged by damp rot and dry rot fungus. (Photo by Stephen Farrell, 2017)

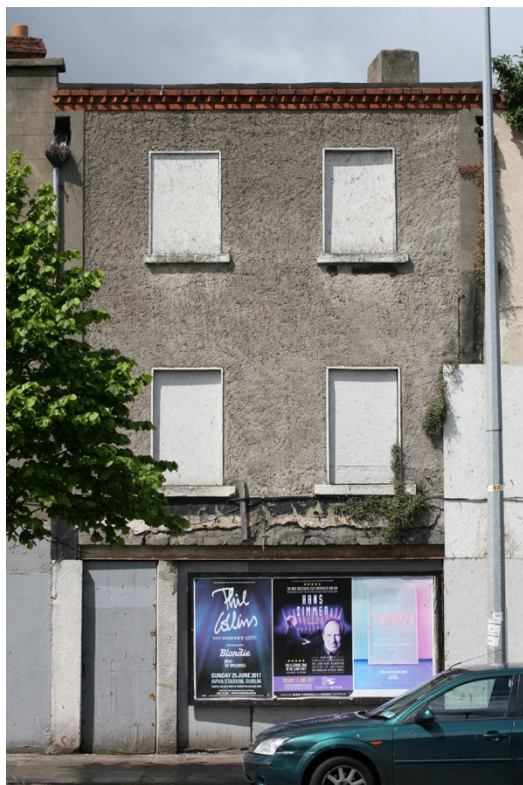
Plate No. 48. General view showing the front elevation to No. 45 Dolphins Barn Street as it appeared in 2017. The window opes are most likely the original size and arrangement, suggesting the front elevation contains much of the original masonry above the ground floor. Note the flat roof, and poor quality shopfront with a steel lintel to support the front wall. (Photo by Stephen Farrell, 2017)

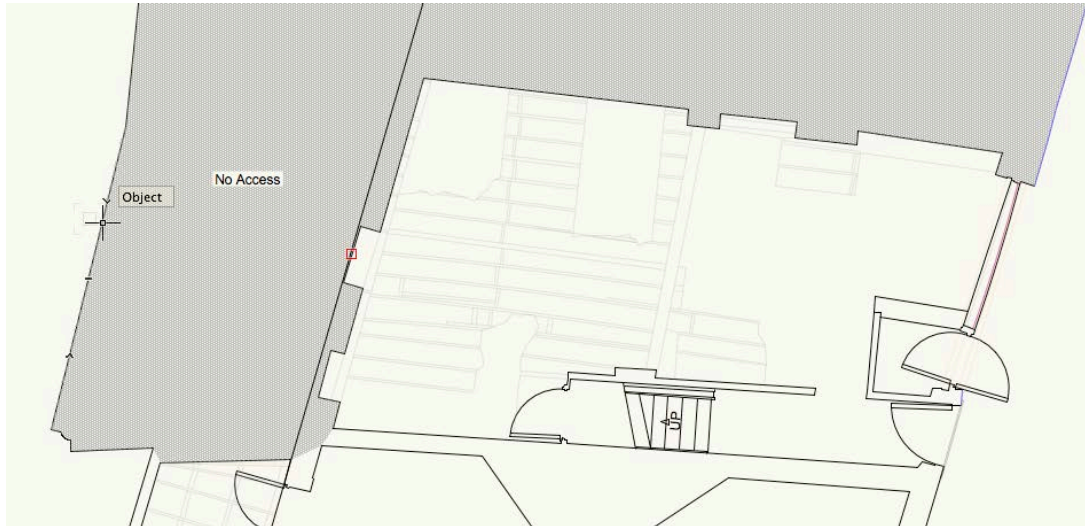
Plate No. 49. Measured survey drawing showing the ground floor in No. 45 Dolphins Barn Street as it currently exists. A 20th century shop currently covers most of the ground floor. No early features remain, including chimney breasts, partitions, doors, joinery or stairs.

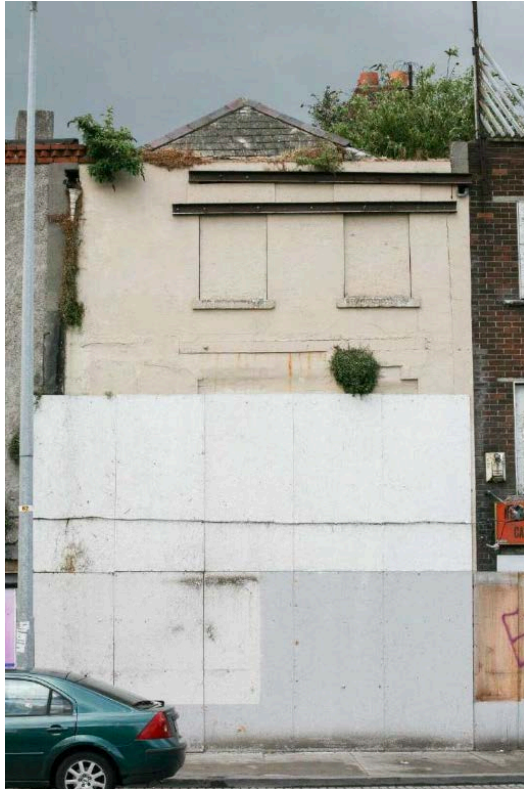
Plate No. 60. General view showing the front elevation to No. 46 Dolphins Barn Street with steel braces fixed to the front parapet. Note the low pitched slated roof and the odd position of the windows in the elevation. It is likely this house was built as a group with Nos. 44 and 45 by the same builder around 1725-1750 (Photo by Stephen Farrell, 2017)

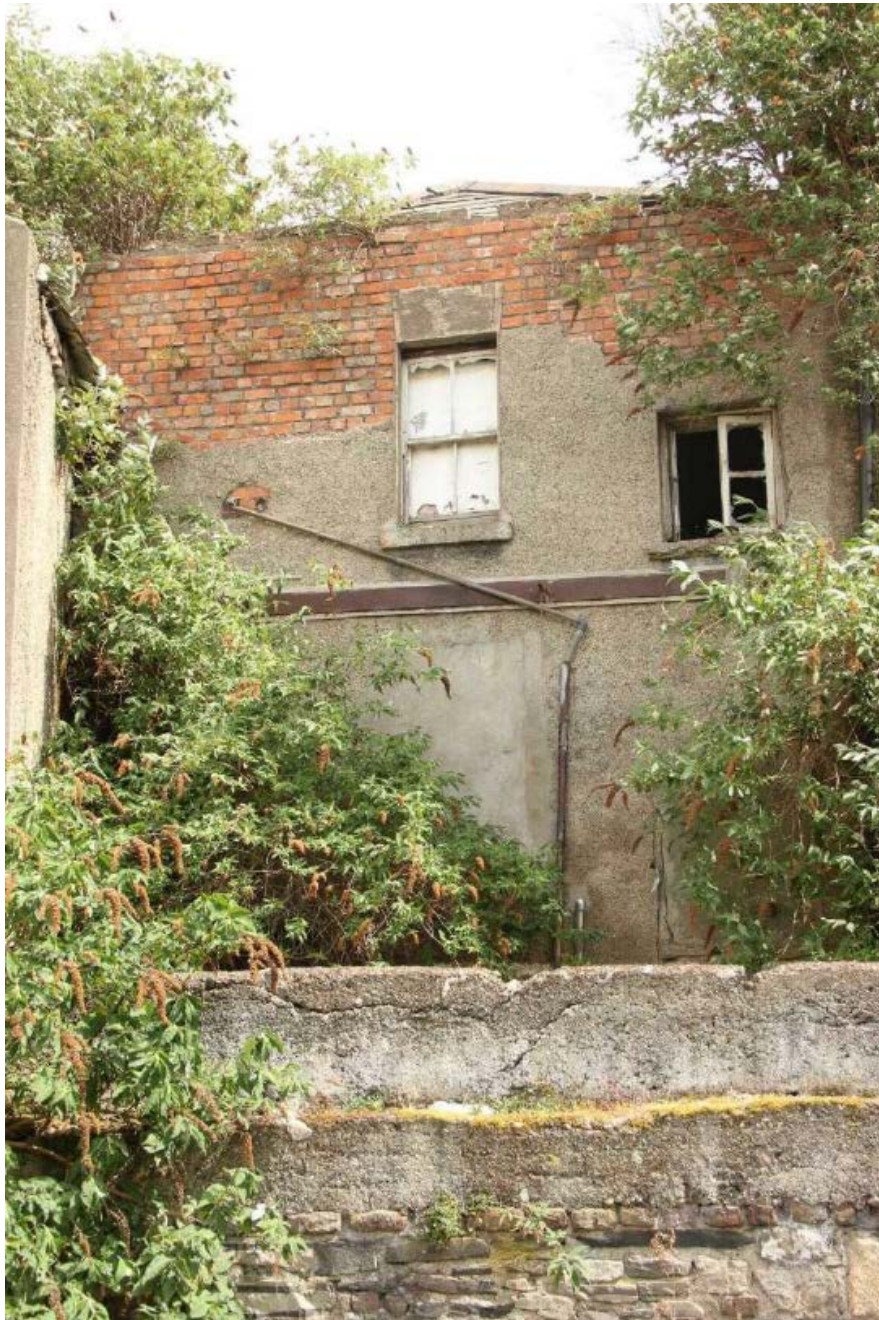
Plate No. 62. General view showing the rear elevation to No. 46 Dolphins Barn Street as it appeared in 2017. It is clear that at least the upper portion of the rear wall was replaced, with the red bricks suggesting that it occurred during the early 20th century. This structure is now too dangerous to enter, other than the entry hall. (Photo by Stephen Farrell, 2017)

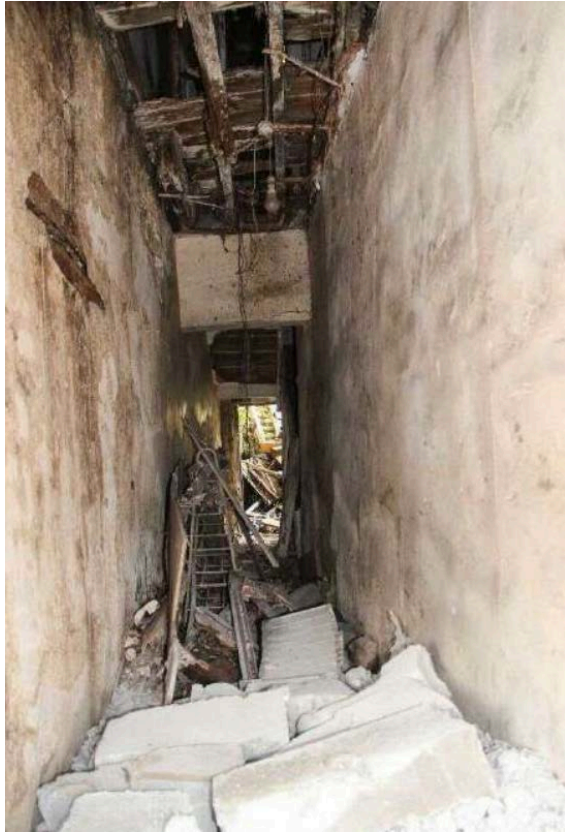
Plate No. 63. General view showing ground floor entry hall to No. 46 Dolphins Barn Street as it appeared in 2017. The dangerously rotted floor joists above show how far this house has deteriorated. This structure is now too dangerous to enter, other than the entry hall. (Photo by Stephen Farrell, 2017)

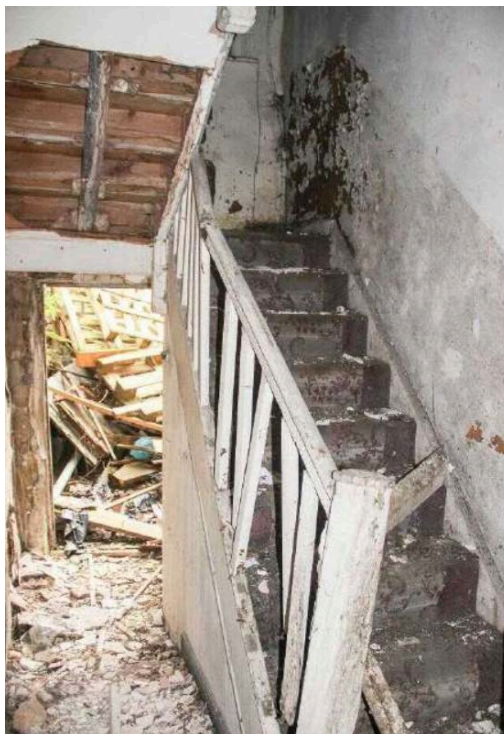
Plate No. 64. Detail view showing the poor quality replacement stair to No. 46 Dolphins Barn Street as it appeared in 2017. (Photo by Stephen Farrell, 2017)

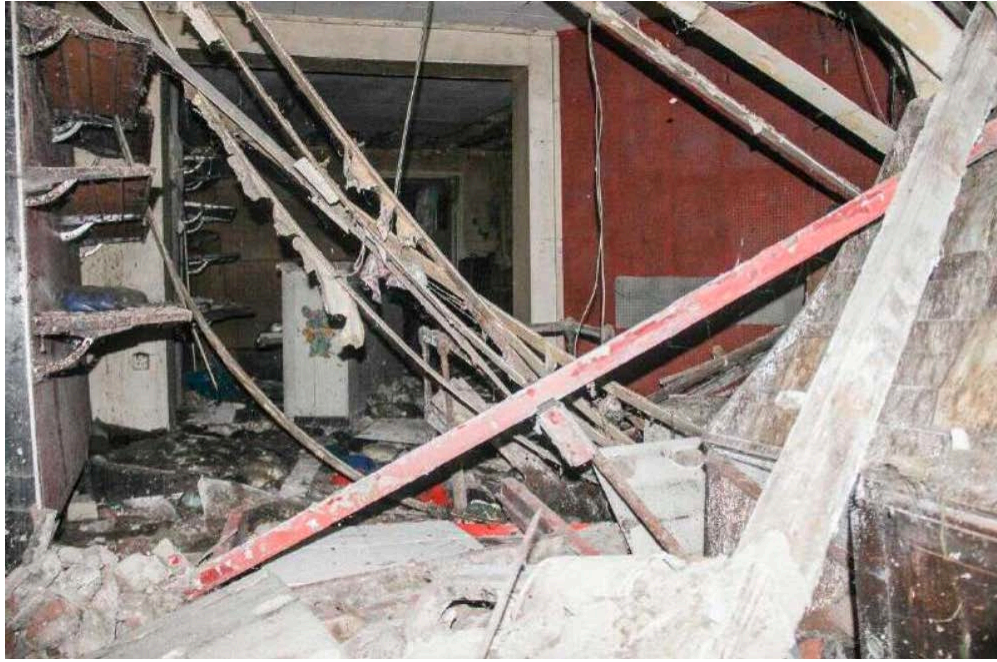
Plate No. 65. General view showing the ground floor shop in No. 46 Dolphins Barn Street as it appeared in 2017. This view shows that the large angled chimney breasts remain in place on the ground floor, and probably also in the floors above. Otherwise, nothing remains of the 18th century building fabric. This structure is now too dangerous to enter, other than the entry hall. (Photo by Stephen Farrell, 2017)

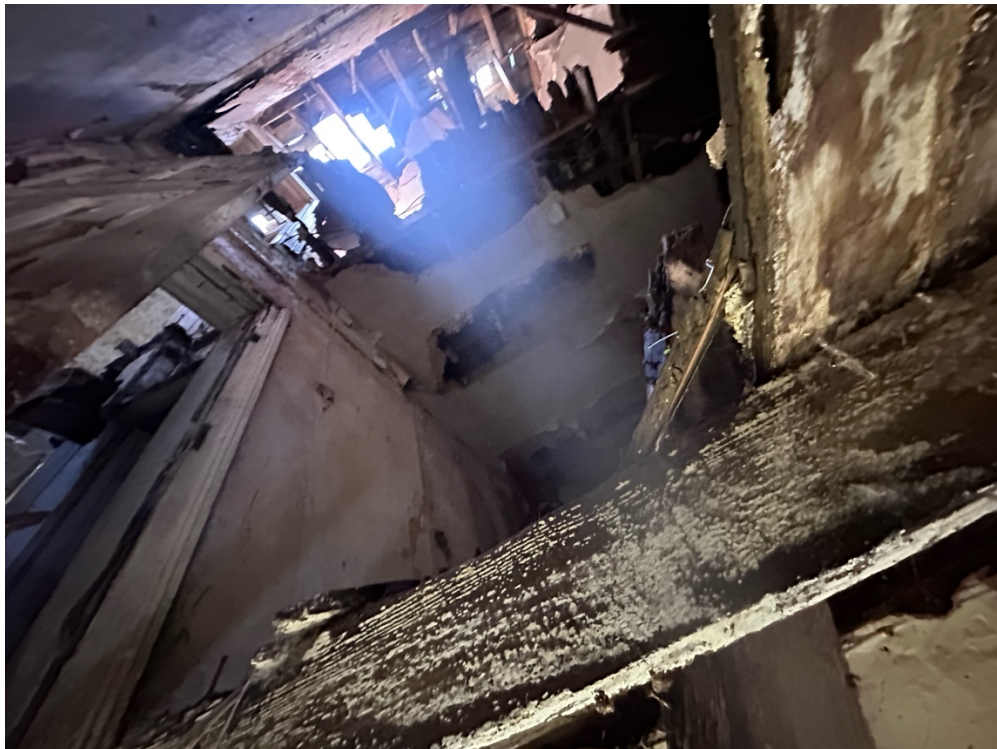
Plate No. 66. General view up from the rear of the first half landing, in No. 46 Dolphins Barn Street as it appeared in 2017. A close study of this photo shows that all of the internal timber floor and the roof structure was replaced during the 20th century, along with all joinery and linings. This structure is now too dangerous to enter, other than the entry hall. (Photo by Stephen Farrell, 2017)
