Proposed Redevelopment at Nos. 43-50 Dolphins Barn Street
Dublin 8

ARCHITECTURE
CONSERVATION
ARCHITECTS

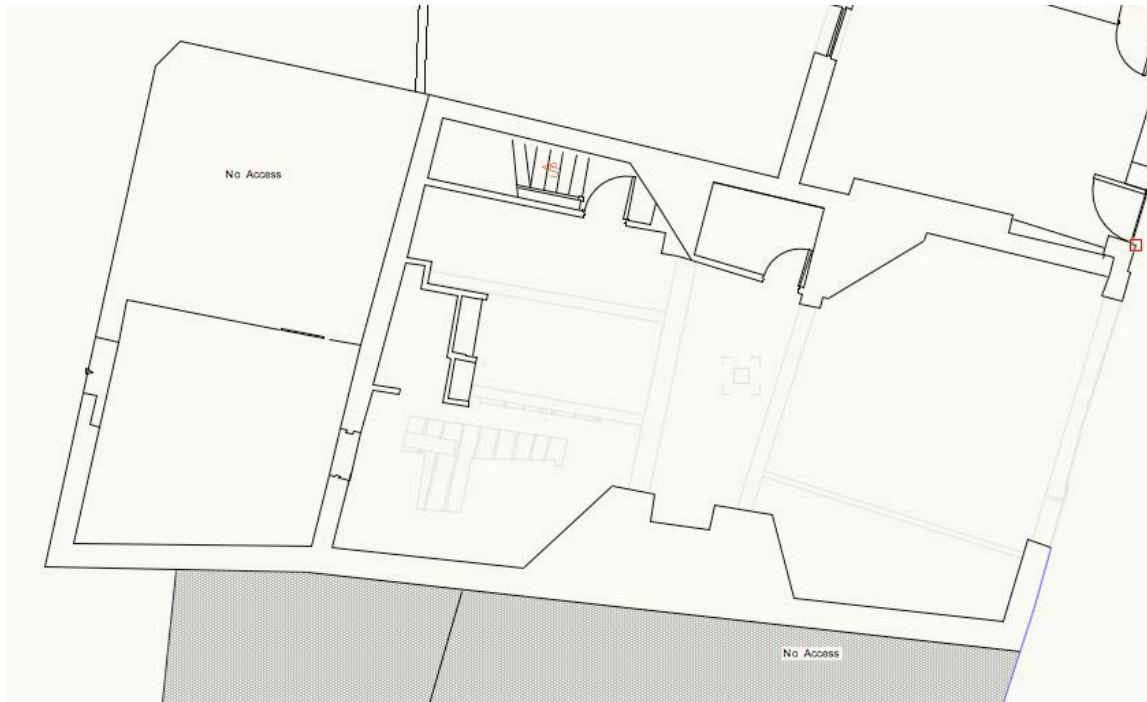
Plate No. 67. Measured survey drawing showing the ground floor in No. 47 Dolphins Barn Street as it currently exists. A 20th century shop currently covers most of the ground floor. No early features remain, other than the distinctive angled chimney breasts.

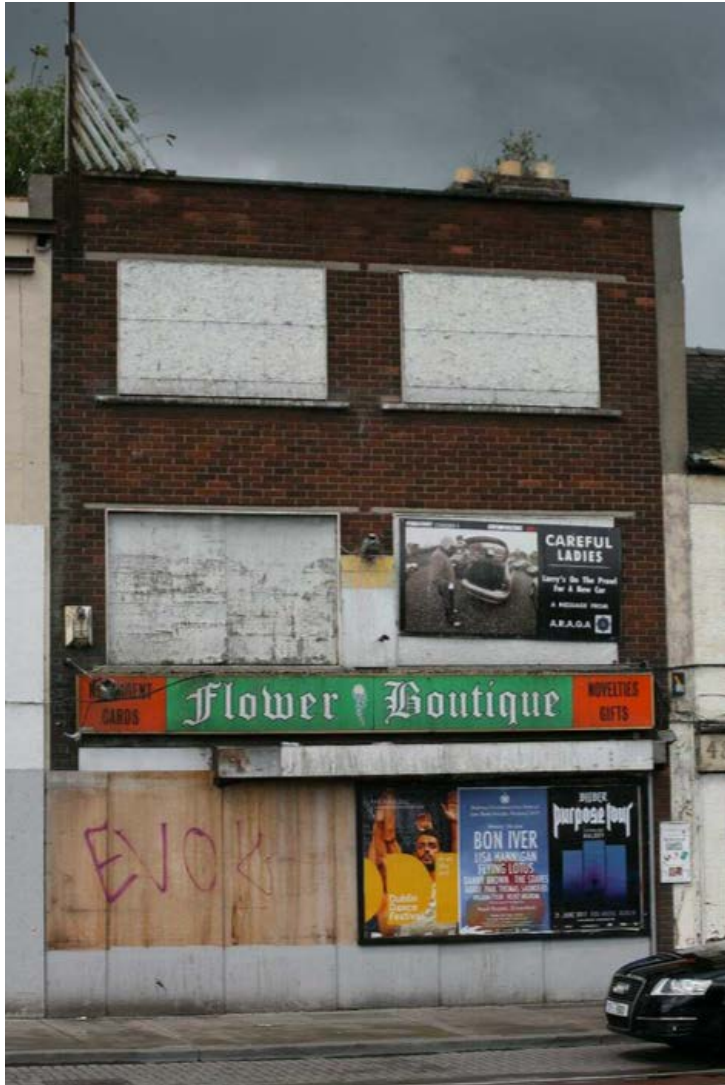
Plate No. 71. General view showing the front elevation to No. 47 Dolphins Barn Street as it appeared in 2017. The front wall, and the pitched slated roof, were completely replaced around 1960, to the design shown above. One of the large chimney stacks can be seen on the north party wall above. (Photo by Stephen Farrell, 2017)

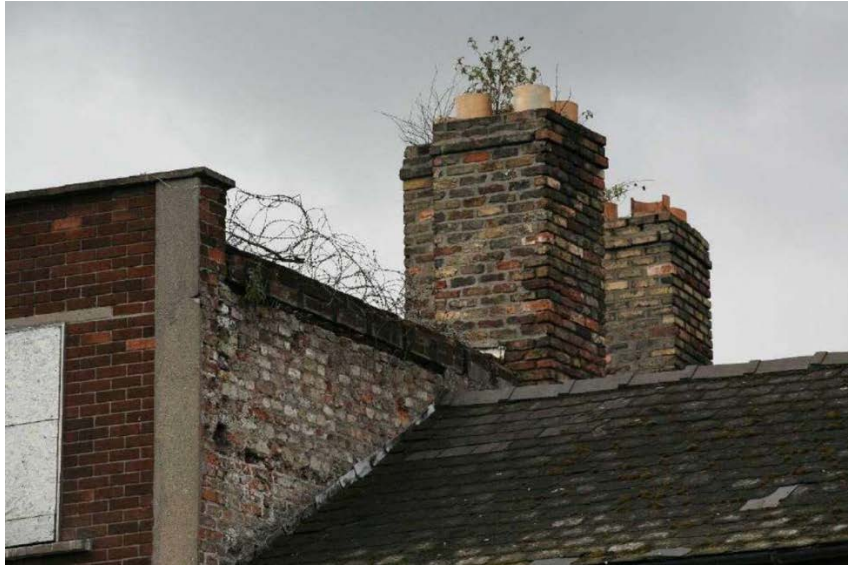
Plate No. 72. General view showing the north party wall and the two massive chimney stacks that served the corner fireplaces in No. 47 Dolphins Barn Street. (Photo by Stephen Farrell, 2017)

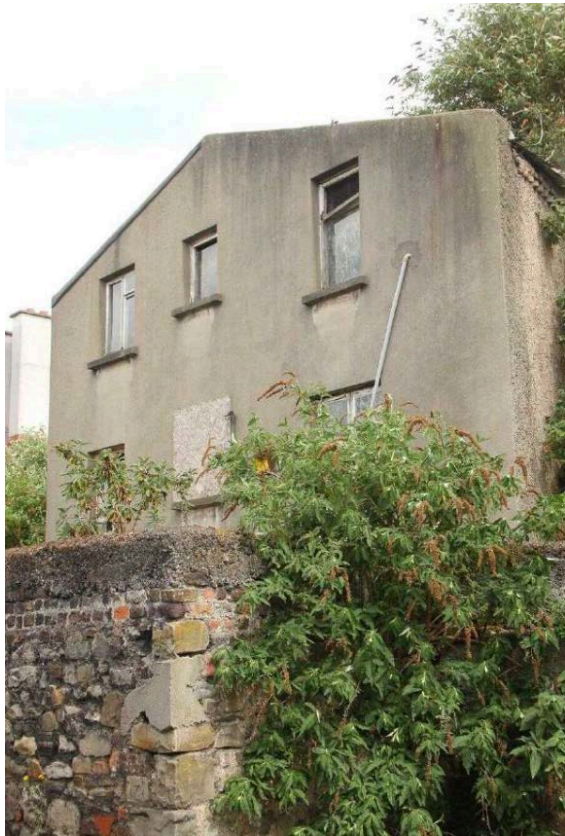
Plate No. 74. General view showing the rear elevation to No. 47 Dolphins Barn Street as it appeared in 2017. The shallow pitch of the rear half of the roof shows that the original gabled roof was replaced, probably around 1960. It is unclear how much of the rear elevation was also replaced. (Photo by Stephen Farrell, 2017)

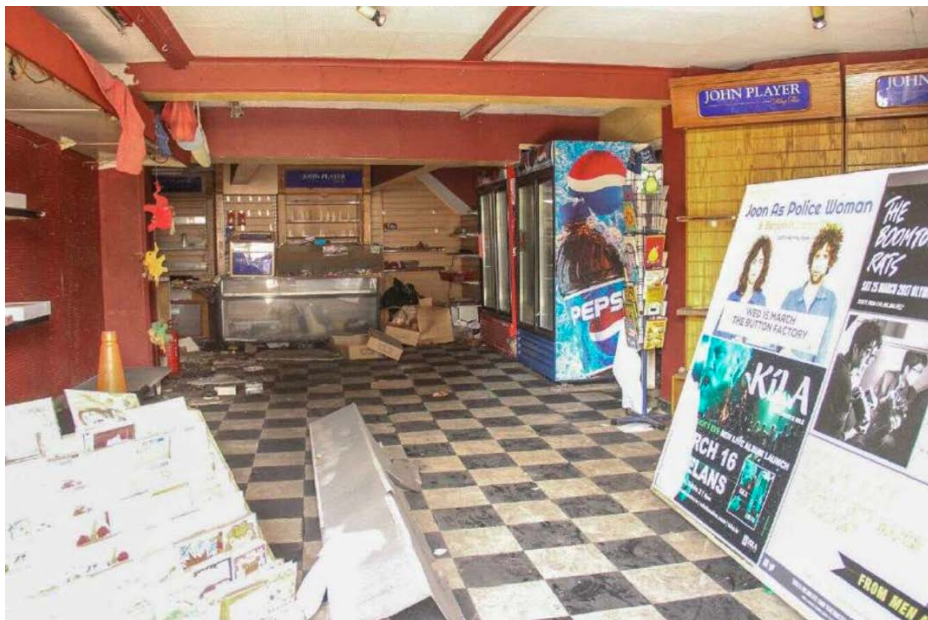
Plate No. 75. General view showing ground floor shop in No. 47, as it appeared in 2017. The John Player cigarette display at right covers one of the angled chimney breasts. The pair of red downstand beam that run from side to side, roughly correspond to the original stairwell walls. (Photo by Stephen Farrell, 2017)

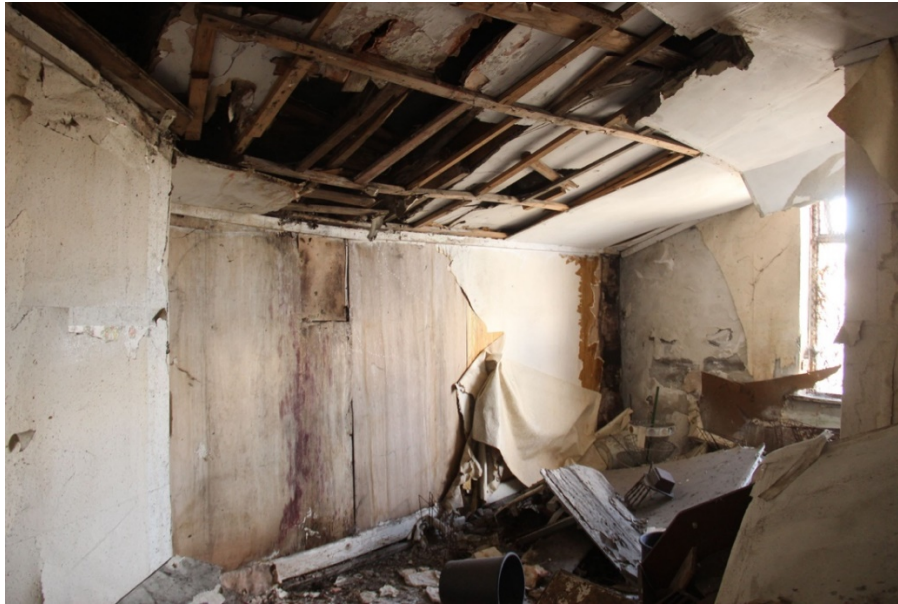
Plate No. 80. General view showing the appearance of the second floor south-west rear bedroom in No. 47 Dolphins Barn Street on the south boundary, as it appeared in 2025. The corner chimney breast is still in place in this room, although the original roof and ceiling has been replaced by later construction. (Photo by author, 2025)

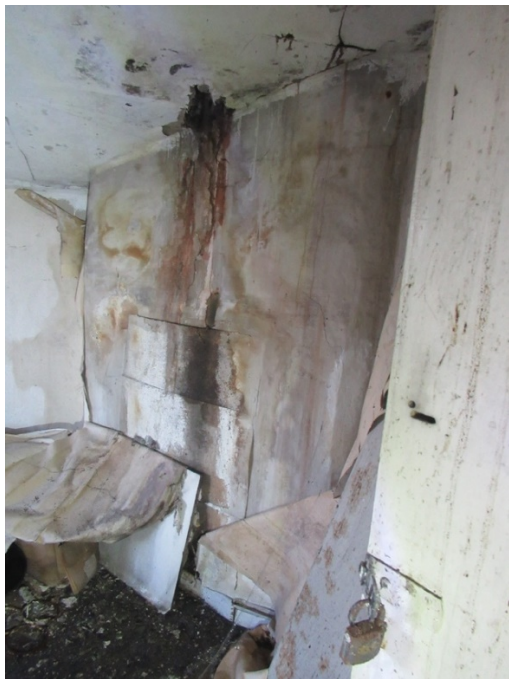
Plate No. 81. General view showing the appearance of the second floor north-west rear bedroom in No. 47 Dolphins Barn Street on the north boundary, as it appeared in 2025. The corner chimney breast is still in place in this room, although the original roof and ceiling has been replaced by later construction. This structure is now too dangerous to enter, other than the entry hall. (Photo by Stephen Farrell, 2017)

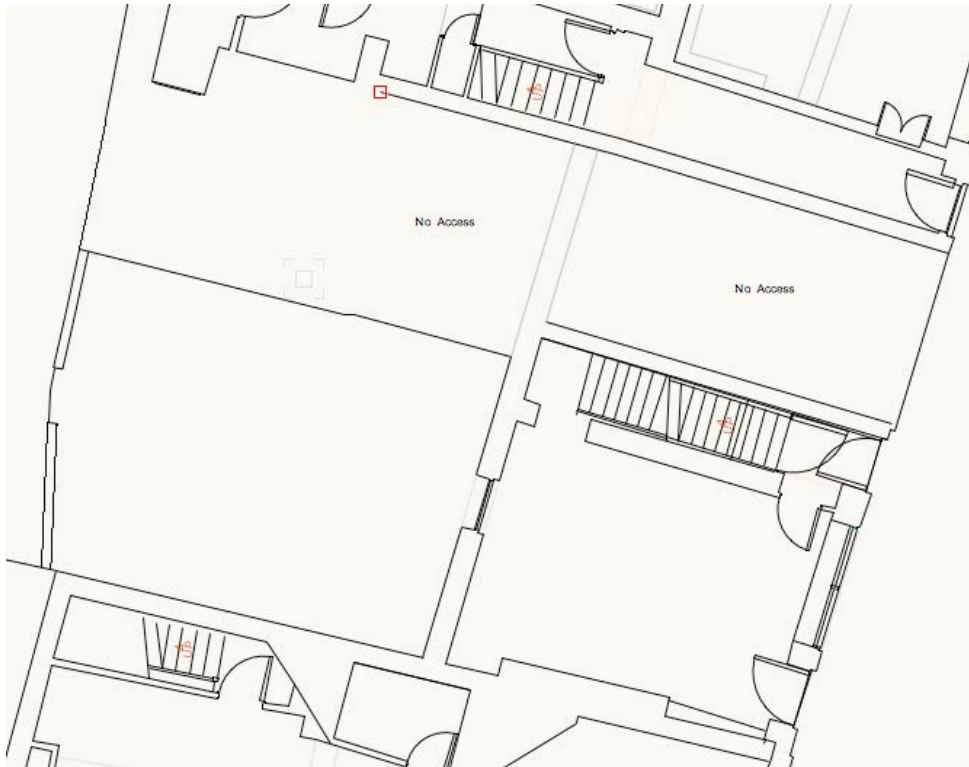
Plate No. 83. Measured survey drawing showing the ground floor in No. 48 Dolphins Barn Street as it currently exists. A 20th century shop currently covers most of the ground floor. No early features remain, due to the total replacement of the house between 1866 and 1888.

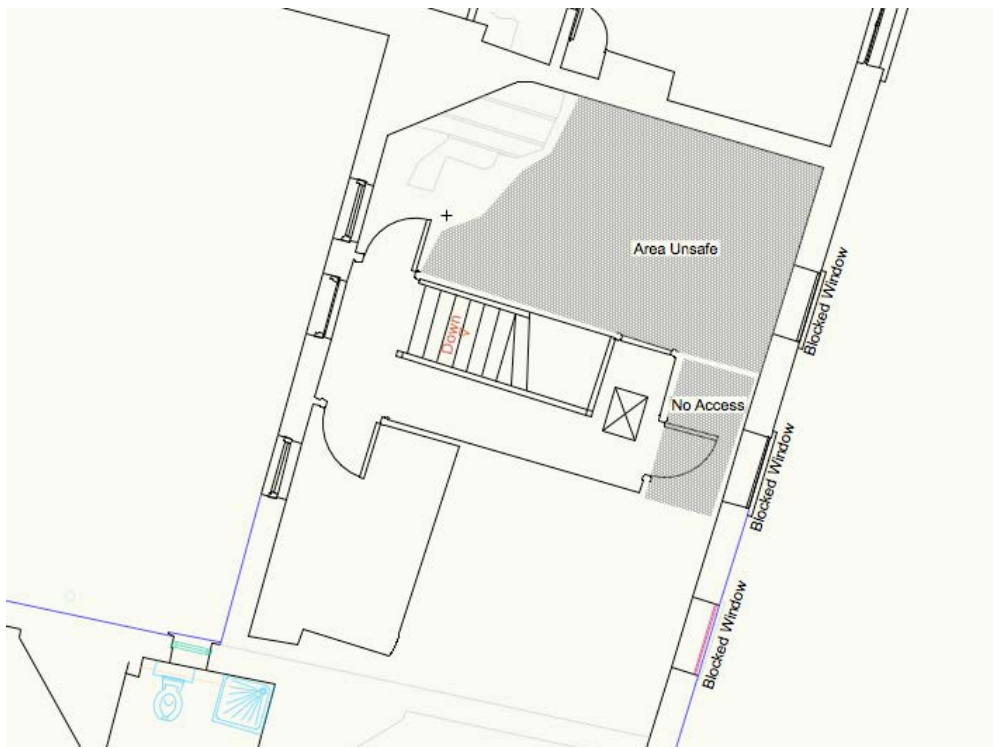
Plate No. 84. Measured survey drawing showing the first floor in No. 48 Dolphins Barn Street as it currently exists. Most of the first floor area was too dangerous for entry for survey. The angled chimney breast over the former vehicular laneway can be seen in the upper bedroom.

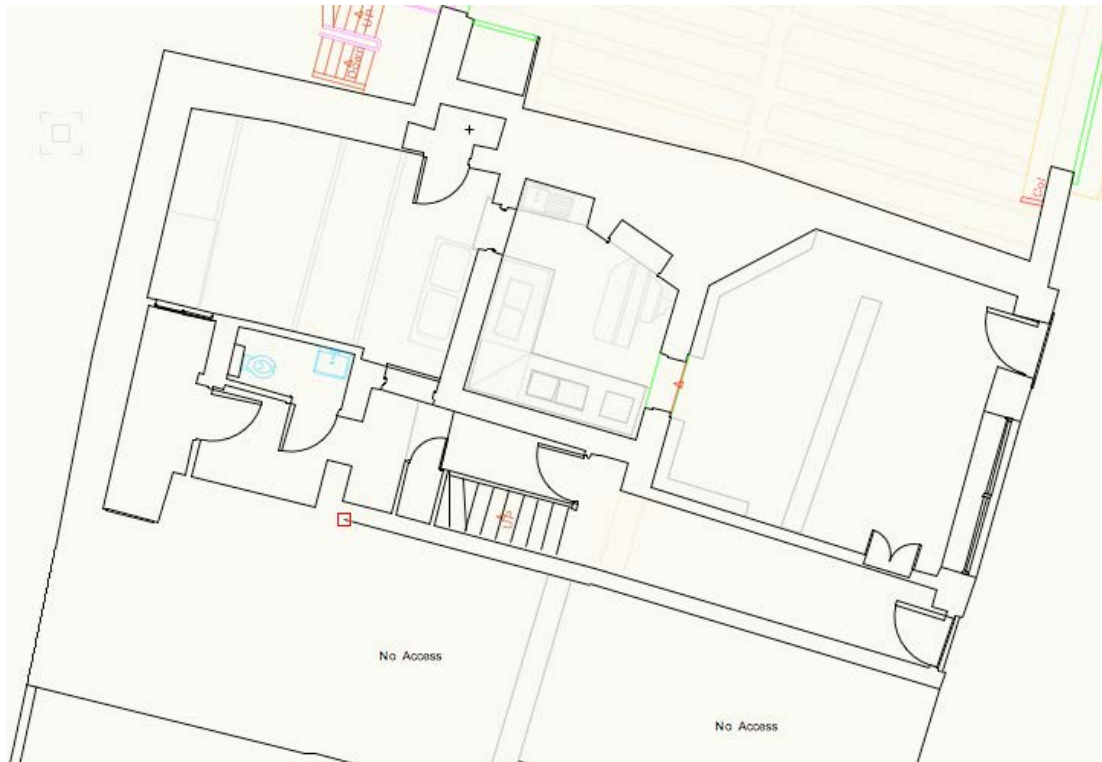
Plate No. 92. Measured survey drawing showing the ground floor in No. 49 Dolphins Barn Street as it currently exists. The massive chimney breast with angled fireplaces in the front and middle rooms suggest that they represent an early 18th century house that was heavily rebuilt during the second half of the 19th century. All of the joinery and other features date from the late 19th and 20th centuries.
