**Arboricultural Report  
Proposed Development at  
Crodaun  
Celbridge  
Co Kildare**

**March 2020**

| <u>Drawing Title</u> | <u>Drawing Subject</u> |
|---|---|
| 1) D1-TCP-Crodaun-03-20 | <b>Tree Constraints Plan</b><br>A plan depicting the predevelopment location, size, calculated constraints and simplified tree quality category system |
| 2) D2-AIA-Crodaun-03-20 | <b>Tree Impacts Plan</b><br>This plan represents the effects of the proposed development works on the above tree population and depicts trees to be retained and removed. |

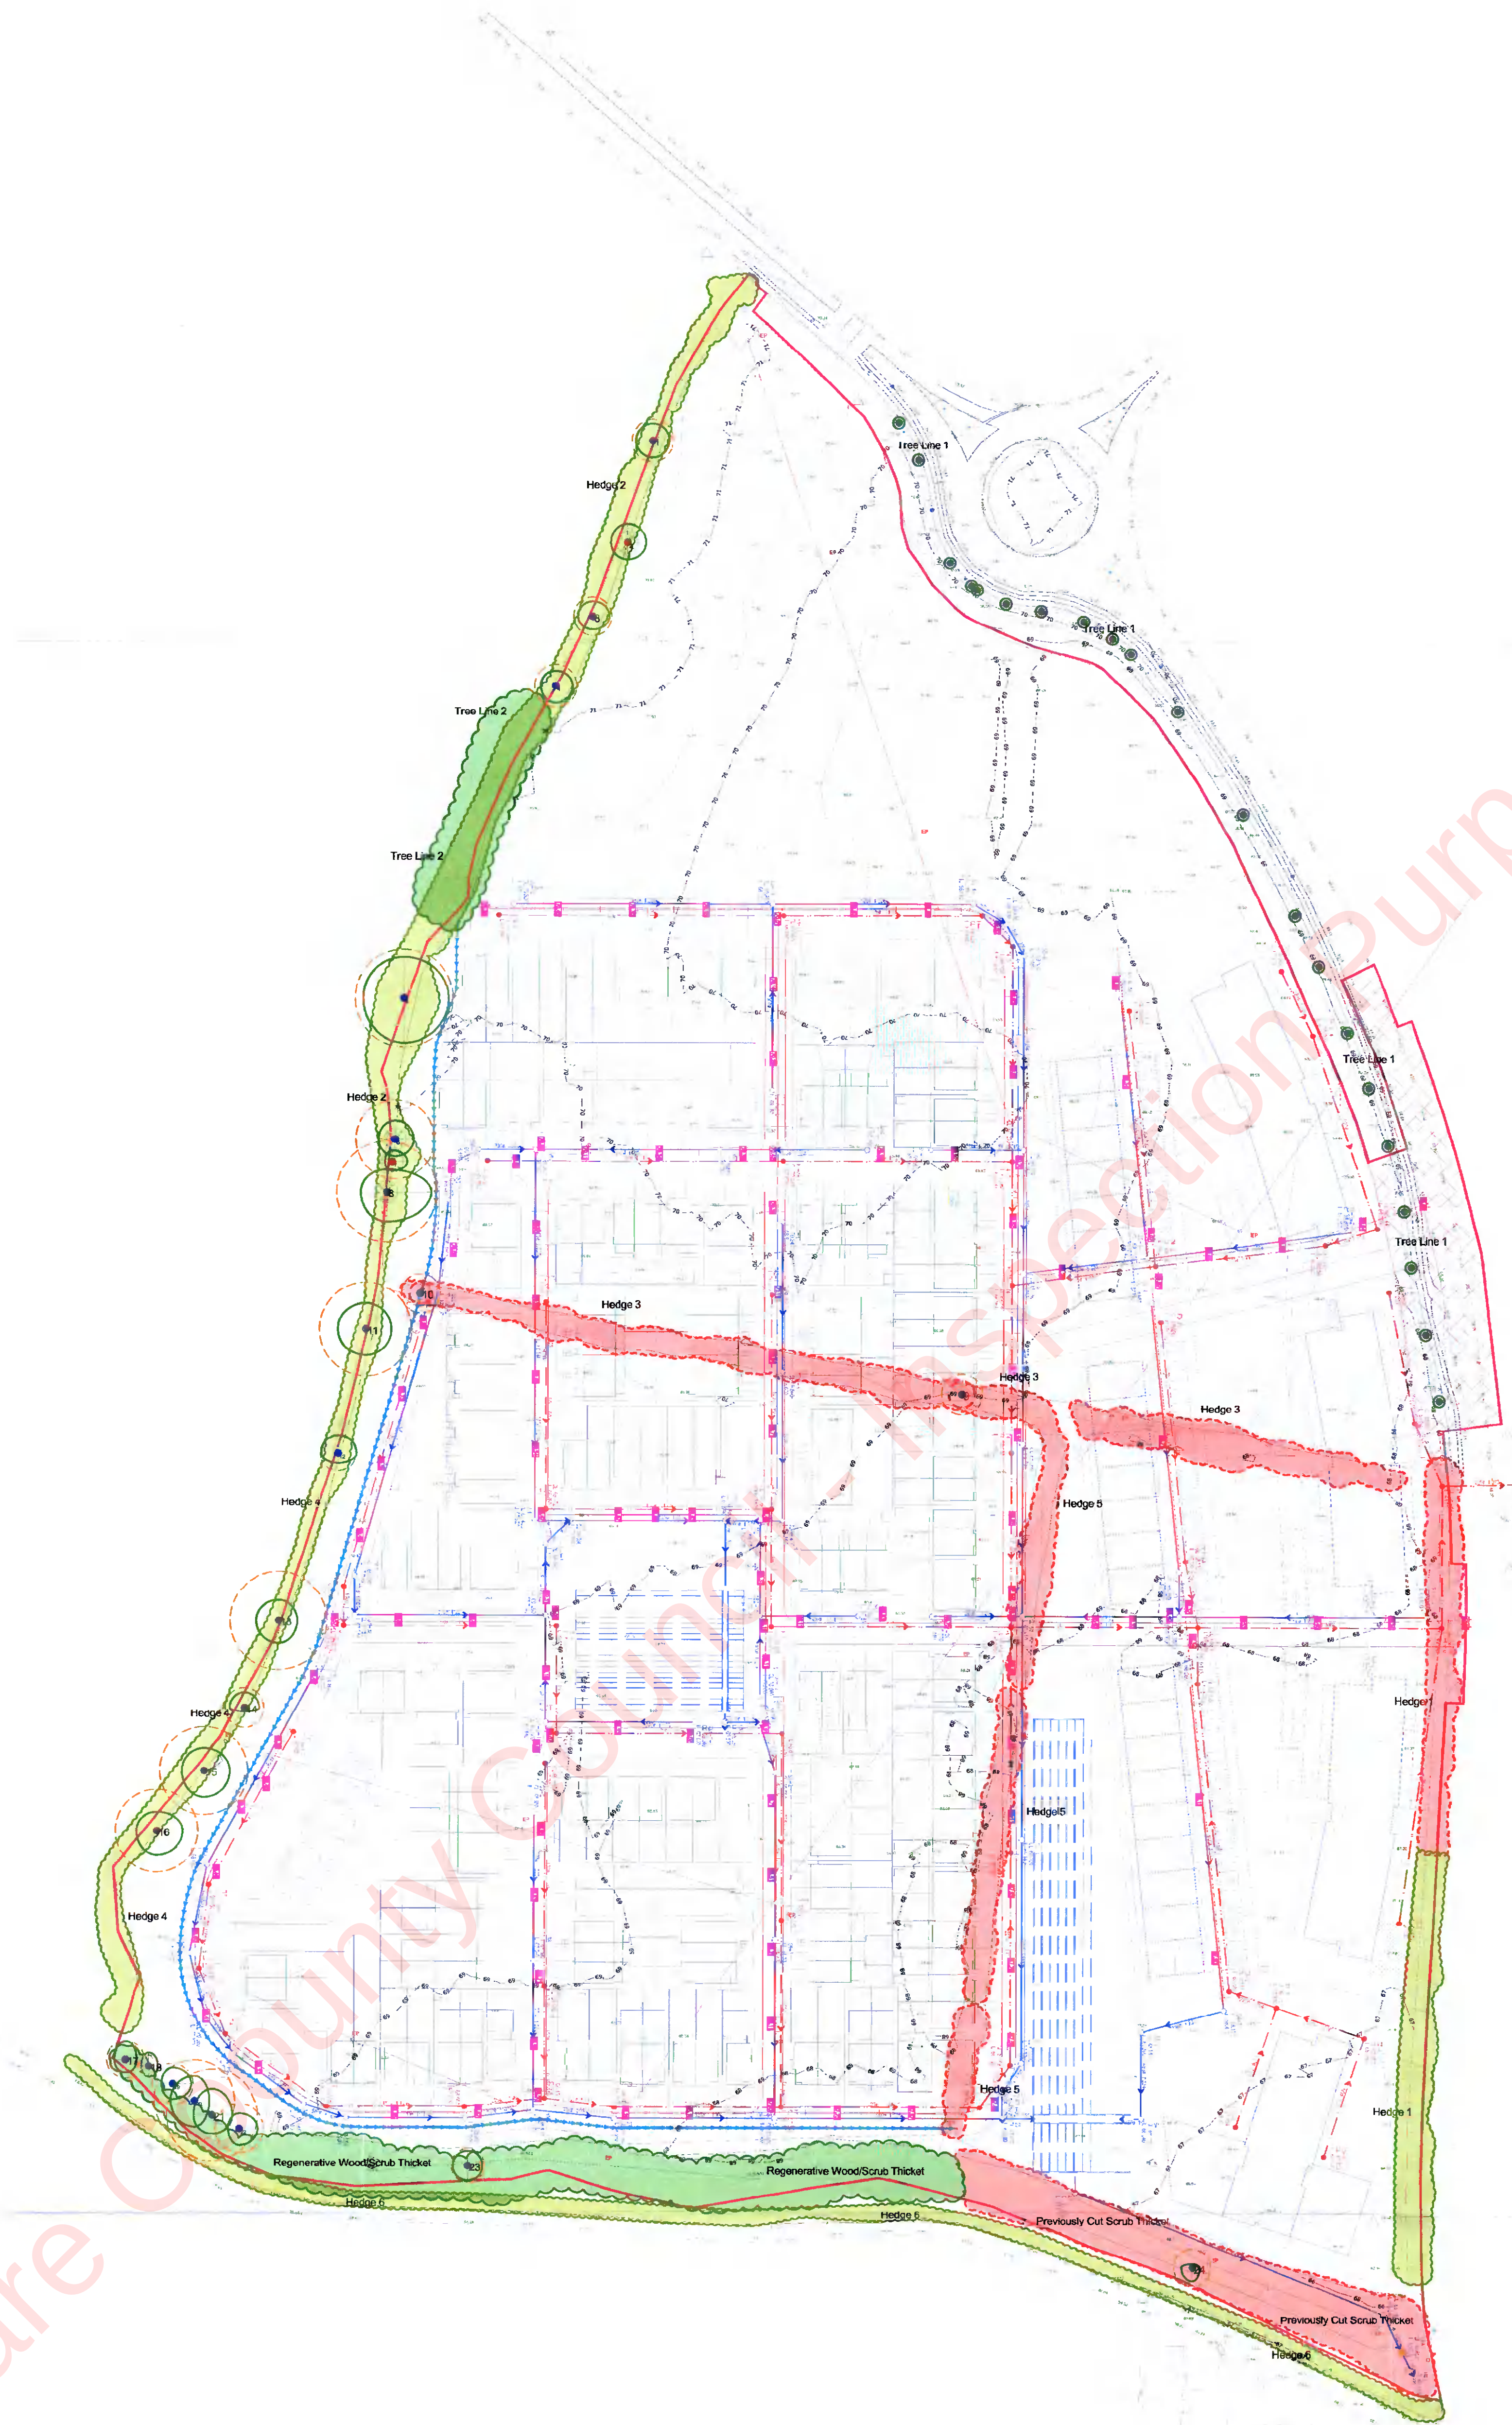
The perceived development impacts have been illustrated graphically on drawing “D2-AIA-Crodaun-03-20”, where trees denoted with “Broken Red” crown outlines will be removed and those denoted with “Continuous Green” crown outlines will be retained.
