INDEPENDENT HOUSE STUDENT ACCOMMODATION  
87-93 MIDDLE ABBEY STREET  
**LRD PLANNING SUBMISSION - ARCHITECTURAL HERITAGE IMPACT ASSESSMENT**

MARCH 2025

**MOLLOY & ASSOCIATES**  
CONSERVATION ARCHITECTS

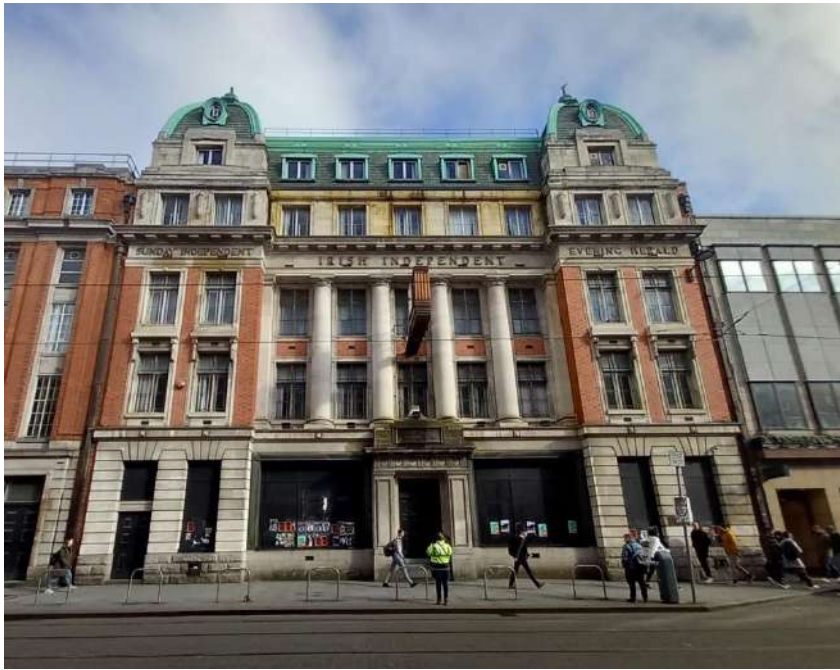
The shopfront windows have heavy bronze panelled surrounds and sill guards. The original window frames are missing, and the windows are presently boarded up. Original bronze window frames, with secondary timber-framed glazing remain on first, second and third floors. However, on the top dormer floor, only one of the original windows is still intact. The original oval windows remain in each of the cupolas at the roof level. The windows are in need of extensive refurbishment.

Plate 1: The front elevation of 87-90 Middle Abbey Street, Independent House [Zone 1].

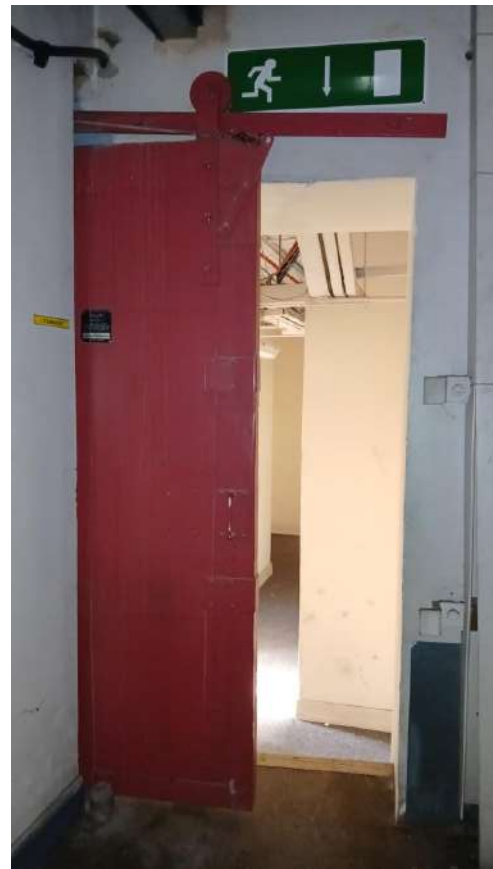
**Plate 12** Steel fire doors separate the connections between Independent House and Emerald Chambers.

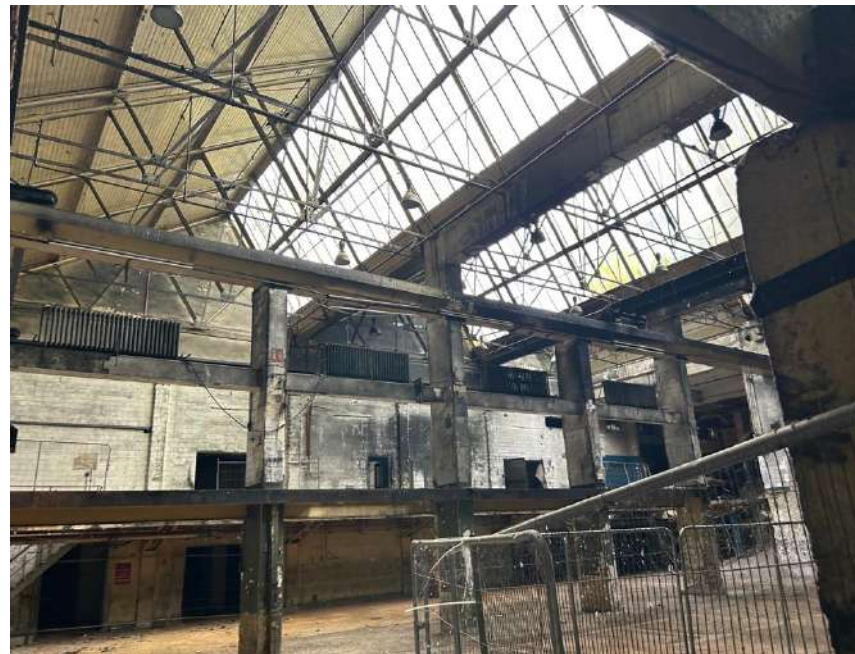
**Plate 16:** The interior of the Printing Hall (Zone 3)

The present three-story height is a consequence of the recent removal of the original ground floor level. The remnants of concrete gantries overlooking the hall level have also been partially demolished, and rebar left exposed. In addition, part of the floor in Zone 4 has been collapsed in, with the debris piled to form a temporary ramp of sorts to the basement floor of the machine hall. It is not known precisely when these works were undertaken, but it predates 2006. It is noted that all former industrial machinery has been previously removed from the printing hall.

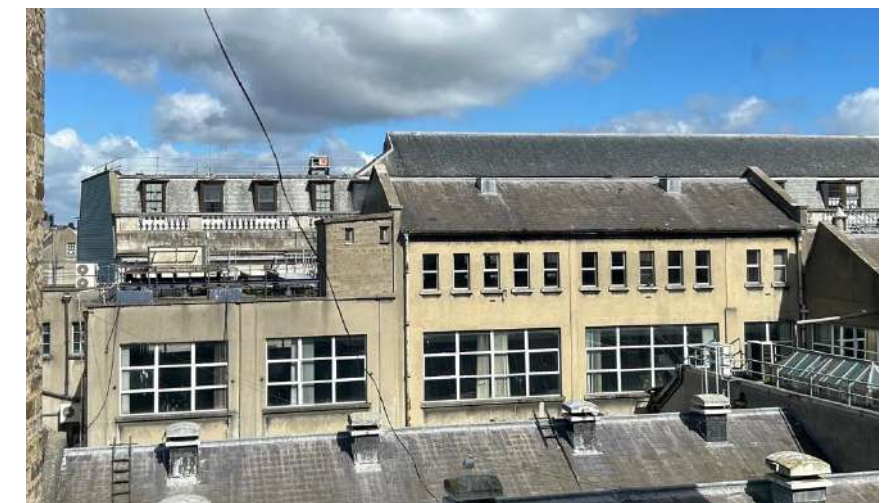
**Plate 24:** Zone 4b, Rear elevation of the former distribution centre and offices for Independent Newspaper group, fronting onto Prince's Street North. Replacement uPVC windows throughout.

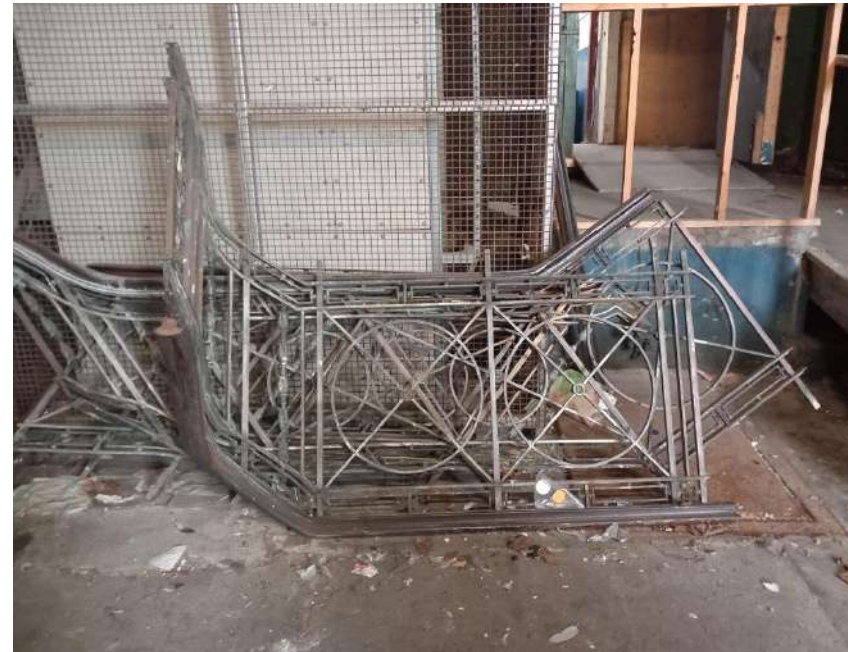
**Plate 52** The original balustrade pertaining to the stairs in Independent House have been cut and dismantled. The high-quality sections and are in a salvageable condition and will be reinstated in their original location.

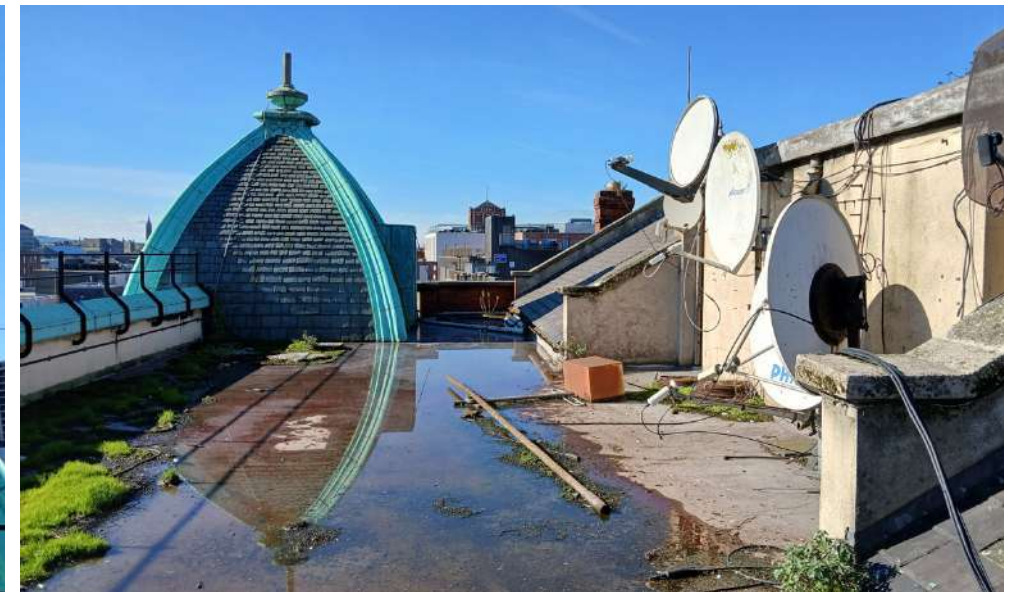
**Plate 27:** Main roof of Independent House facing west. The condition of the concrete roof slab has deteriorated on account of the drainage issues and degradation of roof linings.

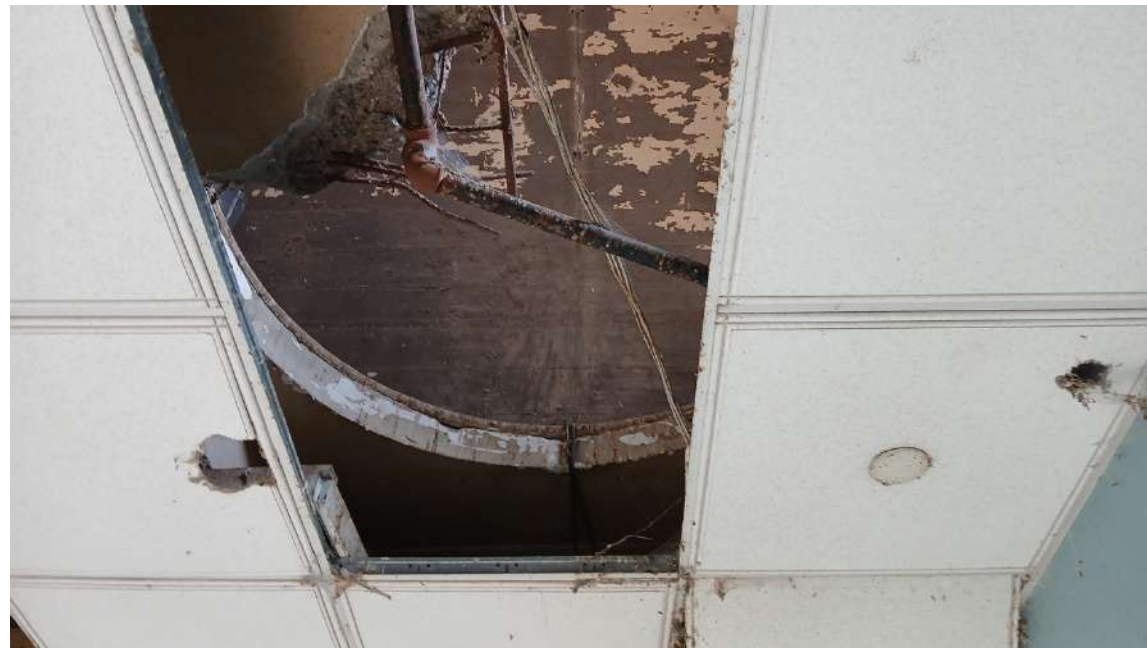
**Plate 32:** There is no direct roof access to the dome on the east. Historically, access was provided from 4<sup>th</sup> floor below, as indicated by the clean circular to the concrete slab, concealed above the contemporary suspended ceiling. Note the partial demolition of roof slab structure, exposing the internal rebar, which has corroded.

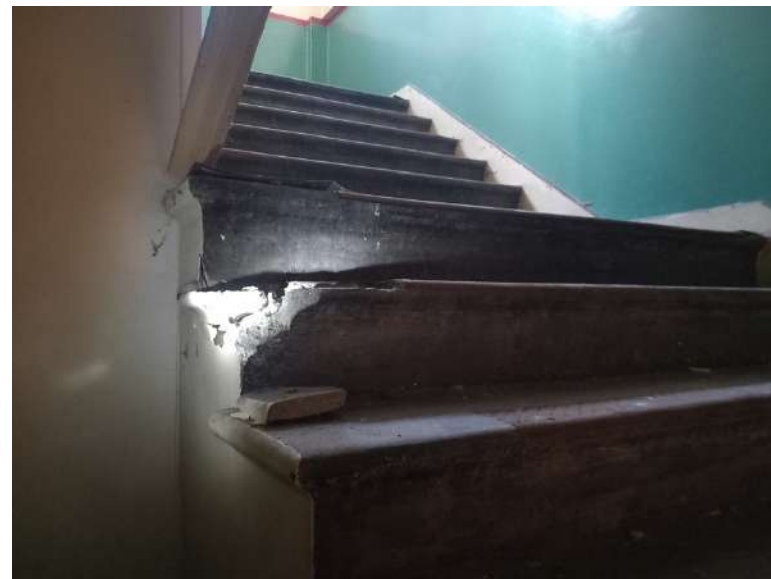
**Plate 39:** Detail of impact damage to polished concrete stair. Note: handrail and balustrade has been cut and is missing.

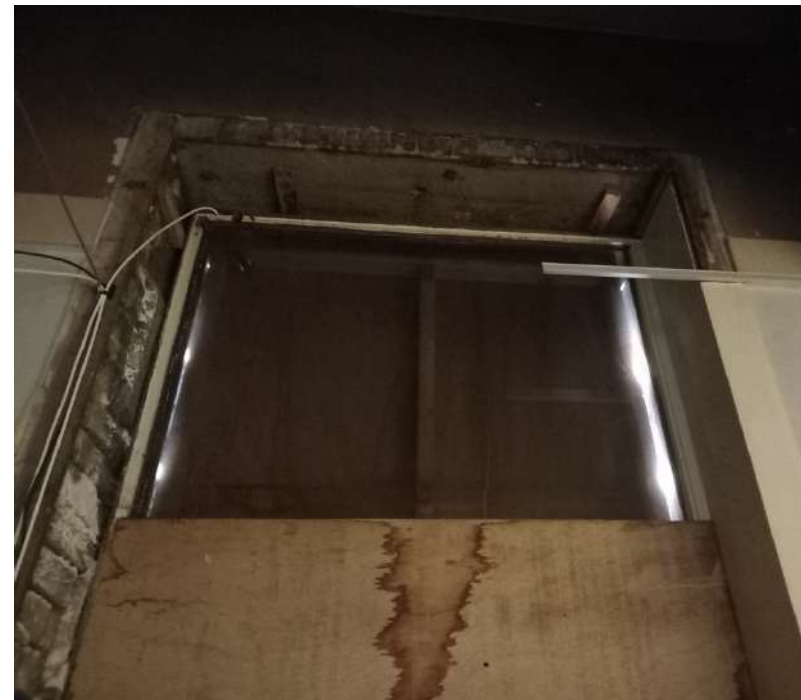
**Plate 43:** Window frames and architraves missing from entrance lobby.

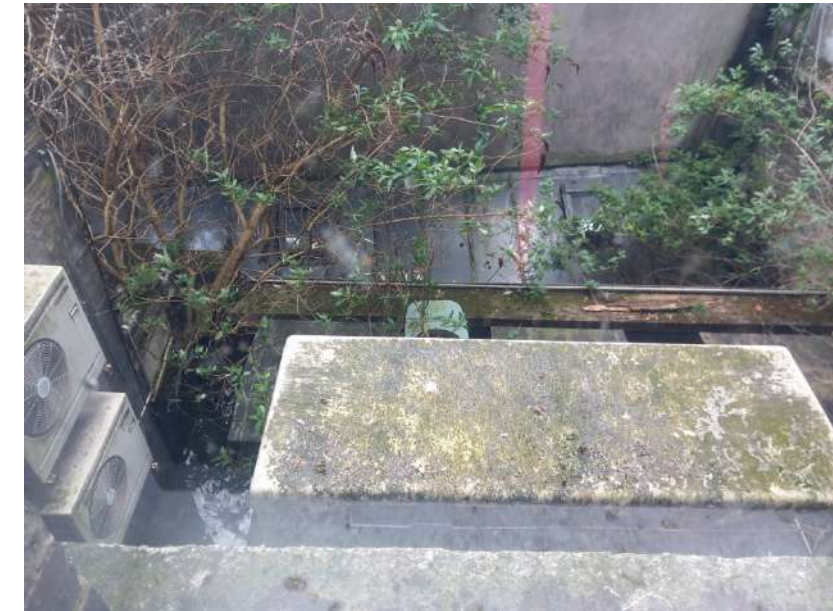
**Plate 119:** The lightwell is in very poor condition resulting in water ingress impacting the lower-level rooms.

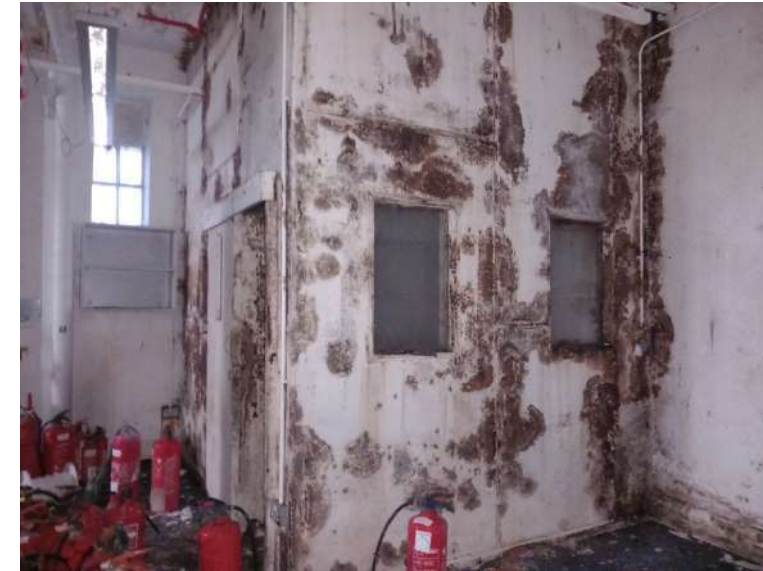
**Plate 137:** Contemporary partition forming internal room. Steel window to William's Lane. The structure has been impacted by water ingress in this area and the condition of embedded steel in concrete frame to be examined by engineer.

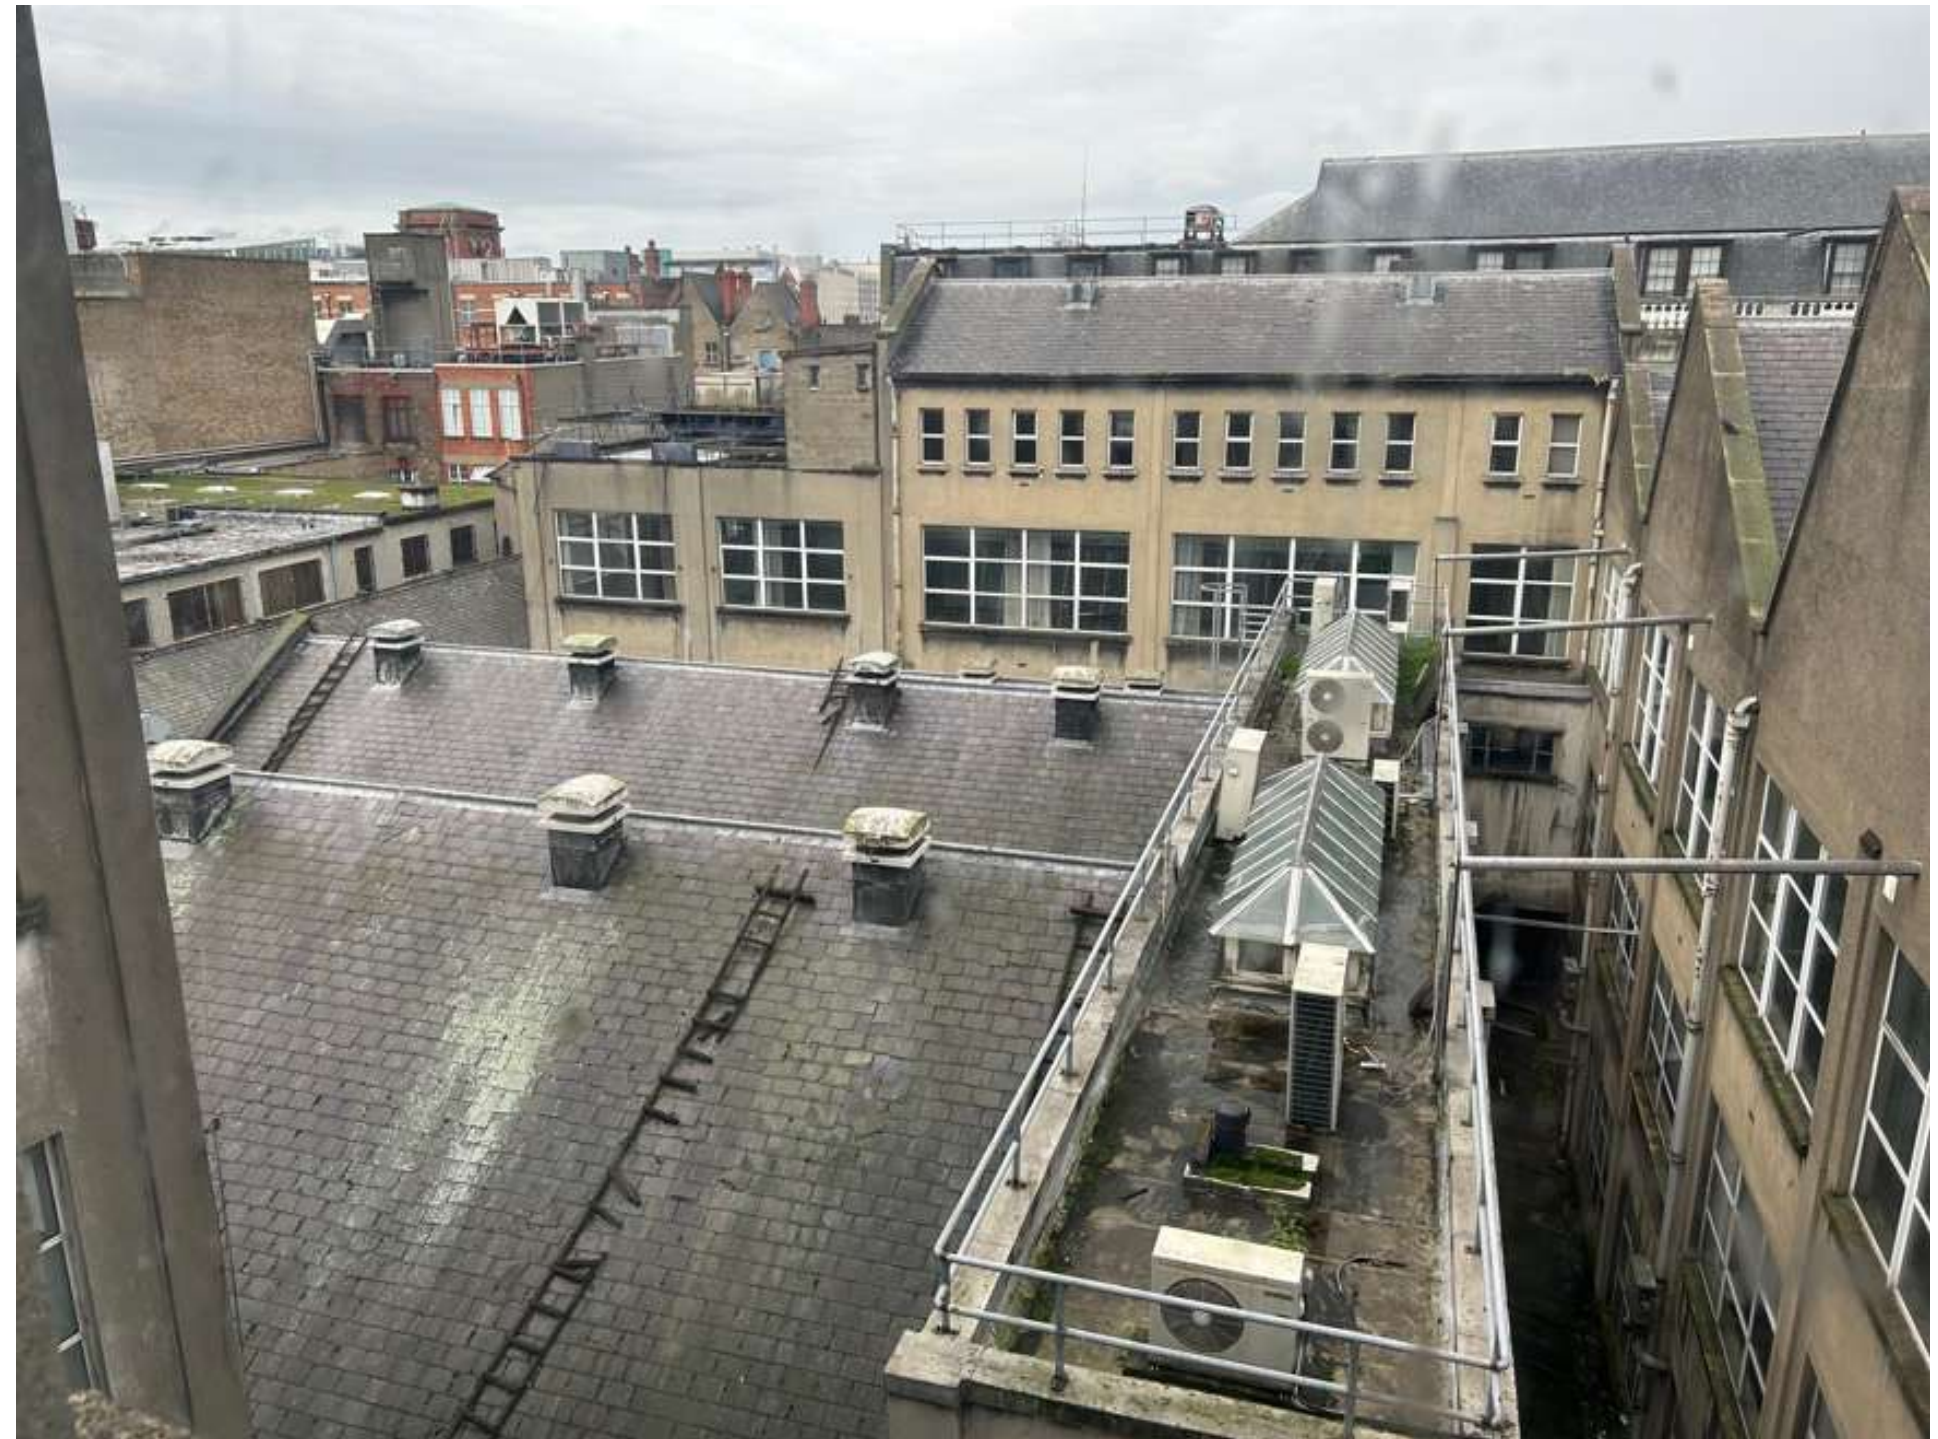
**Plate 186:** View over the machine room roof towards the rear (south) elevation of Area. Slate roof finish to south facing pitch, with rolled lead ridge. Multiple cracked and slipped slates visible. Ventilation stacks dressed in lead.

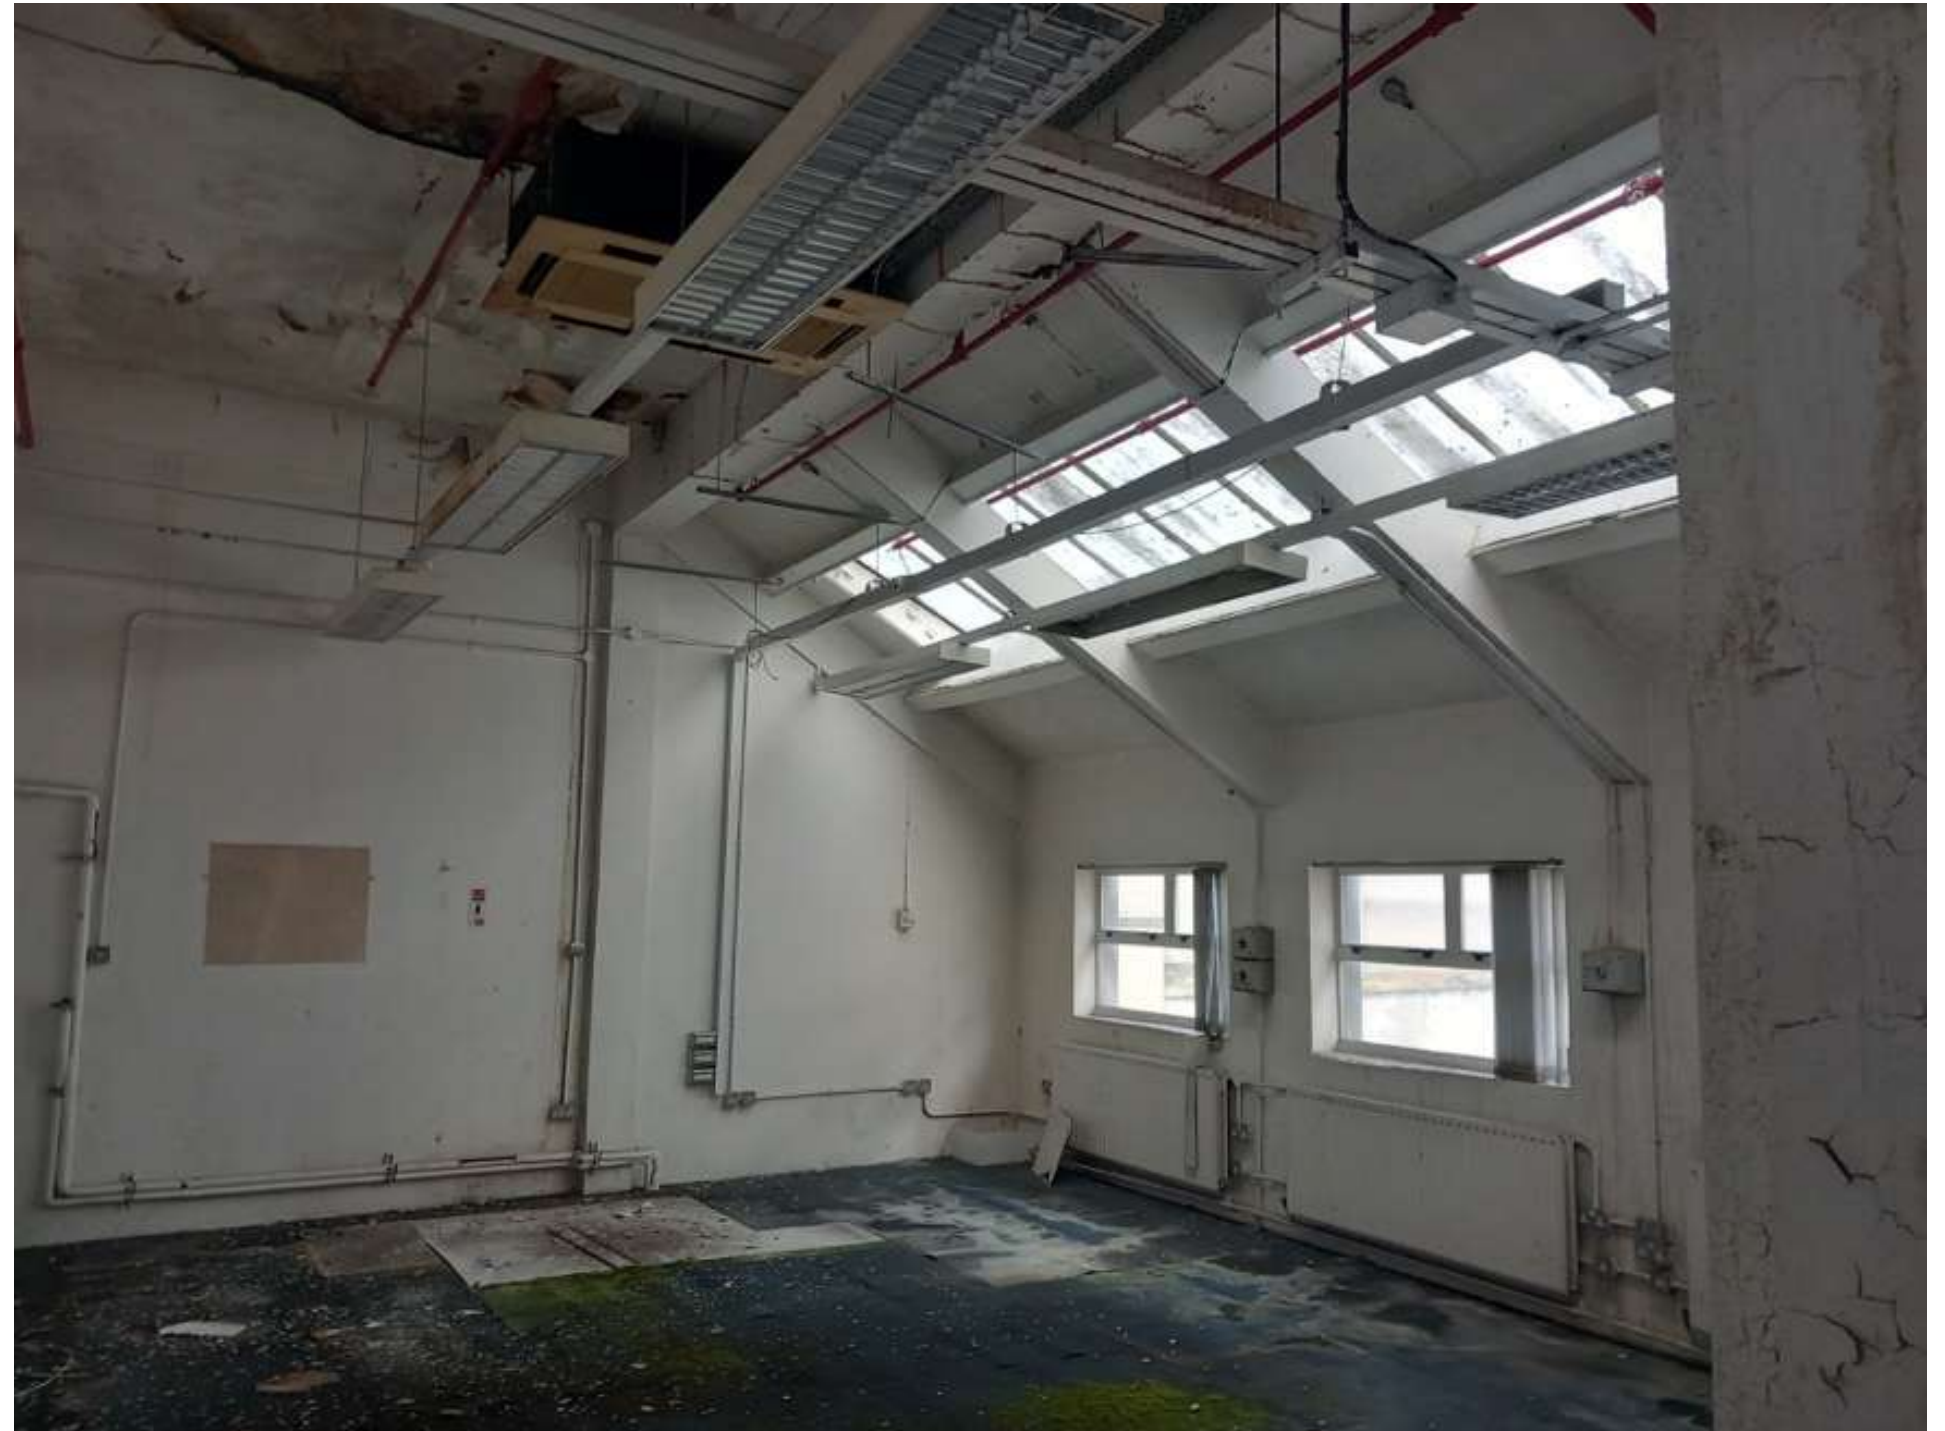
**Plate 268:** Zone 4, second floor annex. North facing rooflight and pitched profile exposed internally. Contemporary windows onto Prince's Street North, contemporary services and raised access floor throughout. Damage due to water ingress evident.

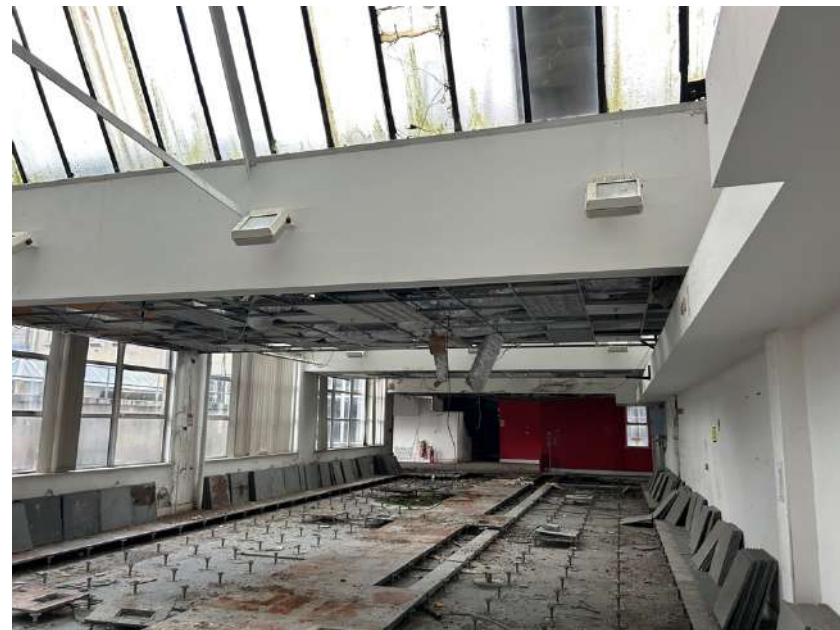
**Plate 278:** View facing north. Rooflights in north-facing pitch. Contemporary windows. Raised access floor. Damage due to sustained water ingress.

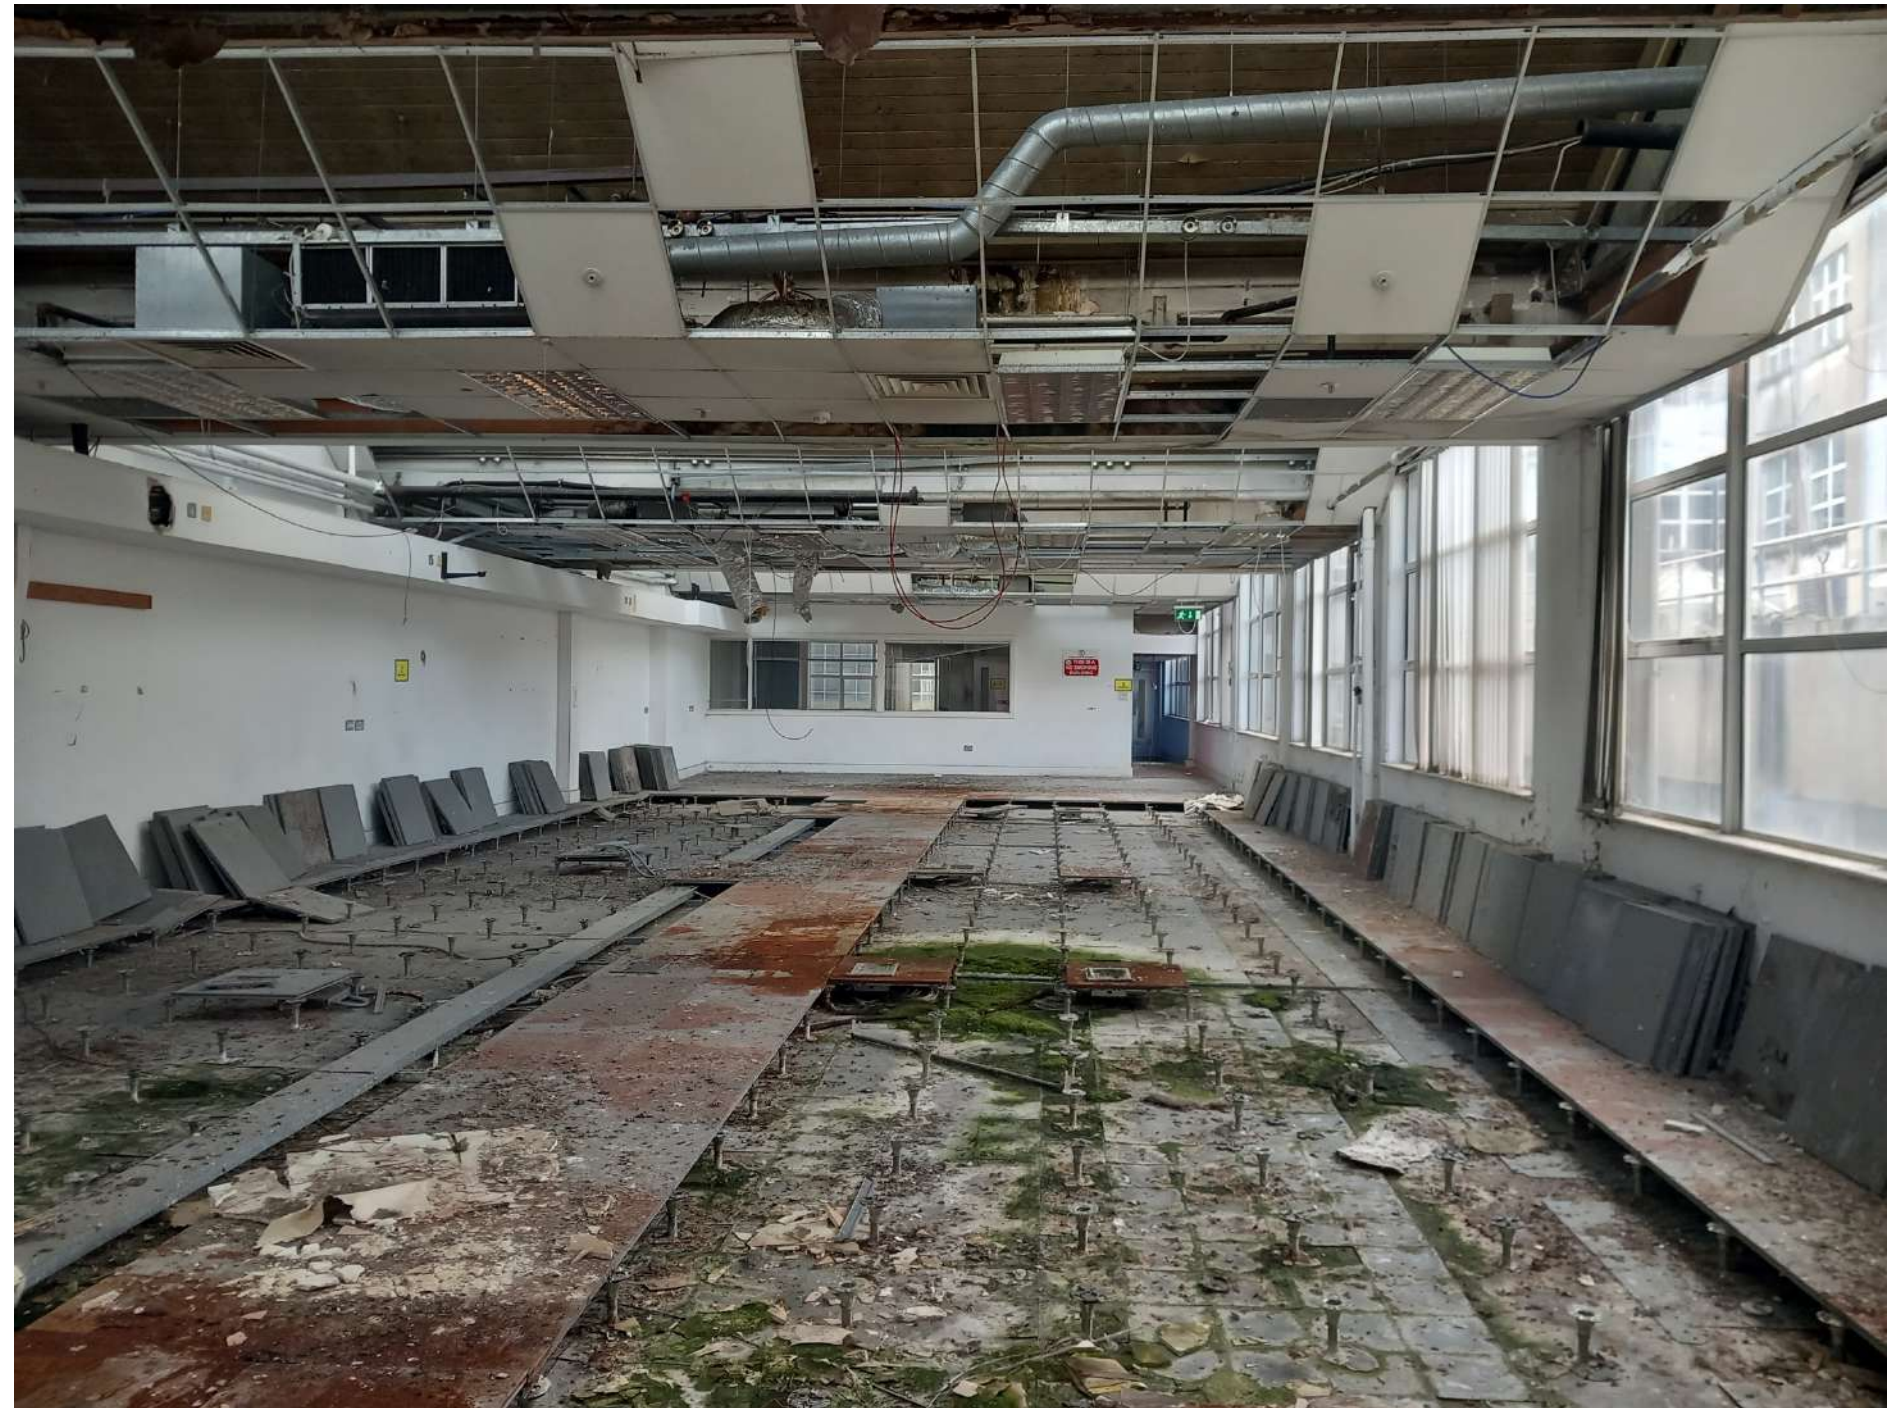
**Plate 279:** View facing south towards contemporary partition. Sawtooth roof above contemporary suspended ceiling. Contemporary windows. Raised access floor. Damage due to sustained water ingress.

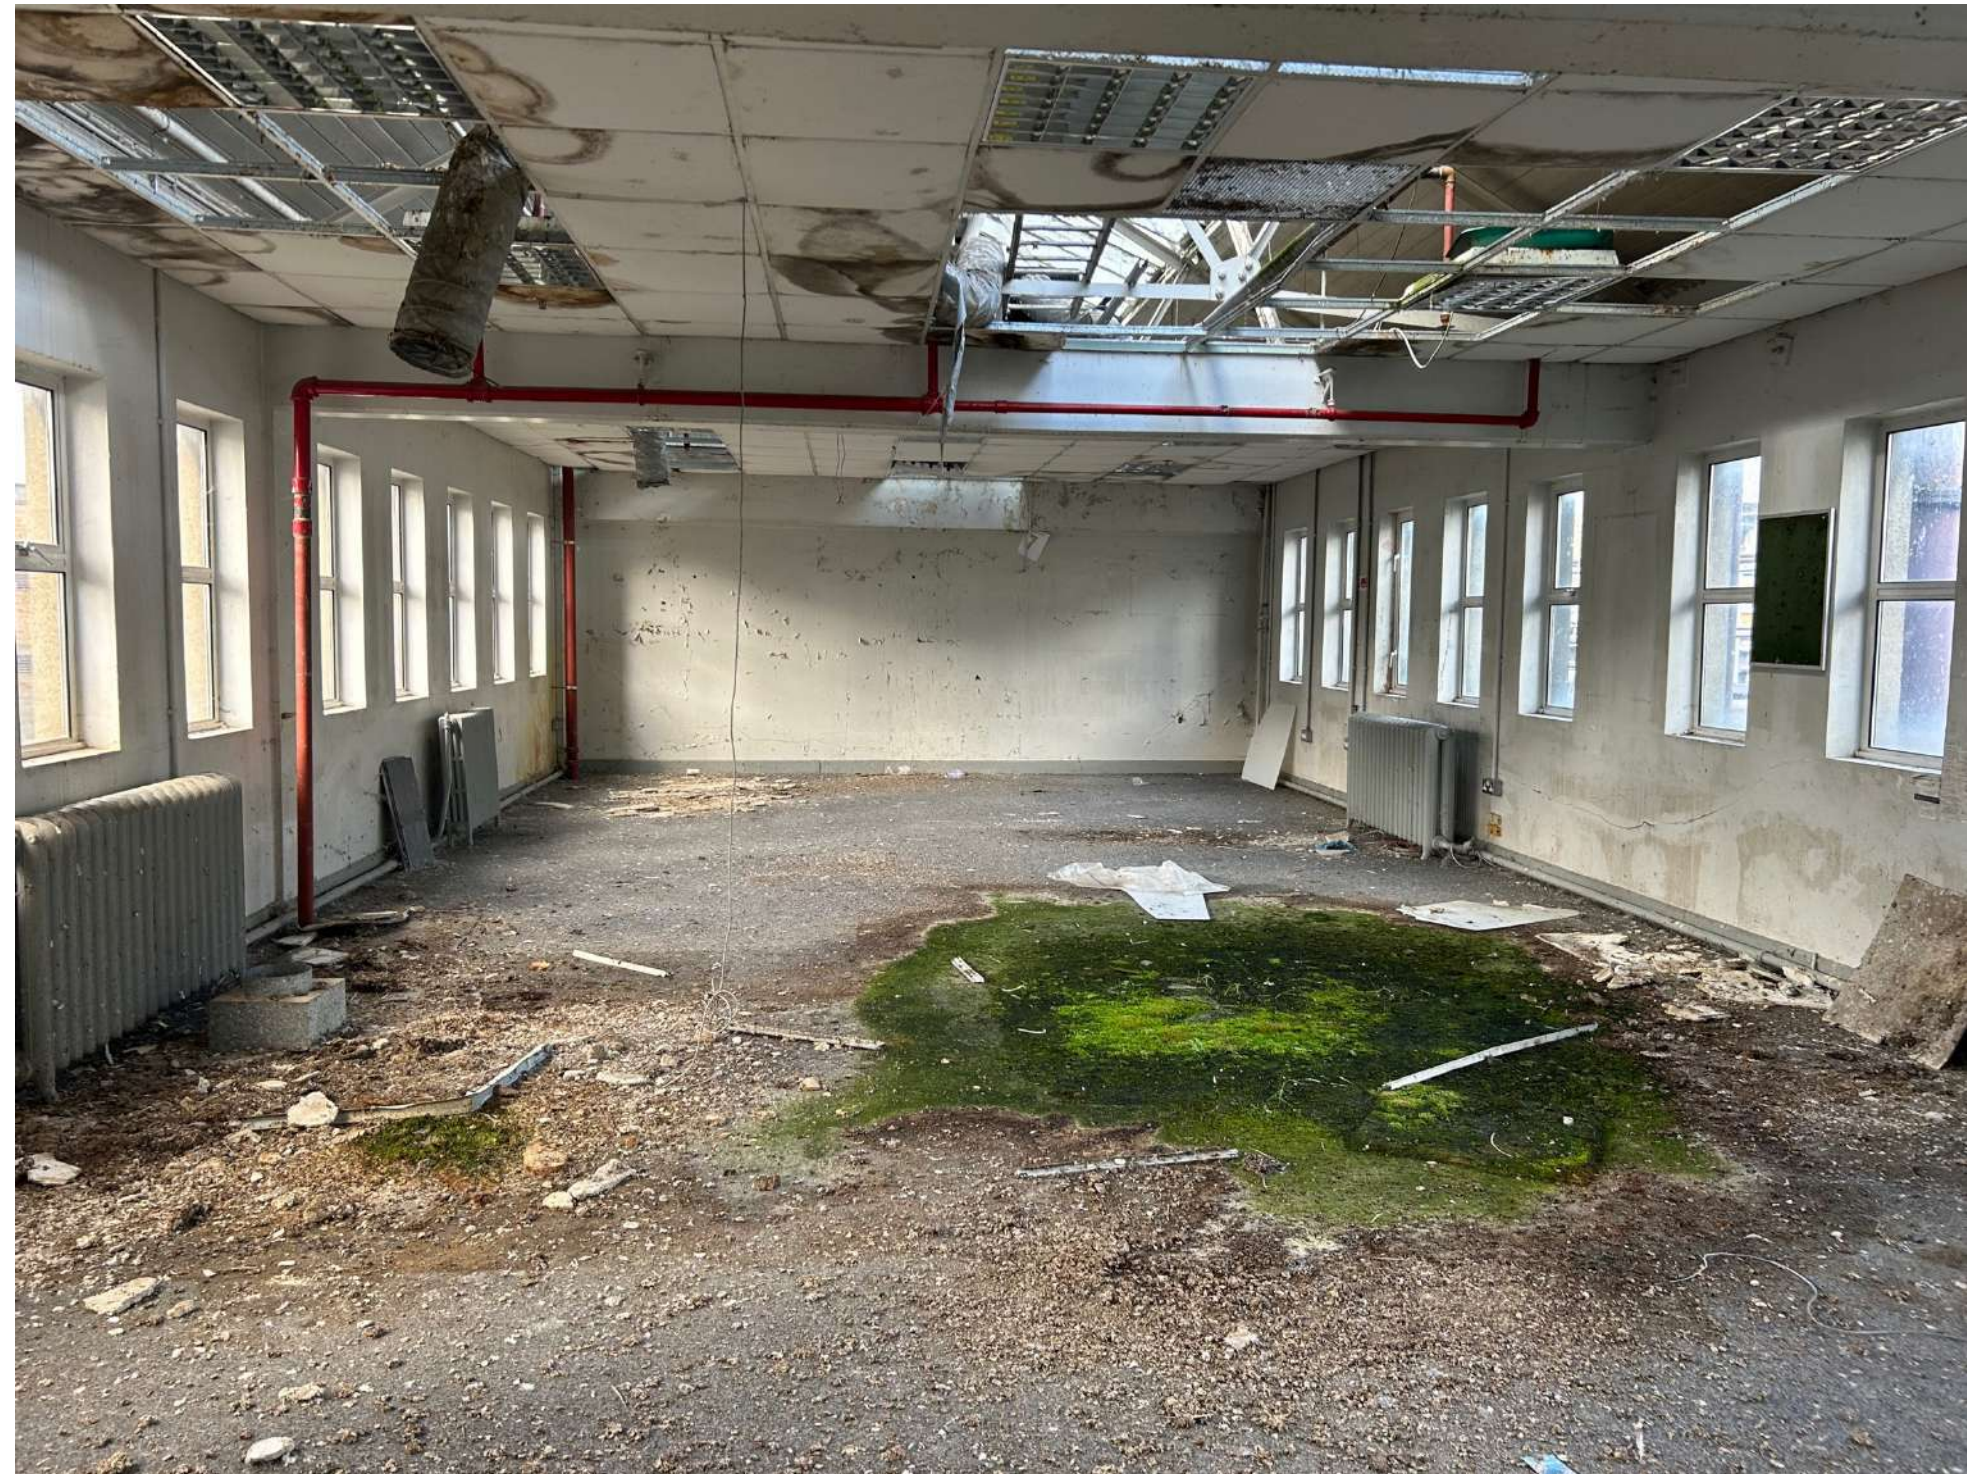
**Plate 281:** Top floor (former library). Steel truss pitched roof, with north facing rooflights, in poor condition, above contemporary suspended ceiling panels. Contemporary windows frame to north and south elevations. Sustained water ingress and pigeon guano has resulted in deterioration of the building fabric.
