# BS5837: TREE SURVEY & RECOMMENDATIONS

On behalf of the  
Homeland Group

Mungret  
Co. Limerick

July 2025

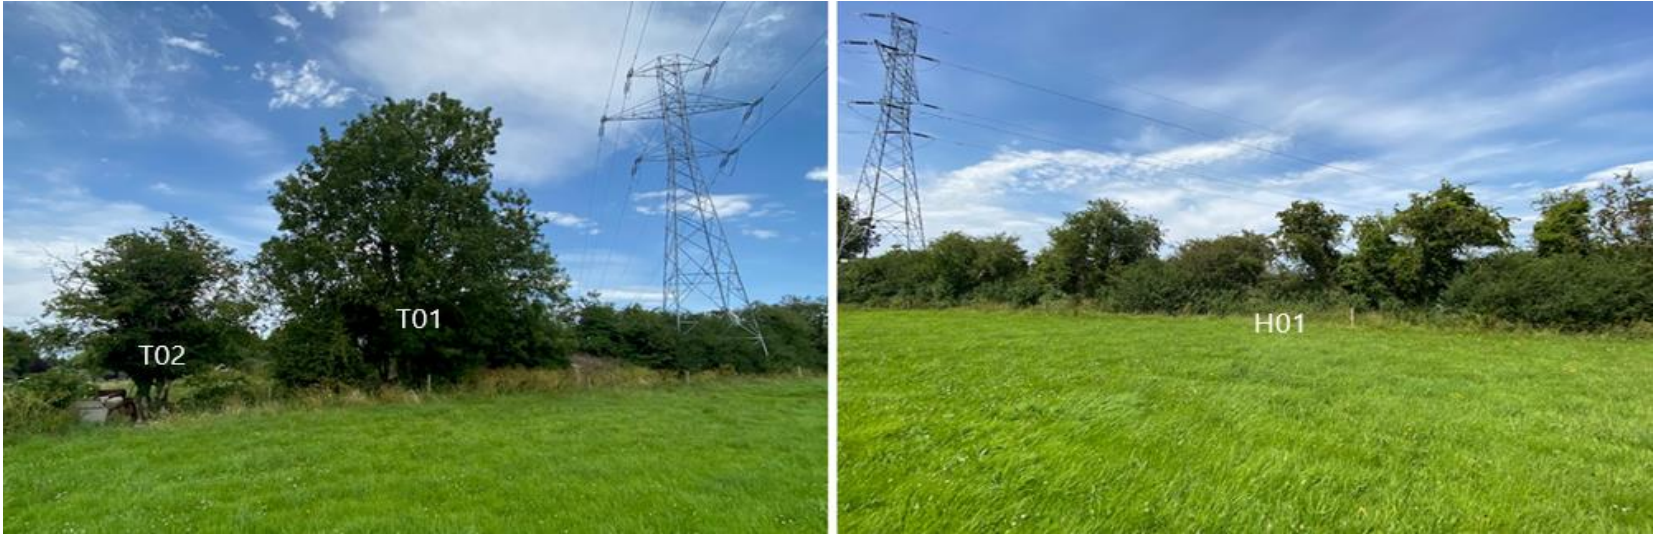
| TREE NO | TREE TAG | SPECIES | AGE | HT | SPREAD<br>N S E W | DBH | RPA | CONDITION<br>PHYSIO / STRUCTURAL | COMMENTS | RECOMMENDATIONS | RC | ERC |
|---|---|---|---|---|---|---|---|---|---|---|---|---|
| H01 | N/A | Hawthorn Hedgerow | M | 8 | N/A | 25 (E) | 3.0 | GOOD / GOOD | Approx. 10 individual clusters of dense mature Hawthorn within a linear boundary Hedgerow – Dense understory of Blackthorn | Retain – no works required | B | >40 |
| 01 | 327 | <i>Fraxinus excelsior</i><br>Ash | M | 18 | 6 5 6 6 | 45<br>40<br>30<br>23 | 7.1 | GOOD / GOOD | 4 stems from base – 2 larger dominant stems - Dense ivy from base obscuring visibility – good Ext growth & leaf vitality throughout – no Evidence of Ash Dieback (A/D) at present Cavity at base to west occluding | Retain – no works required<br>Sever ivy at base | B | 10-20 |
| 02 | 328 | <i>Crataegus monogyna</i><br>Hawthorn | M | 8 | 2 2 1 2 | 28 | 3.4 | GOOD / FAIR | Older bowel with small diameter stems growing Overgrown by T01 – good ext growth on sparse Branch structure | Retain – no works required | C | 20-40 |

Fig 2 - Section of Hedgerow 01 to the east of Pylon – Trees T01 & T02 to west of Pylon

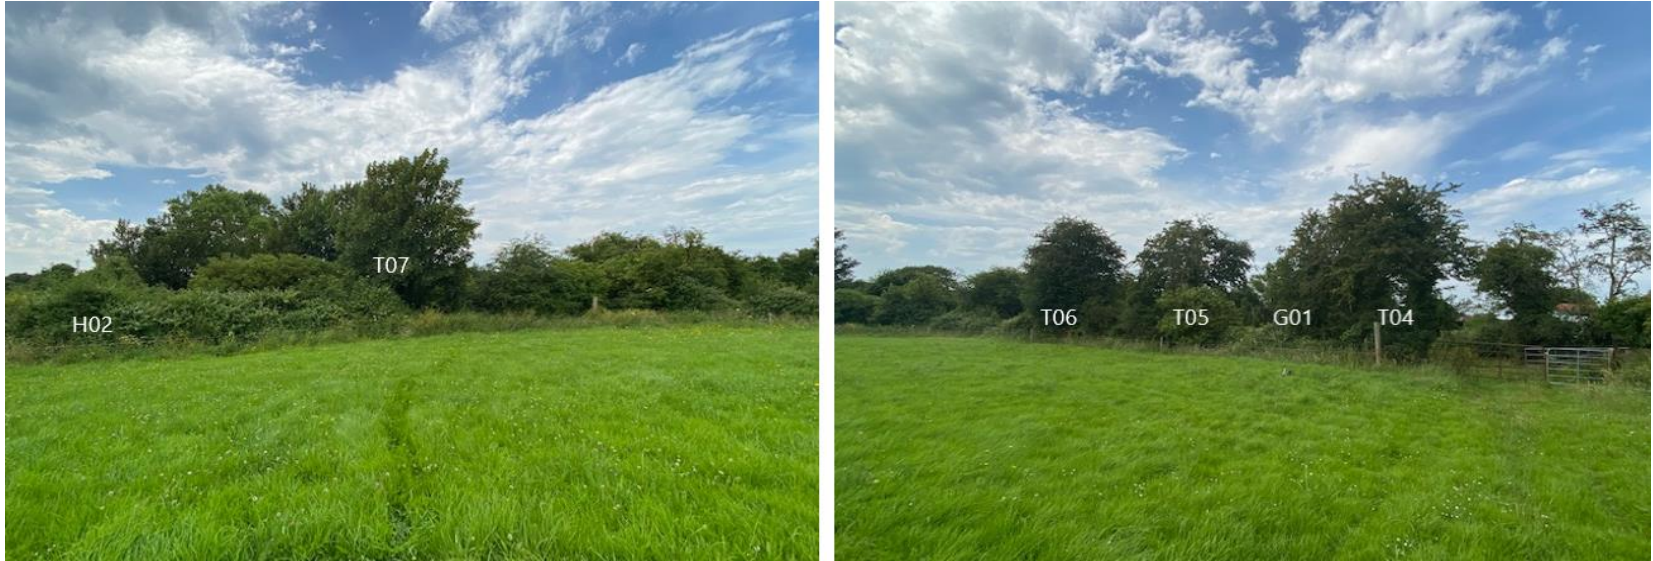
| TREE NO | TREE TAG | SPECIES | AGE | HT | SPREAD<br>N S E W | DBH | RPA | CONDITION<br>PHYSIO / STRUCTURAL | COMMENTS | RECOMMENDATIONS | RC | ERC |
|---|---|---|---|---|---|---|---|---|---|---|---|---|
| 04 | 330 | <i>Crataegus monogyna</i><br>Hawthorn | M | 8 | 2 2 1.5 2.5 | 28<br>21 | 3.5 | GOOD / GOOD | Twin stem older tree – good form, structure & ext growth – dense ivy throughout | Retain – no works required<br>Sever ivy at base | B | >40 |
| 05 | 331 | <i>Crataegus monogyna</i><br>Hawthorn | M | 8 | 3 3 3 3 | 30<br>27 | 4.0 | GOOD / GOOD | 2 individual trees growing either side of old Stone wall – older trees with good form, Structure & ext growth – the tree on the east Side was used to represent the RPA | Retain – no works required | B | >40 |

| TREE NO | TREE TAG | SPECIES | AGE | HT | SPREAD<br>N S E W | DBH | RPA | CONDITION<br>PHYSIO / STRUCTURAL | COMMENTS | RECOMMENDATIONS | RC | ERC |
|---|---|---|---|---|---|---|---|---|---|---|---|---|
| 06 | 332 | <i>Crataegus monogyna</i><br>Hawthorn | M | 9 | 3 3 3 3 | 45<br>30<br>25 | 6.0 | GOOD / GOOD | Older specimen tree – 3 co-dominant stems –<br>Isolated tree part of older boundary hedgerow<br>Older featured trunks – good form, structure &<br>Ext growth | Retain – no works required | A | >40 |
| H02 | N/A | Mixed species<br>Hedgerow | M | 3 | N/A | 17<br>(E) | 2.0 | GOOD / GOOD | Smaller dense hedgerow with Hawthorn, Elder<br>& Blackthorn & colonised by bramble | Retain – no works required | C | >40 |
| 07 | 333 | <i>Acer pseudoplatanus</i><br>Sycamore | E/M | 9 | 3 3 3 3 | 25 x 3 | 4.3 | GOOD / GOOD | Growing from north side of boundary hedgerow<br>H02 – Multiple co-dominant leaders from three<br>Stems – good form , structure & ext growth | Retain – no works required | C | >40 |

Fig 3 - trees T04 – T06 along western boundary & tree T07 and section of H02

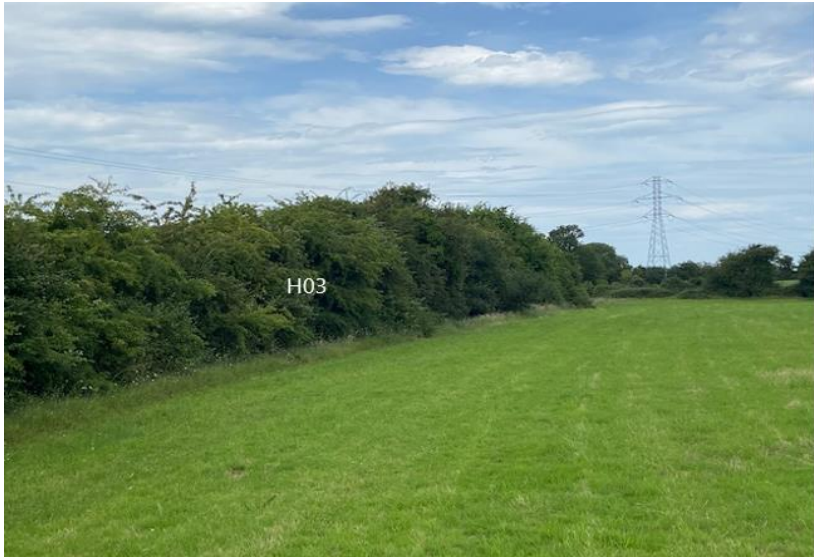
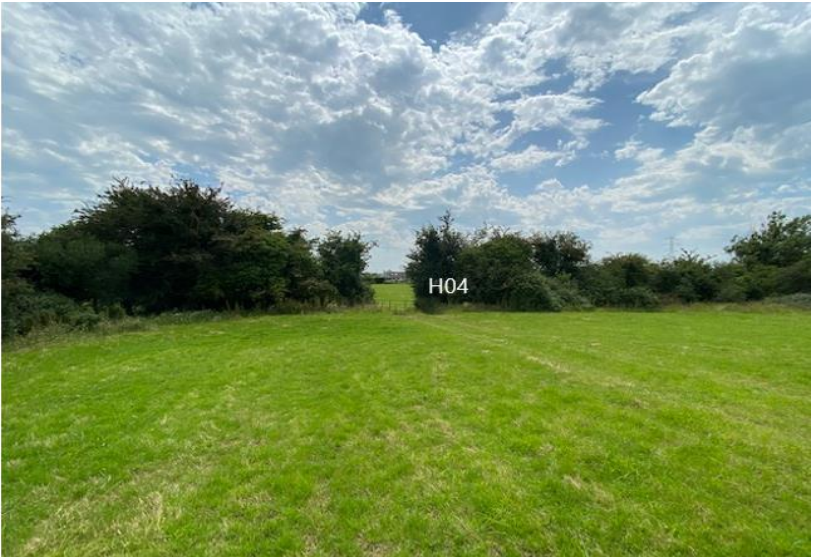
| TREE NO | TREE TAG | SPECIES | AGE | HT | SPREAD<br>N S E W | DBH | RPA | CONDITION<br>PHYSIO / STRUCTURAL | COMMENTS | RECOMMENDATIONS | RC | ERC |
|---|---|---|---|---|---|---|---|---|---|---|---|---|
| H03 | N/A | Hawthorn Hedgerow | M | 8 | N/A | 29<br>(E) | 3.5 | GOOD / GOOD | Older mature Hawthorn hedgerow – multiple<br>older specimen trees within the hedgerow<br>growing from east side of old stone wall/ditch<br>well established important arboricultural &<br>ecological hedgerow | Retain – no works required | A | >40 |
| H04 | N/A | Hawthorn Hedgerow | M | 8 | N/A | 25<br>(E) | 3.0 | GOOD / GOOD | Individual clusters of dense mature Hawthorn<br>within a linear boundary Hedgerow –<br>Dense understory of Blackthorn | Retain – no works required | B | >40 |

**Fig 4 – Hedgerow H03 along western boundary & H04 along southern boundary**

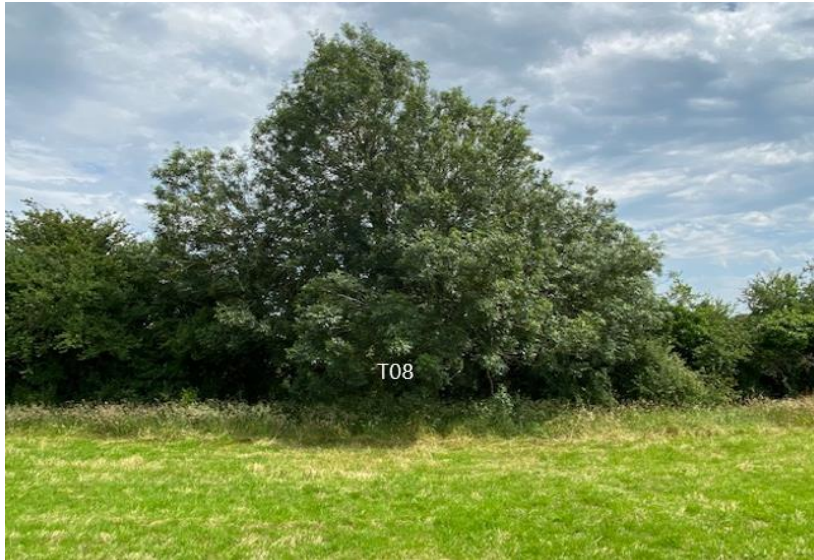
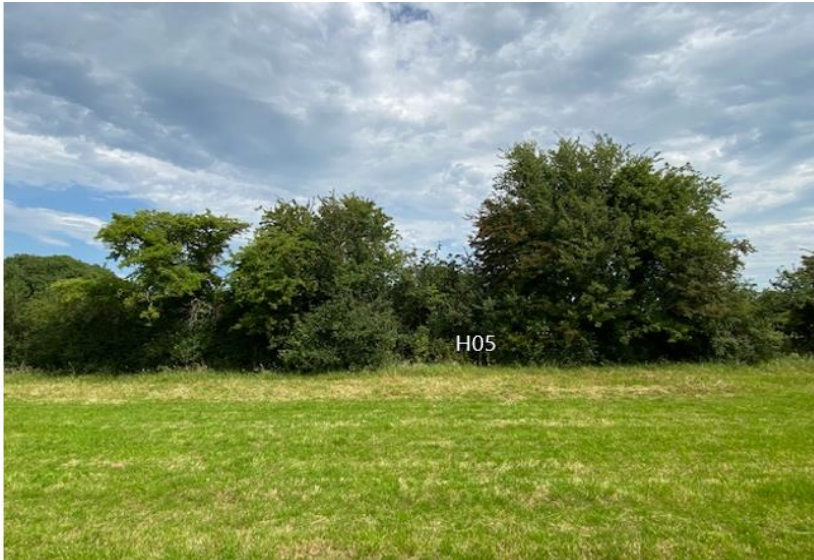
| TREE NO | TREE TAG | SPECIES | AGE | HT | SPREAD<br>N S E W | DBH | RPA | CONDITION<br>PHYSIO / STRUCTURAL | COMMENTS | RECOMMENDATIONS | RC | ERC |
|---|---|---|---|---|---|---|---|---|---|---|---|---|
| H05 | N/A | Hawthorn Hedgerow | M | 8 | N/A | 25<br>(E) | 3.0 | GOOD / GOOD | Smaller dense hedgerow with three distinct<br>Clusters of taller older Hawthorn trees | Retain – no works required | B | >40 |
| 08 | 565 | <i>Fraxinus excelsior</i><br>Ash | M | 13 | 4 4 4 4 | 34 x 2<br>20 | 5.2 | FAIR / GOOD | Early A/D evident within the canopy on apical<br>Twigs of lower branches – multiple branches<br>With epicormic growths – typical indicator of<br>A/D progression – 3 stems with 2 larger<br>Dominant – acute union with bark inclusion | Crown reduce in line with dense<br>Hedgerow & monitor | C | 10-20 |

**Fig 5 – Tree T08 within hedgerow H05 & example of larger Hawthorn in H05**

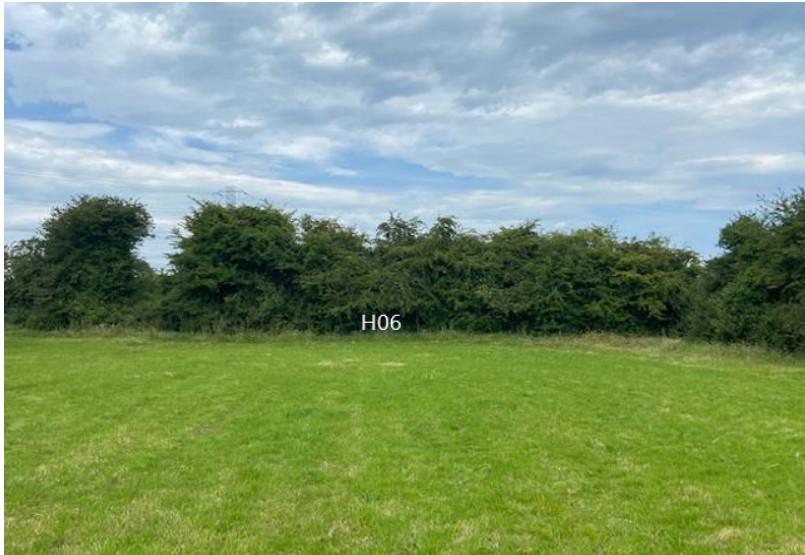
| TREE NO | TREE TAG | SPECIES | AGE | HT | SPREAD<br>N S E W | DBH | RPA | CONDITION<br>PHYSIO / STRUCTURAL | COMMENTS | RECOMMENDATIONS | RC | ERC |
|---|---|---|---|---|---|---|---|---|---|---|---|---|
| H06 | N/A | Hawthorn Hedgerow | M | 8 | N/A | 25 (E) | 3.0 | GOOD / GOOD | Well established important arboricultural & ecological hedgerow – dense merging canopy throughout with good form & structure | Retain – no works required | B | >40 |
| 09 | 335 | <i>Fraxinus excelsior</i> Ash | M | 13 | 0 4 2 3 | 50 | 6.0 | FAIR / FAIR | Located to the south end of linear group along eastern boundary – dense ivy from base – early A/D evident within the canopy – older twin stem With large stem failure in the past to the N/E Large wound evident at older union – roots to The east possibly impacted in the past during Construction of the school grounds | Unsuitable for retention post Development | U | <10 |
| 10 | 336 | <i>Fraxinus excelsior</i> Ash | M | 14 | 1 1 3 3 | 38 | 4.6 | FAIR / FAIR | Narrow form – merging to the north & south Early A/D evident throughout the canopy roots to the east possibly impacted in the past during construction of the school grounds | Unsuitable for retention post Development | U | <10 |
| 11 | 337 | <i>Fraxinus excelsior</i> Ash | M | 18 | 4 5 5 7 | 71 | 8.5 | FAIR / GOOD | Twin stem from 2.5m with good union – both Stems with future co-dominance – isolated Apical twigs with poor ext growth & leaf vitality Majority of canopy with good ext growth & leaf Vitality - Heavily weighted lateral branches extending to the west over proposed site – older branch failure in the past to the west – roots to the east possibly impacted in the past during construction of the school grounds | Retain and monitor Lateral prune the heavily weighted Branches to the west by 25% | B | 10-20 |

Fig 5 – Central hedgerow H06 & trees T09 – T11 along eastern boundary

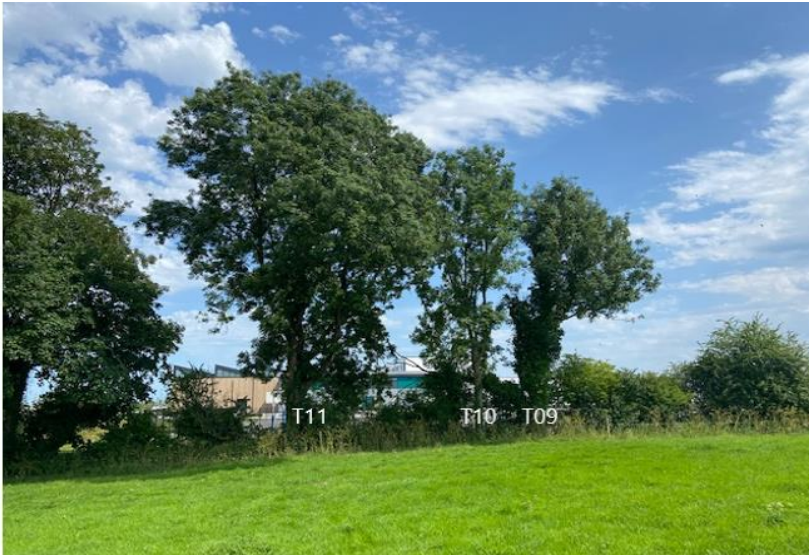
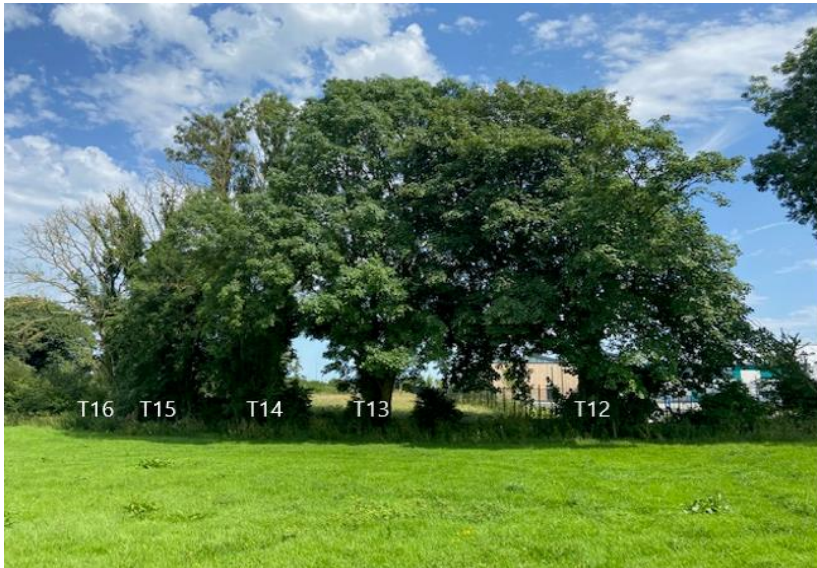
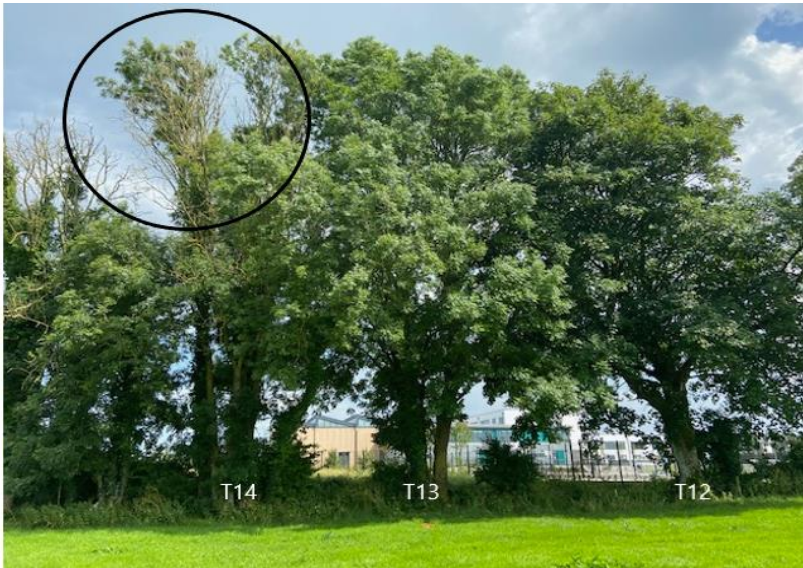
| TREE NO | TREE TAG | SPECIES | AGE | HT | SPREAD<br>N       S       E       W | | | | DBH | RPA | CONDITION<br>PHYSIO / STRUCTURAL | COMMENTS | RECOMMENDATIONS | RC | ERC |
|---|---|---|---|---|---|---|---|---|---|---|---|---|---|---|---|
| 12 | 338 | <i>Acer pseudoplatanus</i><br>Sycamore | M | 17 | 6 | 6 | 7 | 8 | 94 | 11.3 | GOOD     /     GOOD | Large spreading canopy from east to west –<br>Merging to the north & south – heavily weighted<br>Lateral branches to the west over the proposed<br>Site – dense branch structure with good ext<br>Growth & leaf vitality – large branch failure in<br>The past to west in the lower canopy – wound<br>Occluding - roots to the east possibly impacted<br>in the past during construction of the school<br>grounds | Retain and monitor<br>Lateral prune the heavily weighted<br>Branches to the west by 25% | B | >40 |

Fig 6 – Trees T12 – T16 along eastern boundary & close up of T14 with A/D throughout the canopy

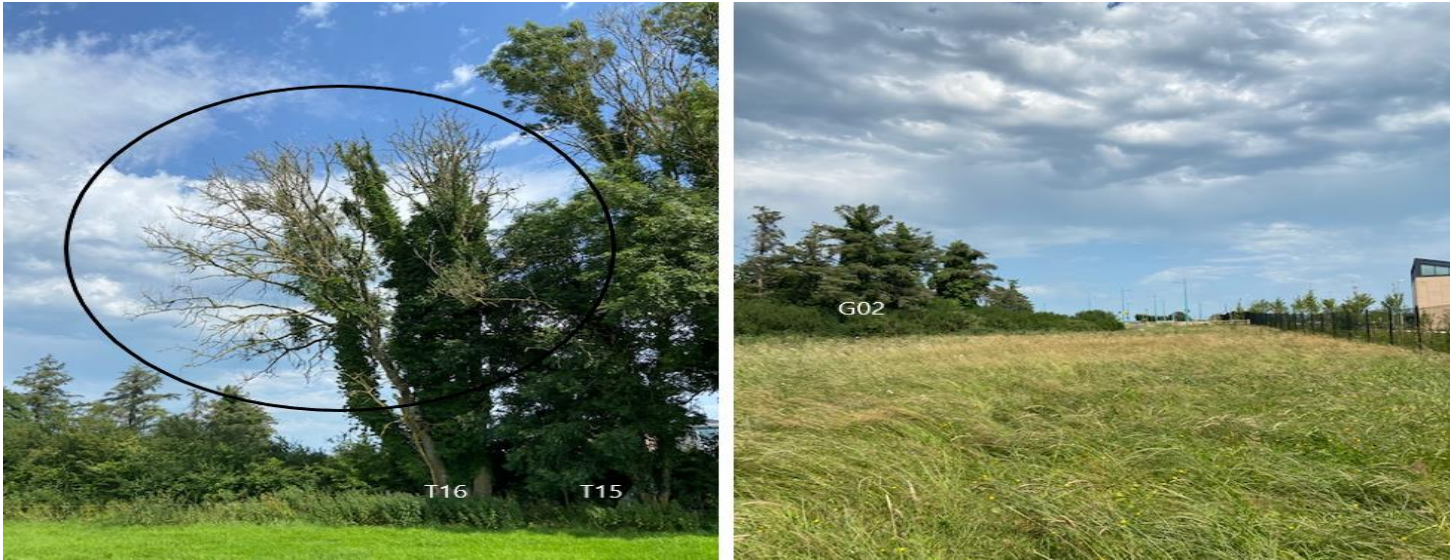
Fig 7 – Trees T16 & T15 with extensive A/D & the group of trees G02 to north of proposed entrance to site

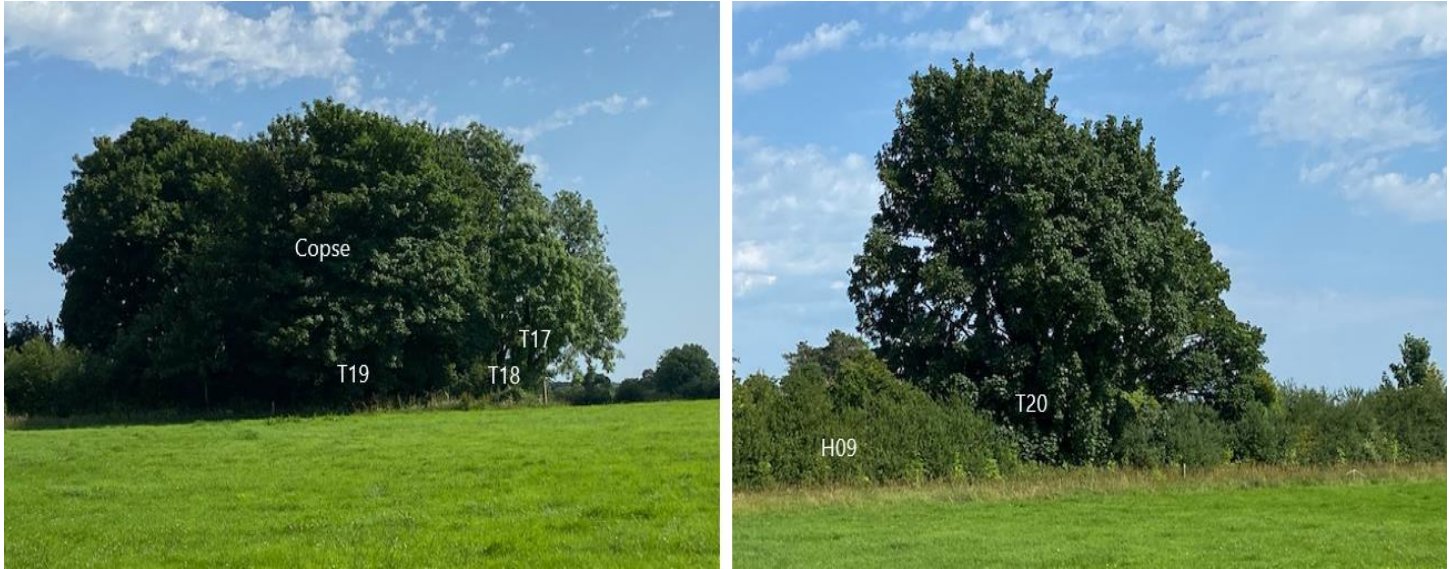
| TREE NO | TREE TAG | SPECIES | AGE | HT | SPREAD<br>N S E W | DBH | RPA | CONDITION<br>PHYSIO / STRUCTURAL | COMMENTS | RECOMMENDATIONS | RC | ERC |
|---|---|---|---|---|---|---|---|---|---|---|---|---|
| H09 | N/A | Mixed Species Hedgerow | M | 4 | N/A | 17 (E) | 2.0 | GOOD / GOOD | Dense low sized hedgerow dominated by Hawthorn & Blackthorn with isolated Elder & Hazel & colonised with bramble & ivy | Retain – no works required | C | >40 |

Fig 8 – Copse along eastern boundary with trees T17 – T19 along margins & Tree T20 along east side of hedgerow H09

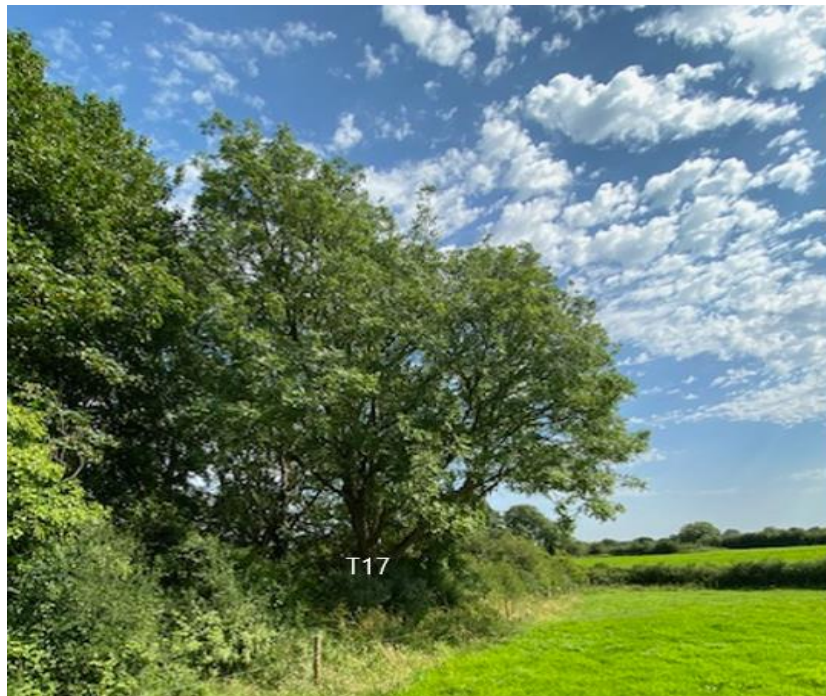
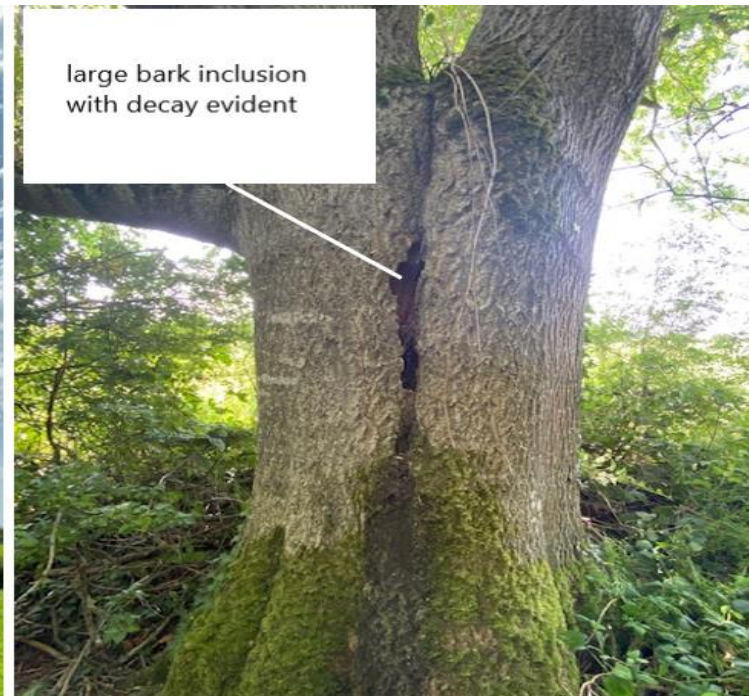
| TREE NO | TREE TAG | SPECIES | AGE | HT | SPREAD<br>N S E W | DBH | RPA | CONDITION<br>PHYSIO / STRUCTURAL | COMMENTS | RECOMMENDATIONS | RC | ERC |
|---|---|---|---|---|---|---|---|---|---|---|---|---|
| 17 | 343 | <i>Fraxinus excelsior</i><br>Ash | M | 18 | 6 6 2 8 | 104 | 12.8 | GOOD / FAIR | Tree located along western margin of small copse – twin stem with acute union and very large bark inclusion from base to 2m with decay evident – heavily weighted lateral branches to the west over the proposed site – early indications of A/D within the canopy | Crown reduce stem to the north To reduce stresses on the acute Union Lateral prune extended branches By 25% | C | >40 |

large bark inclusion  
with decay evident

**Fig 9 – Tree T17 at western edge of copse with large bark inclusion & decay present**
