# Phase 3 Residential Development, Ballymastone, Donabate, Co. Dublin

## Stage 1 Road Safety Audit

20003-DBF-XXXX-XX-RP-C01-000107

**October 2025**

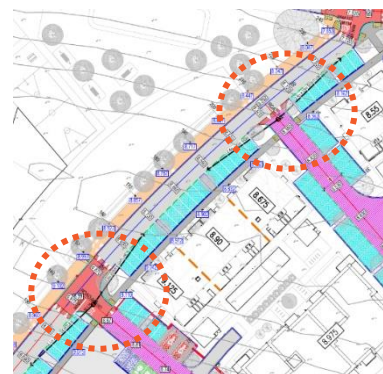
#### 2.1.2 Location (G2) - Visibility at Junctions

It is noted that the extent of available clear unobstructed visibility splay for vehicle drivers at Home Zone (Road 143 & 144) / Link Street junctions could potentially be obstructed by vehicles parked within the proposed adjoining perpendicular car parking bays and tree planting along the Link Street. This may lead to collisions between vehicles, pedestrians, or cyclists.

It is recommended that appropriate visibility splays to approaching vehicles should be provided at all junctions. Ensure that the visibility envelope should be kept clear of any obstruction including landscaping which should be no higher than 0.6m and/or accommodate a tree specified with a small diameter trunk with elevated canopy outside / above of the visibility splay.

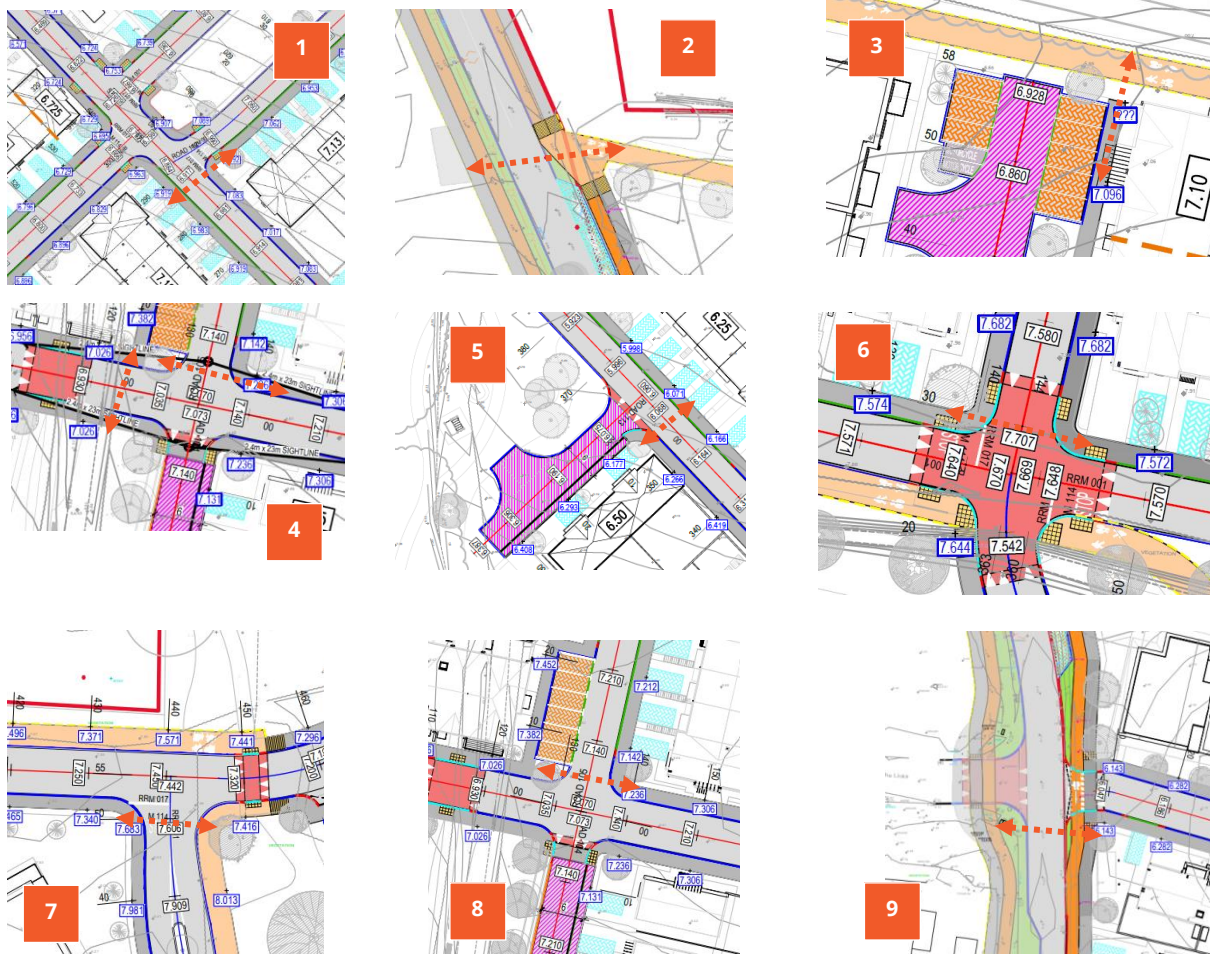
### 2.1.3 Location (G3) - Pedestrians/Cyclists Desire Lines

The auditors identified a number of pedestrians/cyclists desire lines within the residential development which do not seem to have been catered for in the preliminary scheme design. It is also noted that a number of alternative crossing facilities are located further away from the desire line and these may prove unattractive for users due to the longer travel distance required.

The lack of adequate walking and cycling facilities (e.g. connecting paths, dropped kerbs and tactile paving) along key travel the desire lines may lead to pedestrians or cyclists walking/cycling on carriageway who may be struck by vehicles or may trip/fall when accessing to/from footpath with full height kerb.

It is recommended that the designers investigate the opportunity of implementing additional connections and appropriate pedestrians/cyclists crossing facilities along the identified key desire lines within the development and at site access locations. Appropriate connection widths should be provided responding to the connections function as a footpath or a shared pedestrian cycle path.

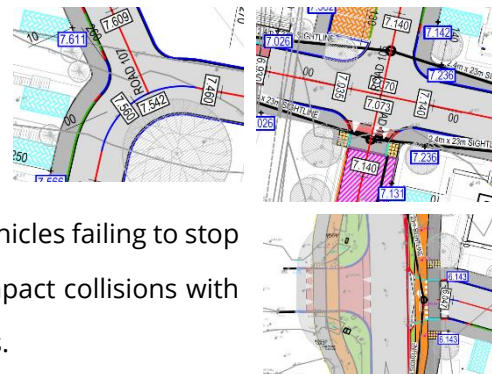
## 2.1.6 Location (G6) - Priority at junctions

The auditors are unclear that who has priority at the site western site access and internal junctions. No road markings including 'stop line and ' and associated 'stop sign' are provided at the internal junction. Failure to provide the appropriate regulatory signs may result in vehicles failing to stop at the minor arm of junctions which may lead to side impact collisions with vehicles travelling along the major arm through junctions.

At detail design stage it is recommended that appropriate STOP road markings and accompanying regulatory 'Stop Sign' are provided at all junctions in accordance with the Traffic Signs Manual.

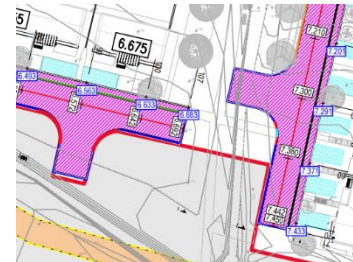
### 2.1.10 Location (G10) Vehicle Turning Head

It is noted that a number of vehicle turning heads are provided within the development. The auditors are concerned in the absence of appropriate regulations and the convenience to adjoining dwellings that residents or visitors may park their vehicles within the proposed turning head thereby restricting the ability of other vehicle drivers to undertake a safe U-turn manoeuvre.

It is recommended that the design of the turning head is revisited to safeguard its intended function.

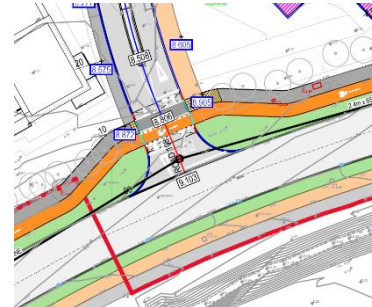
### 2.2.1 Location (S1) –

It is noted that a set back raised pedestrian and cycle crossing is proposed at the site access. The pedestrian crossing is provided with buff colour tactile paving and yield road markings either side of the crossing. It is not clear who has priority. The buff tactile indicates vehicles have priority whereas the yield road marking indicates that pedestrians have priority. This may confuse road users and may result in collisions between vehicles and pedestrians or cyclists.

It is recommended that the yield road marking should be removed and the design revisited response to the latest DMURS (Advice Note 6) guidance. Alternatively if the designs which to afford the pedestrian and cyclists priority, appropriate controlled crossing with required design elements should be provided on accordance with DMURS.

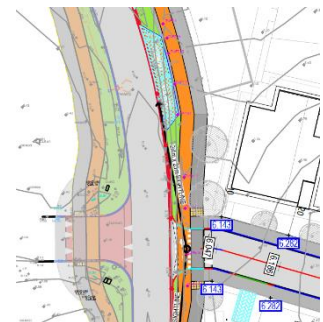
### 2.2.4 Location (S4) – Visibility at Site Access along The Links

The development proposed a site access from The Links road which forms a four arm junction. The auditors note that there is an existing set down area along The Links road adjacent the site access. Vehicles particularly high sided commercial (Van etc) and SUV's parled in the set down area may partially obstruct visibility for vehicle drivers exiting the proposed new site access. This may lead to side swipe collisions.

It is recommended that the set down area should be reassigned to bicycle parking or similar so that visibility for the vehicle drivers exiting the subject site will not be obstructed.

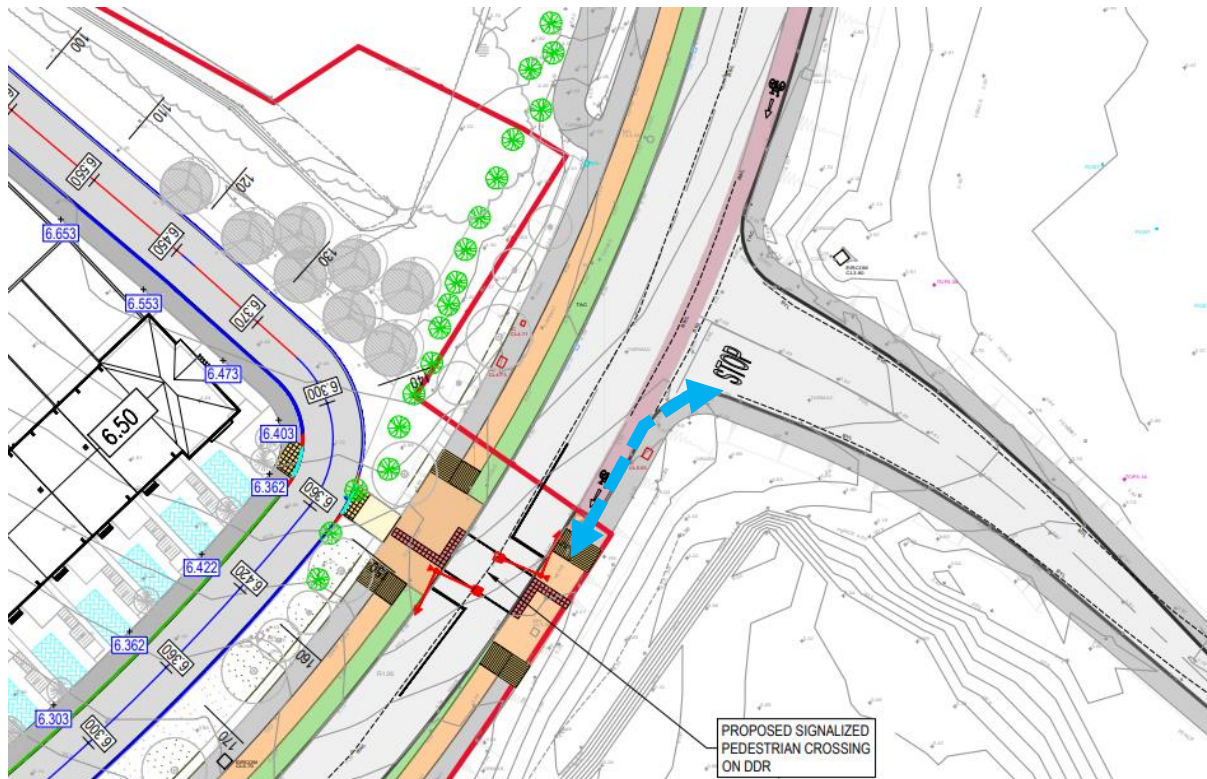
### 2.2.5 Location (S5) – Northbound Cycle Desire Line

The introduction of the new controlled Pedestrian / Cycle TOUCAN crossing provides a beneficial active travel connection between the subject residential develop and the existing playing fields located to the southeast and access via the junction and associated connection located as short distance to the north of the TOUCAN crossing facility. This new connection generates a new northbound cycle desire line along the eastern side of the distributor road between the new

TOUCAN crossing location and the access action to the playing fields. The introduction of a northbound cycle desire line in this location along either (i) the existing off-site (one-way) cycle track or (ii) the segregated footpath, could give rise to conflicts between active travel users.

It is recommended that the new northbound cycle desire line is formally accommodated over this short length along the eastern side of the distributor between the TOUCAN crossing and the playing fields site access unless another more convenient active travel access to the playing fields is to be provided.

| To be Completed By Designer | | | | To be Completed by Audit Team Leader |
|---|---|---|---|---|
| S5 | Yes | No | The recommended cycle track connection northwards from the Toucan crossing towards the playing fields site access is outside of the proposed development red line boundary. However, the Local Authority will be made aware of the proposed recommendation. | Yes |

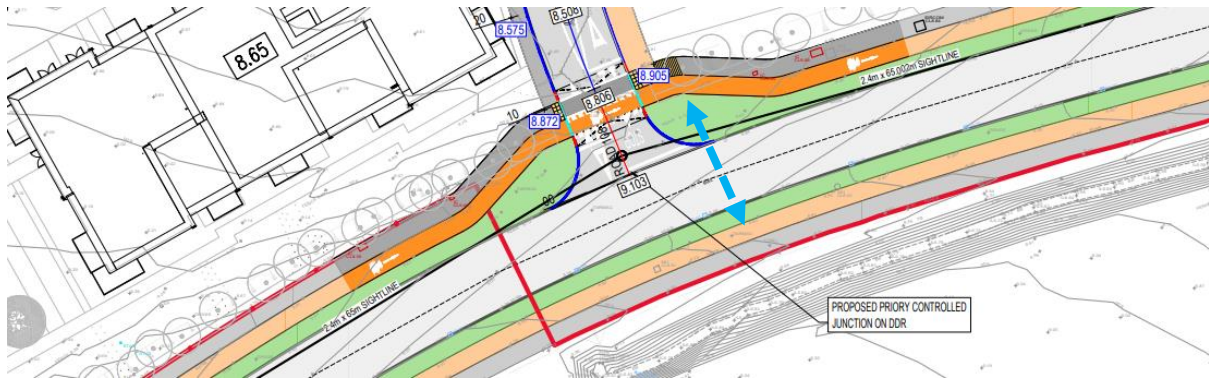
## 2.2.6 Location (S6) – Vehicle Access on Distributor Road

The introduction of a new site access gives rise to a new travel design line for both pedestrians and cyclists to cross the distributor road carriageway in the general area of the site access junction (to access the footpath and southbound cycle track). In the absence of a Pedestrian and Cycle connection active travellers are required to cross the grass verge and raised kerbs which represent both a trip and slip type hazard.

The design of the new site access junction with the existing distributor road should accommodate the active travel desire line across the distributor road carriageway in this general location.

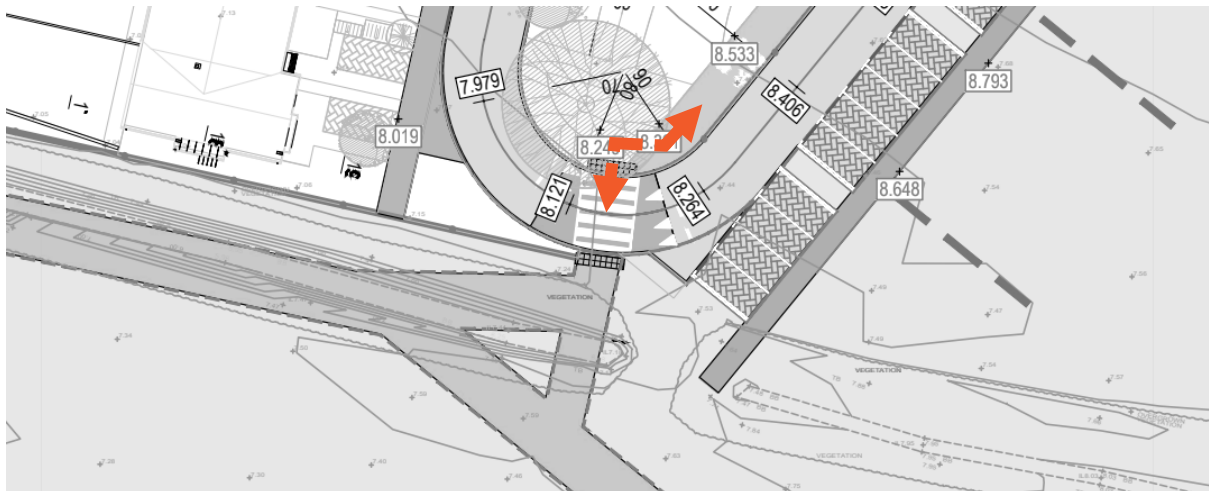
## 2.2.7 Location (S7) – Shared Path to Zebra Crossing

The shared ped/cycle path does not seem to extend / tie-in with the proposed Zebra crossing. In the absence of a continued path a trip hazard may be present.

The scheme designers are asked to confirm that the shared path extends all the way to/from the proposed zebra crossing.

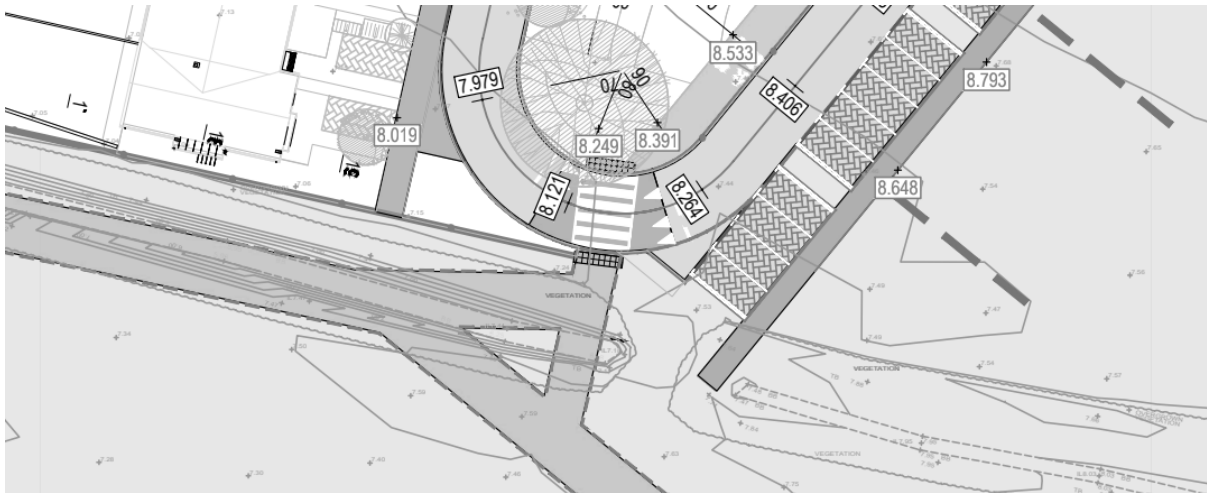
## 2.2.8 Location (S8) – Zebra Crossing Design

Zebra crossing road markings provided but incorrect tactile details and no beacon / signs provided. Potential confusion regarding who has right of way leading to potential conflict between active travel users and moving vehicles on the crossing point.

Clarification regarding the intended crossing type. Design Zebra crossing as per appropriate guidance with correct tactile and signage provided. Ensure that appropriate clear unobstructed forward visibility is provided between vehicle drivers (approaching the crossing) and active travel users about to step onto the Zebra crossing.

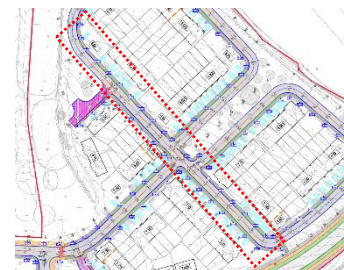
## 2.2.9 Location (S9) – Long Straight Road

The development proposed a long straight section of road located north east of the site access along Donabate Distributor Road. This may encourage high speed leading to collisions between vehicles, pedestrians or cyclists.

It is recommended that appropriate traffic calming measure should be implemented.

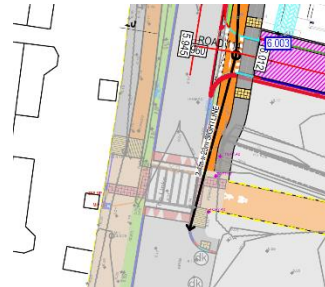
### 2.3.1 Location (C1) – Zebra Crossing along The Links

It was observed during the site visit that the Zebra Crossing along The Links adjacent Road 114 is missing Belisha Beacons/signages. The zebra crossing should be provided with appropriate Belisha Beacons/signages.

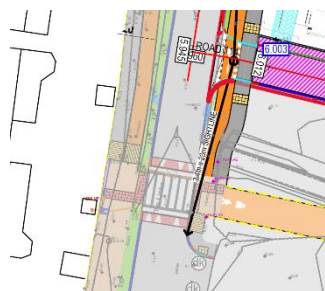
### 2.3.2 Location (C2) – Bespoke Signages at The Links

It was observed during the site visit that Bespoke signages (Shared Space) at Zebra Crossing along The Links adjacent Road 114 which is confusing. Appropriate standard signages should be provided.

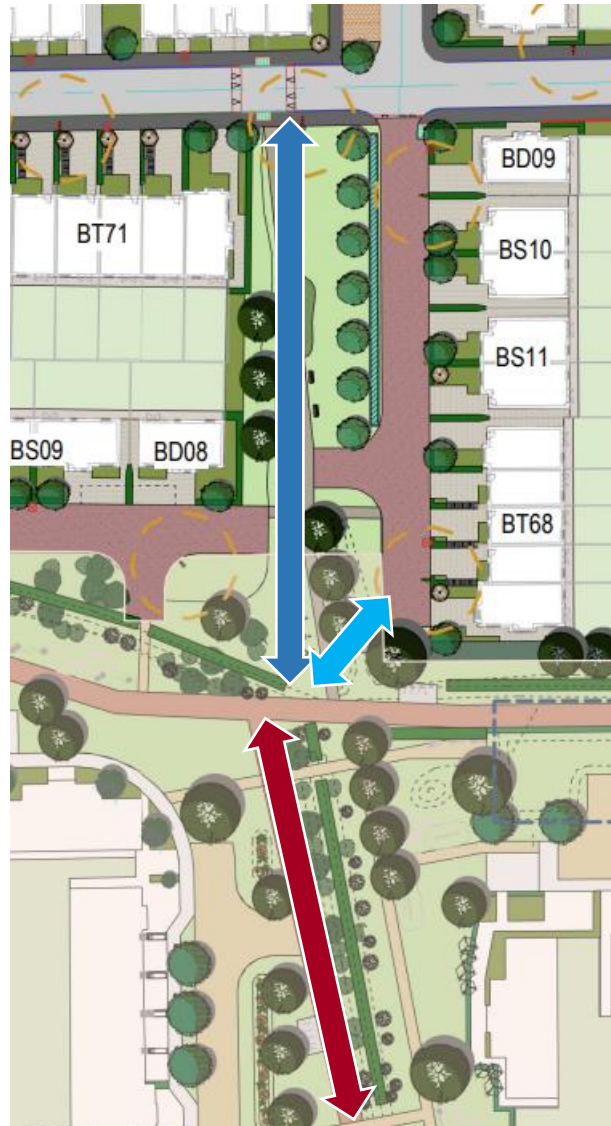
### 2.3.4 Location (C3) – Continuation of Greenway (Shared Path) Northwards

To the south of subject Phase 3 development a north-south active travel greenway is being provided through the Phase 2 lands. This north-south greenway connects with an east-west aligned greenway along the northern extends of the Phase 2 lands (and located immediately south of the subject Phase 3 lands). Influenced by the Phase 2 proposals a potential desire line for cyclists

could extend north-south into the Phase 3 development (to the west of internal ROAD 104). Whilst a pedestrian path is provided along the general alignment of this extended north-south cycle travel desire line (Indicated PURPLE route in Figure below) this path is not sufficiently wide to accommodate both pedestrians and cyclists. Consideration should be given to extending the Phase 2 north-south greenway northwards into the Phase 3 lands and either upgrading the proposed (PURPLE) footpath or providing a onwards cycle connection (BLUE) with Road 104.
