INDEPENDENT HOUSE STUDENT ACCOMMODATION  
87-93 MIDDLE ABBEY STREET  
**LRD PLANNING SUBMISSION - ARCHITECTURAL HERITAGE IMPACT ASSESSMENT**

MARCH 2025

**MOLLOY & ASSOCIATES**  
CONSERVATION ARCHITECTS

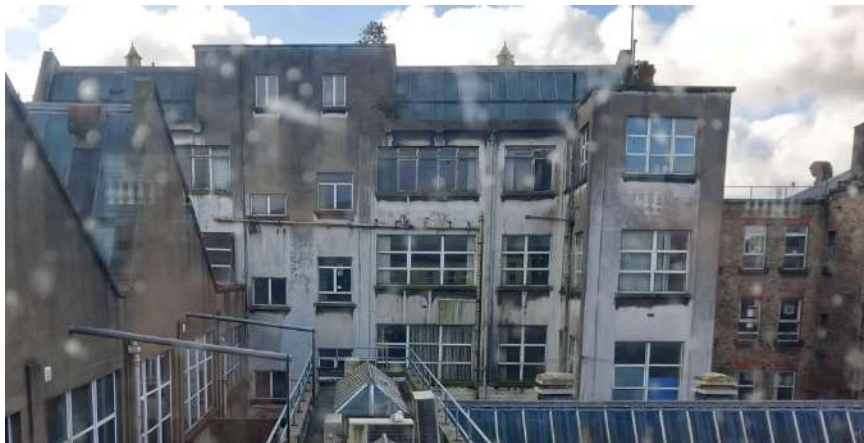
The rear façade of the office building is utilitarian in terms of design and choice of materials. The staggered windows of the stair enclosure create an irregular division across the façade. There are no decorative elements present; the external walls are finished with cement render and feature concrete sills. Only two of the original metal windows with casement and pivot openings remain, while the rest have been replaced by contemporary uPVC windows.

**Plate 2** The rear elevation of 87-90 Middle Abbey Street, Independent House [Zone 1].

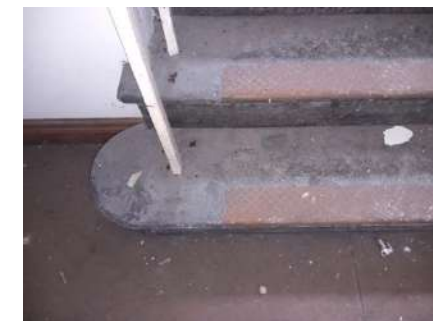
**Plate 4** Detail of bullnose bottom step and inset incised metal nosings on the treads.

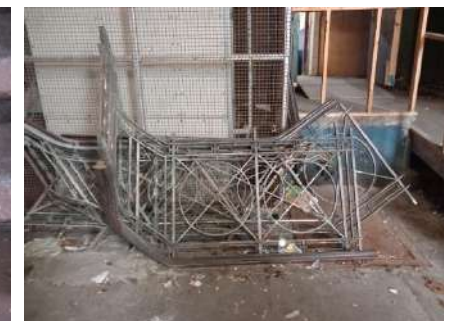
**Plate 5** Original balustrade, previously installed on ground to first floor levels. Presently located in Zone 4b.

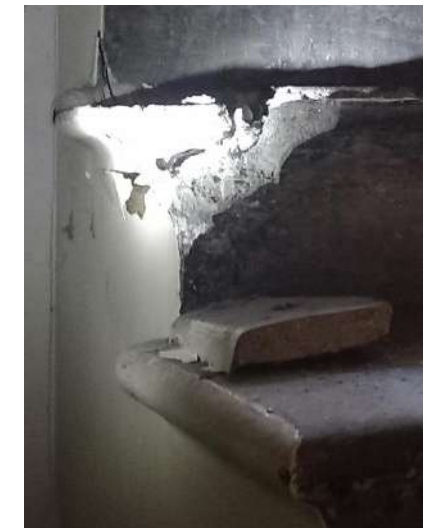
**Plate 7** Impact damage at the entrance hall reveals the composition of the stairs to be concrete with a polished composite layer applied.

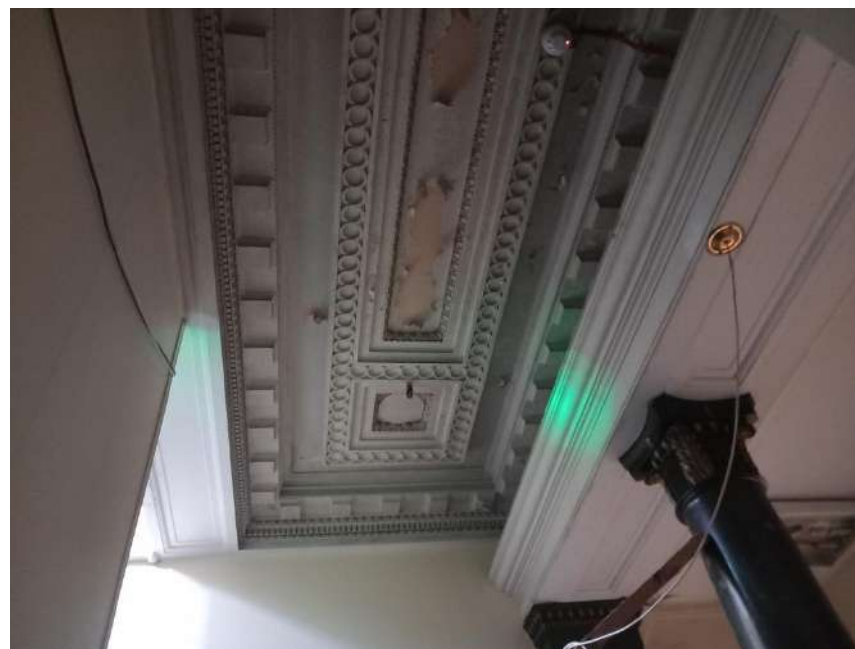
**Plate 8** The ceiling in stair hall features a neoclassical geometric design.

The ceiling in the entrance hall is partially obscured by a contemporary suspended ceiling, so the full extent of the decorative plasterwork remains unknown at this time. Both the entrance hall and the inner stair hall feature a neoclassical geometric design, consisting of a series of rectangular panels surrounded by a border of concentric circles and a modillion cornice, all framed by a moulded cornice. The composition within the stair hall is divided

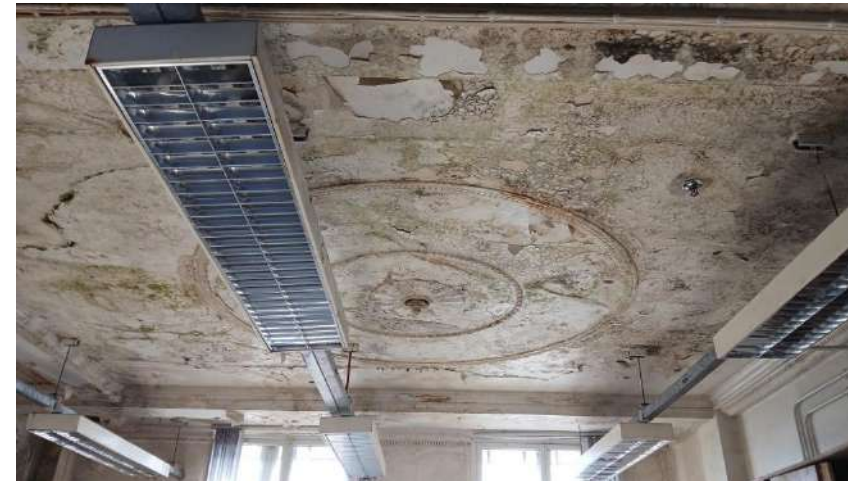
**Plate 9** The boardroom ceiling at third floor level features low relief regency style cornicing and centrepiece

At third floor level, the boardroom's dividing wall has been removed to create a single open-plan room that spans the entire depth of the building. The ceiling features a pair of regency style centrepieces in low relief, accompanied by a moulded cornice. Unfortunately, this ceiling is in very poor condition due to ongoing water ingress, with mould and delamination evident.

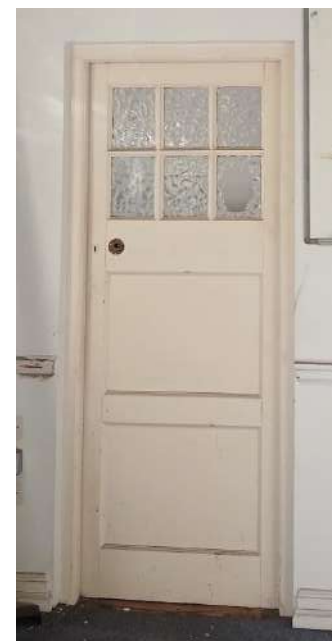
**Plate 10** Typical original door: The original narrow panelled doors comprise of three panels, with six glazed panes in the upper panel. Circular brass knobs.

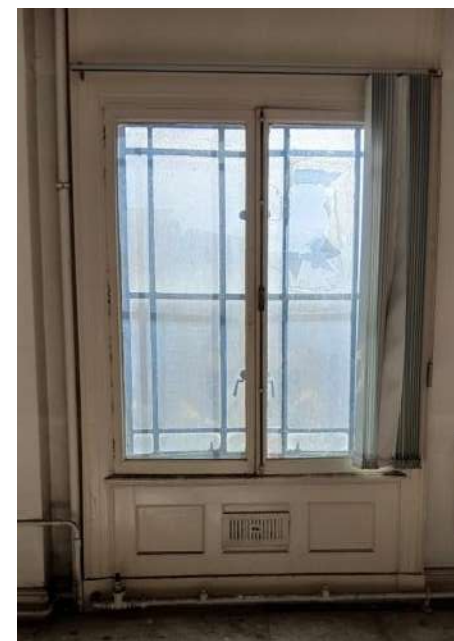
**Plate 11** Typical window: the windows have timber framed secondary glazing with moulded architraves and panelled window aprons. Many of the surrounds have been damaged by the installation of pipework and services.

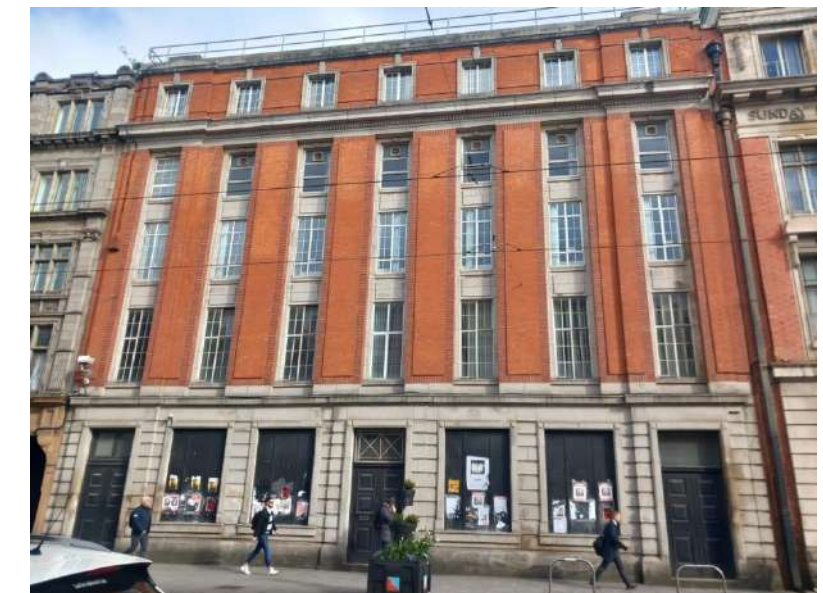
The building has been vacant for an extended period, and the interior of the structure has suffered the damaging effects of sustained water ingress, and bird damage particularly on the upper levels.

**Plate 13** Front elevation of 91-93 Middle Abbey Street, Emerald Chambers, RPS 8797 [Zone 2]

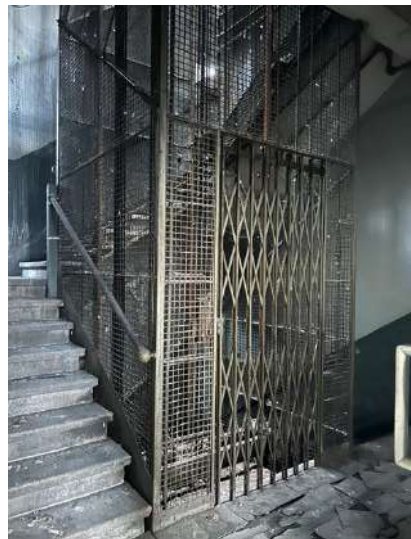
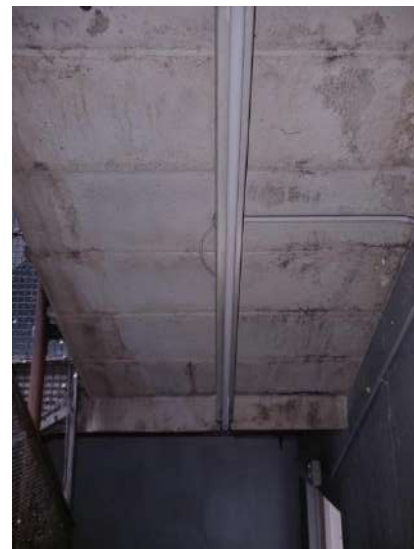
**Plate 14:** Handrail mounted on caged lift enclosure **Plate 15:** Underside of the granite stair lift enclosure

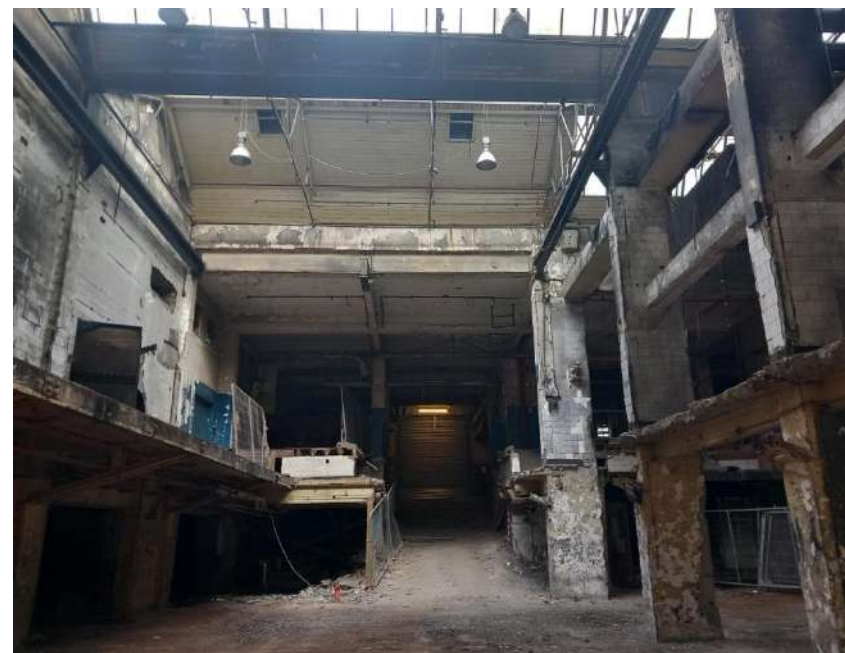
**Plate 19:** The western side of the Printing Hall, was added c1939.

The internal walls and columns within the hall are covered in square-format glazed, plain white tiles. This would have provided a robust, low maintenance finish and also reflect and improve daylight levels within the hall. Many of the tiles have become detached from the substrate. The dark staining on the tiles are likely attributable to prolonged exposure to the printing process, a testament to the structures historical use.

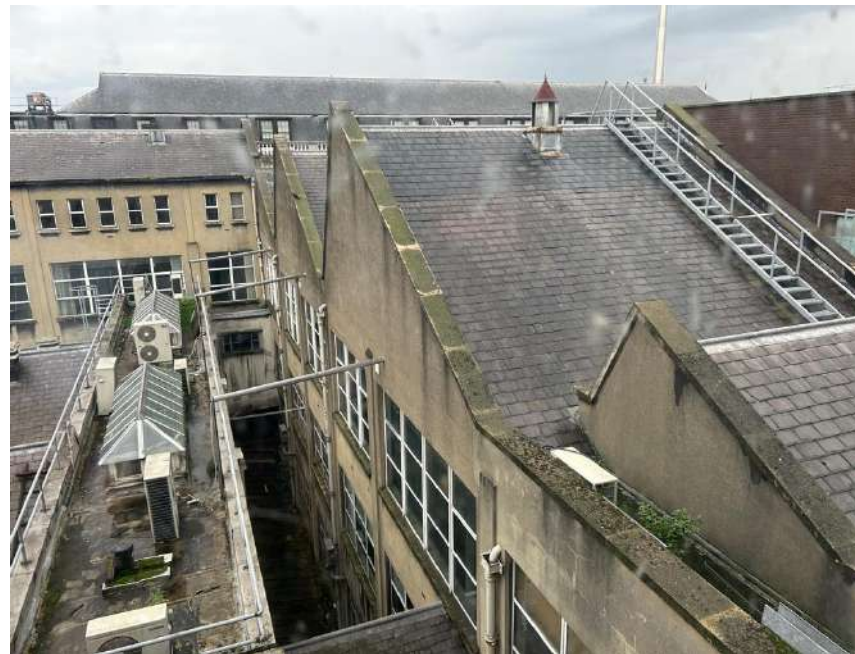
**Plate 21:** Sawtooth roof profile of Area 4. To the east of the narrow lightwell.

At entrance level, there are a number of panelled door and glazed screen partitions that are likely original. The upper floors of Zone 4a lack any notable features of heritage interest. Previously, they functioned as open-plan offices equipped with raised access floors, with modern partition walls, and suspended ceilings. The upper floor is in poor condition due to ongoing water ingress from the roof.

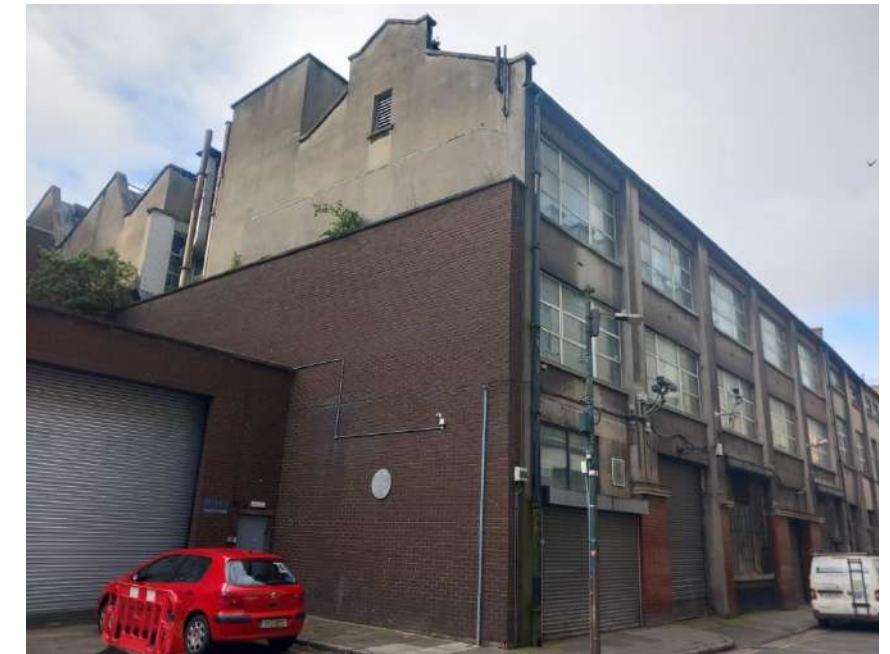
had been removed to create a makeshift ramp to facilitate machinery access to carry out partial demolitions of the machine hall. The finishes are robust and utilitarian, befitting its intended use as a vehicular distribution bay, with concrete floors and painted plaster walls.

**Plate 23:** Zone 4b, Former distribution centre and offices for Independent Newspaper group, fronting onto Prince's Street North

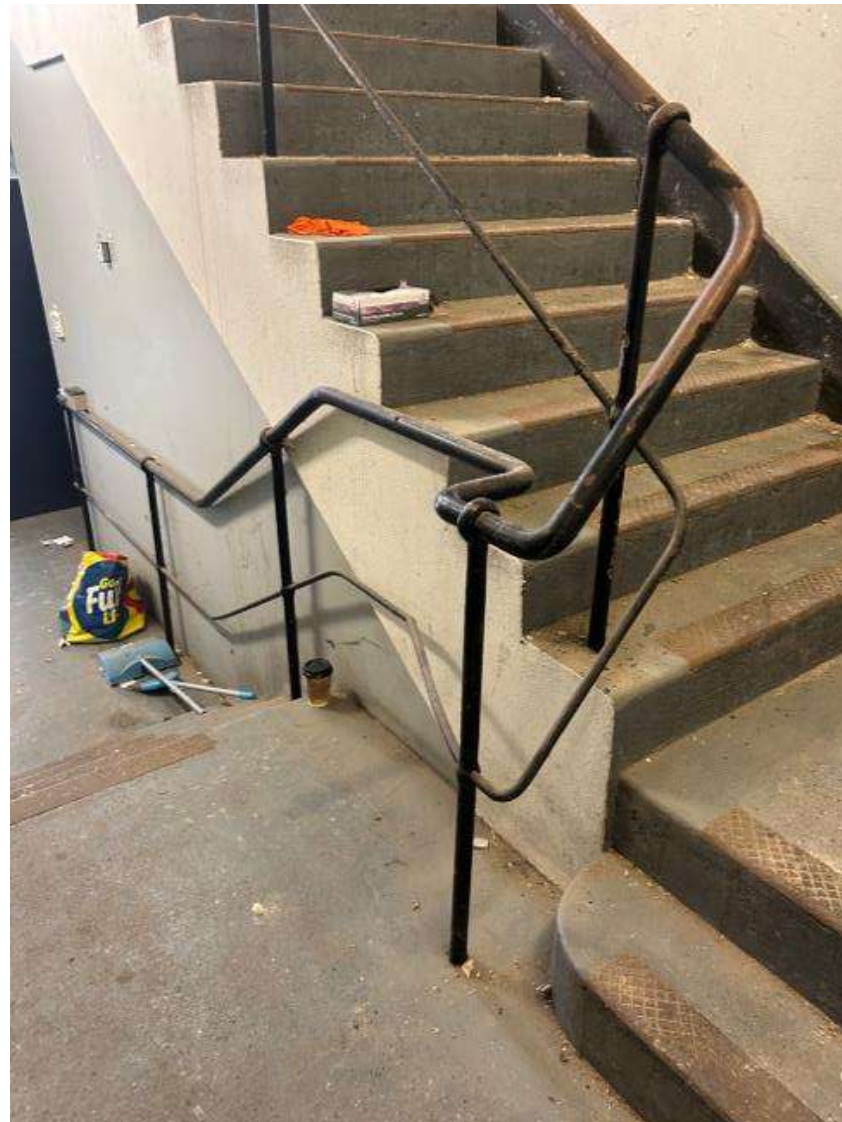
**Plate 25:** Concrete stair with incised metal nosings, matching those in Zone 1, and industrial tubular steel handrail with ball joints.

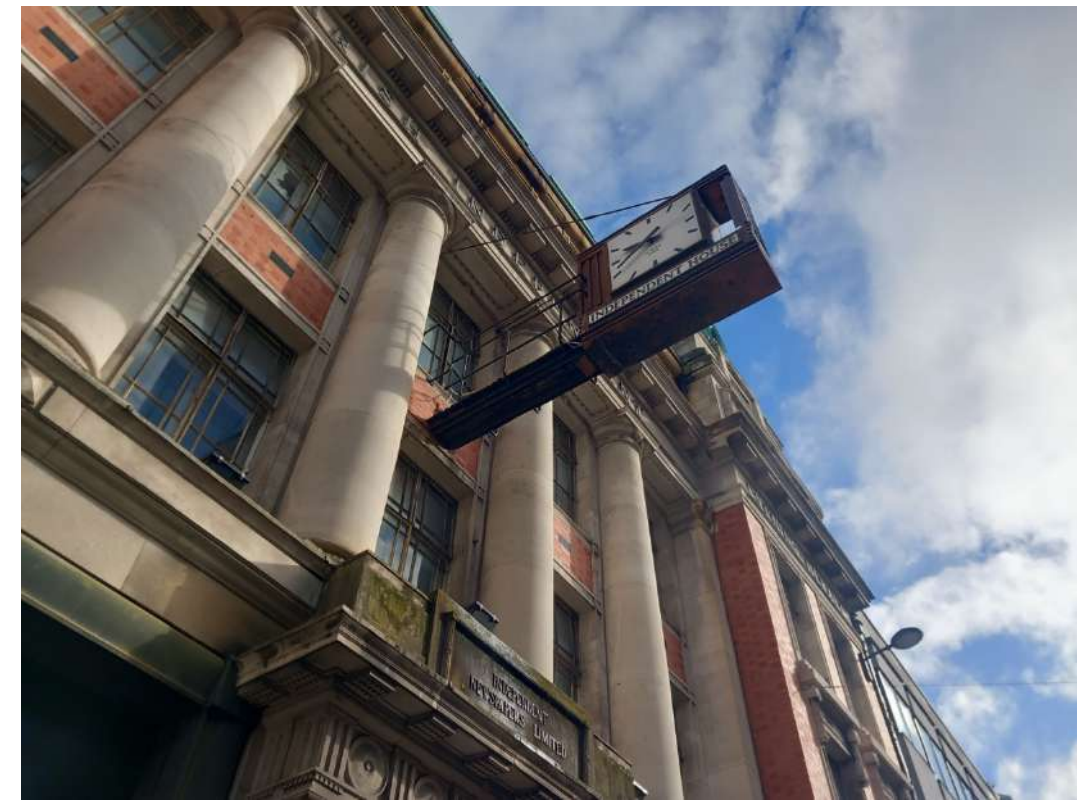
**Plate 17:** Projecting Art-deco style clock framed in copper. A mid-twentieth century replacement.

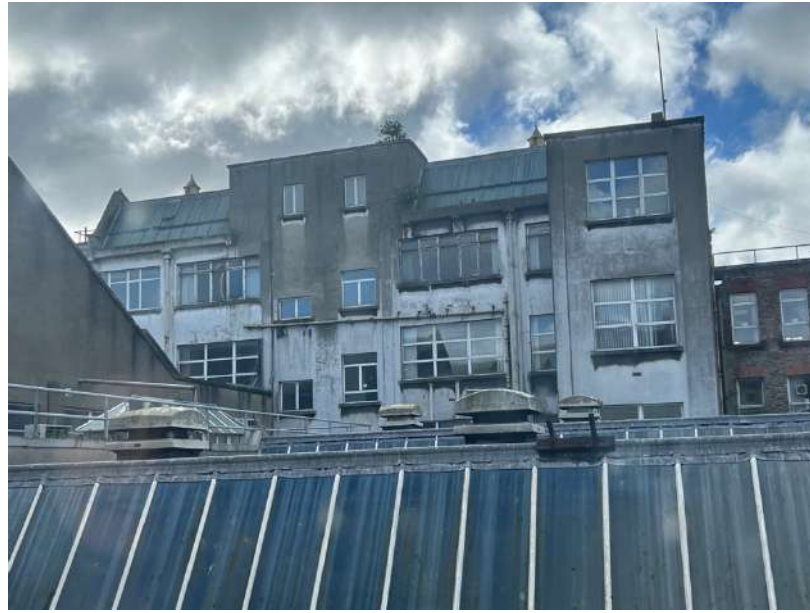
**Plate 18:** Rear façade of Independent House, render finish, cast iron rainwater goods, mixture of original and later uPVC windows. North-facing rooflights to upper floor.

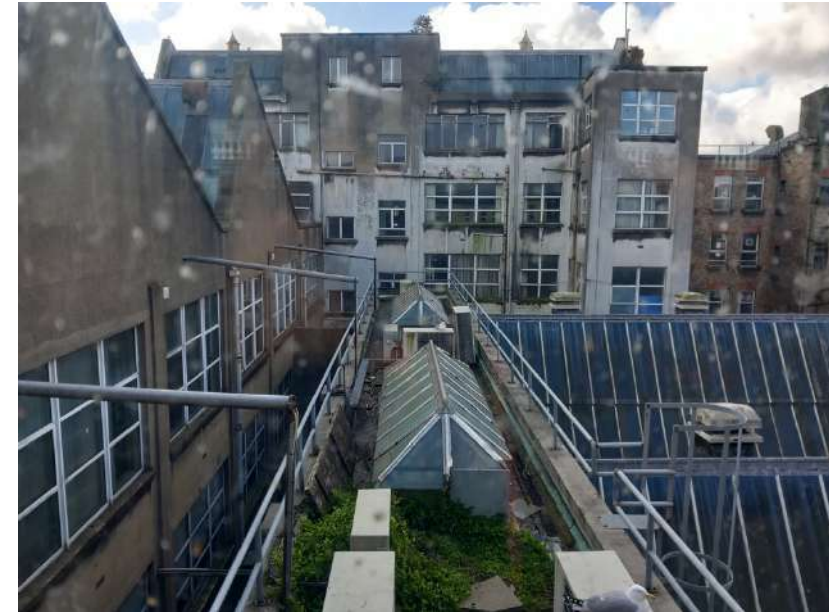
**Plate 20:** Rear façade of Independent House. The projecting bay to the west (right) is a later extension to what was originally a single storey return.

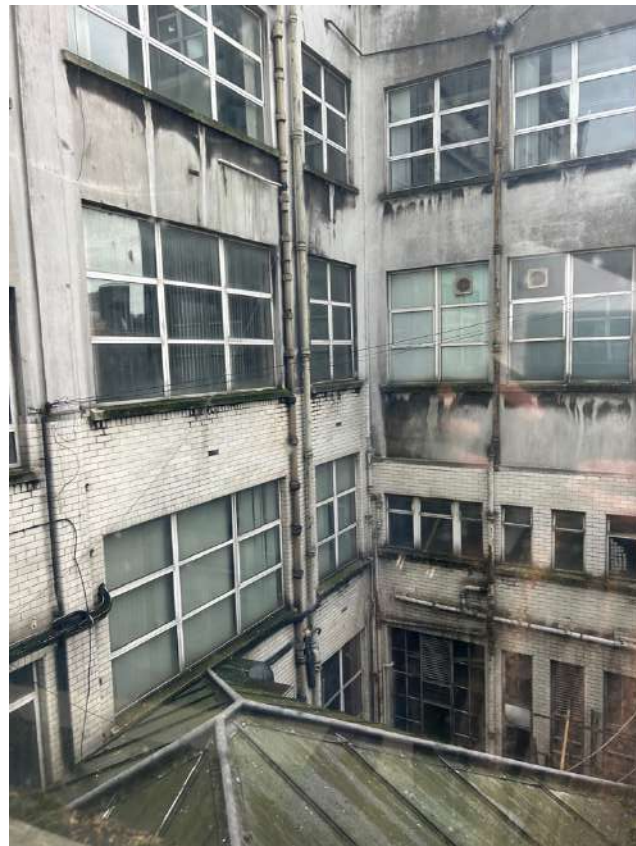
**Plate 21:** Rear façade of Independent House, with rear return shown to right. It appears that the rear return was vertically extended from original two storeys to 5 storeys.

The rear toilet return, originally a two-storey over basement structure, was vertically extended to fourth floor level in the mid-twentieth century. It is proposed to remove this later addition and reinstate its original form. The original rectangular window openings, depicted on Plate 39, will be reinstating on levels 2-4 post removal.

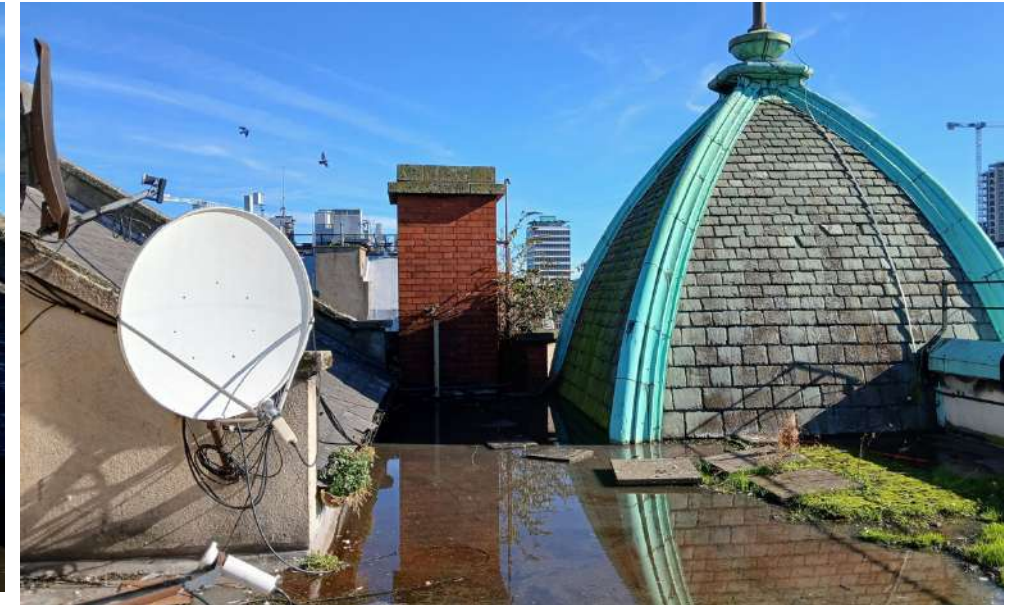
**Plate 24:** Brick chimneystack on eastern boundary wall. Note the standing water on the central flat roof section, suggesting blocked drainage. The eastern dome is not accessible from the roof level.

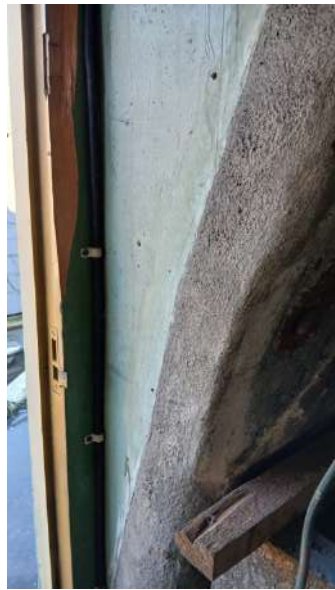
**Plate 28:** The dome structure is comprised of a thin concrete shell.

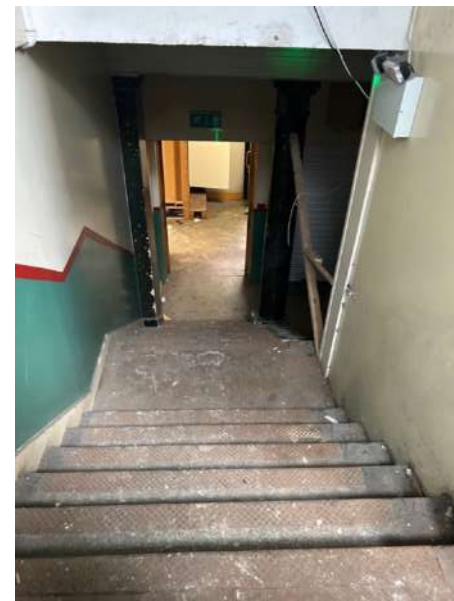
**Plate 39:** Detail of impact damage to polished concrete stair. Note: handrail and balustrade has been cut and is missing.

**Plate 52** The original balustrade pertaining to the stairs in Independent House have been cut and dismantled. The high-quality sections and are in a salvageable condition and will be reinstated in their original location.

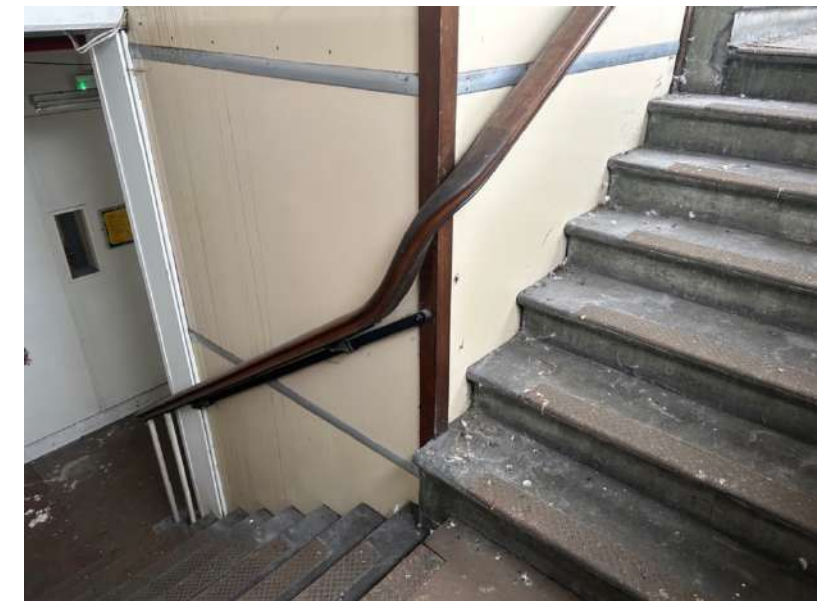
**Plate 41:** Polished concrete stairs with quarter landings. Handrail missing on upper levels.

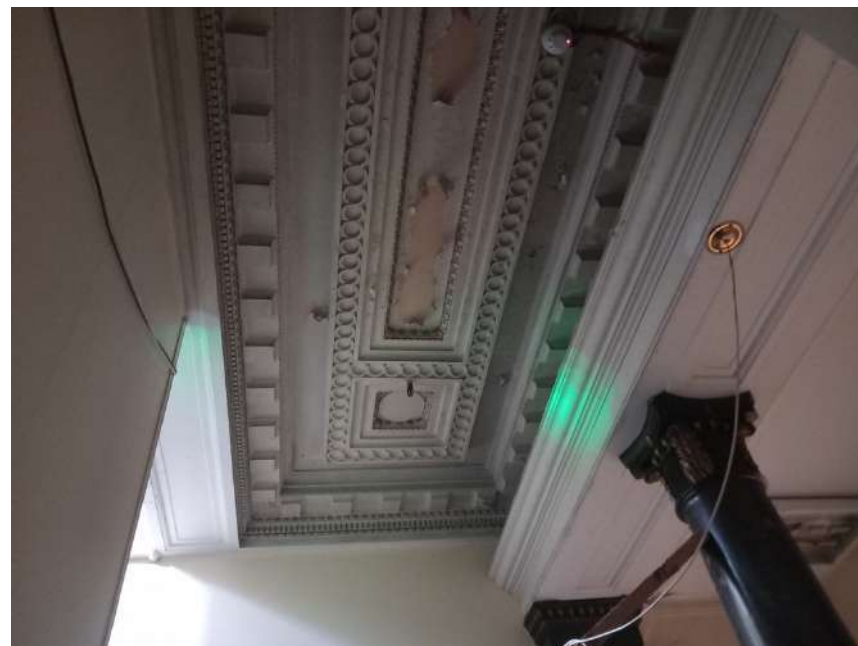
**Plate 44:** Entrance lobby, with contemporary doors, partition walls and fittings, suspended lay-in ceiling tiles. Original decorative ceiling noted above later ceiling.

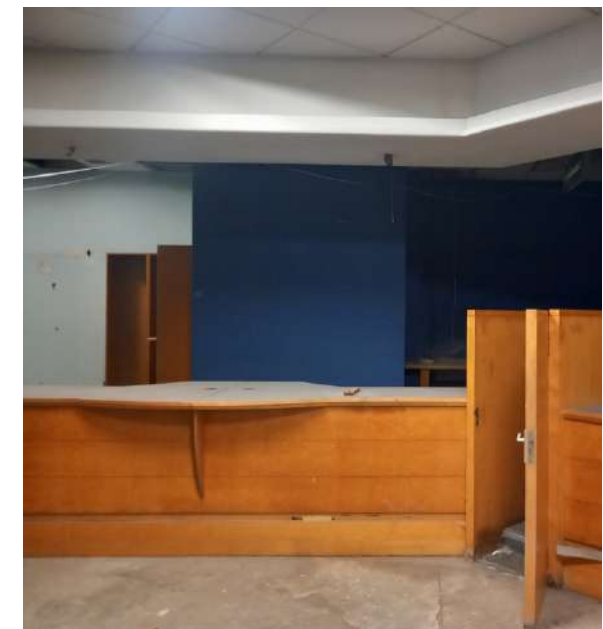
**Plate 46:** Contemporary fittings in entrance lobby. Original decorative ceiling noted above later ceiling.

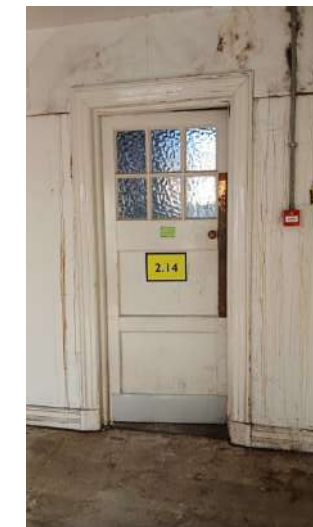
**Plate 56:** Limited remains of original joinery on level 2: panelled door with multipaned glazing un upper panel

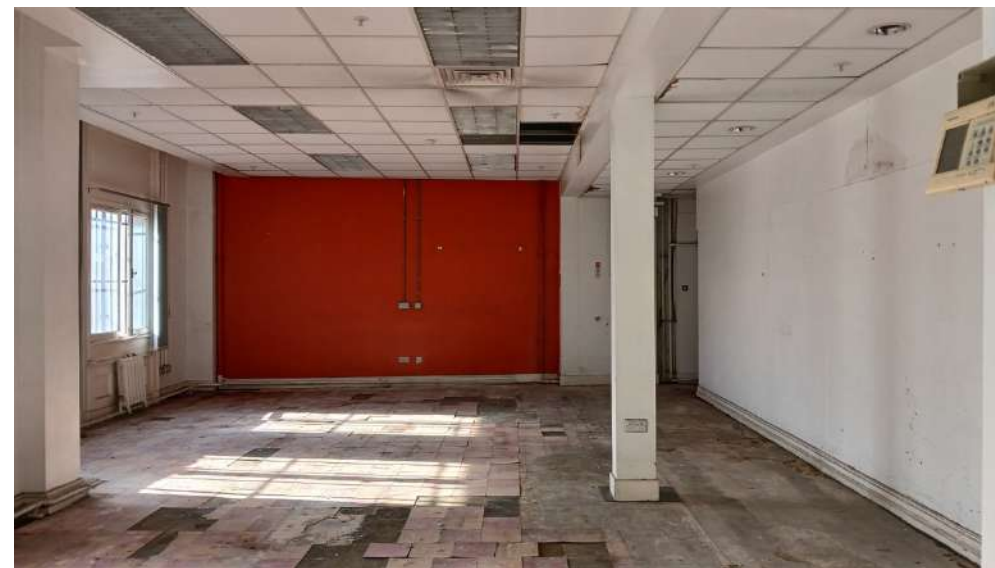
**Plate 57:** Level 2 has been extensively modernised to create an open plan office space. Contemporary wall linings and suspended ceiling. Original window fabric.

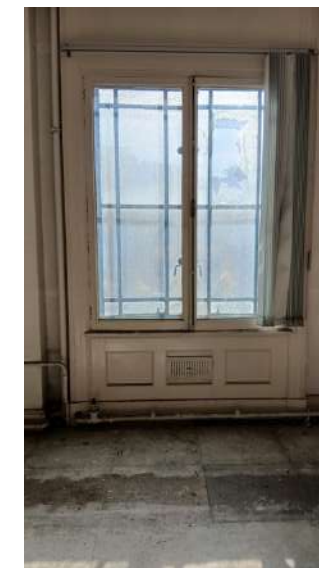
**Plate 58:** Original metal frames windows with margin lights externally, and timber-framed secondary glazing system with original ironmongery.

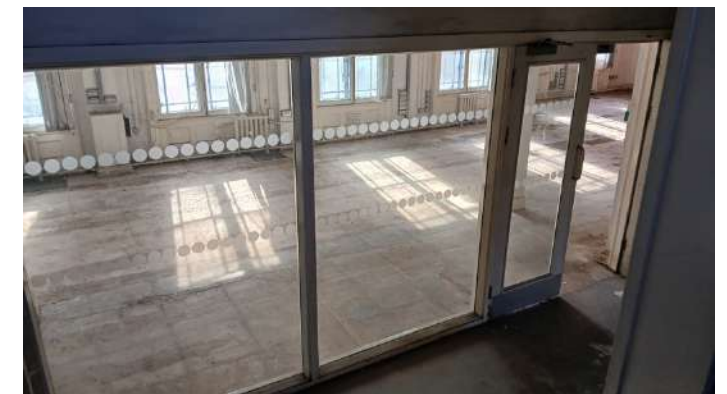
**Plate 59:** Contemporary glazed screen to staircase enclosure.

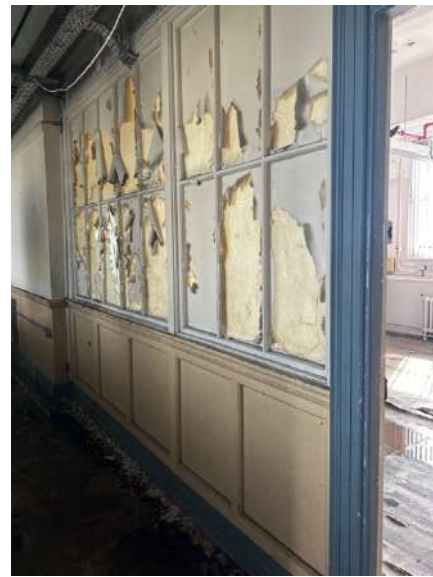
**Plate 60:** Original partition wall in corridor with panelled wainscoting to lower level and multipaned glazed screens over. Original moulded timber architraves and skirtings.

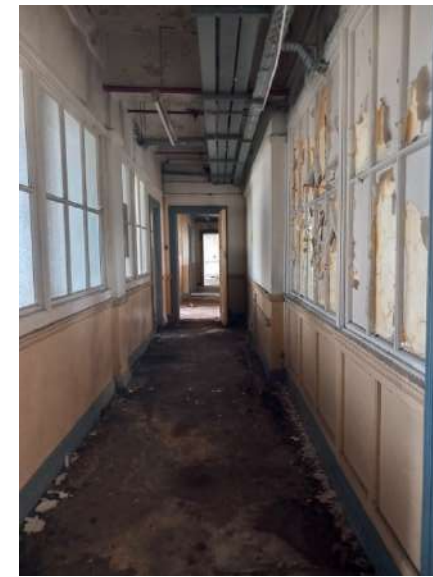
**Plate 61:** Original partition walls on either side of spine corridor with panelled wainscoting to lower level and multipaned glazed screens over. Panelled cross-corridor doors.

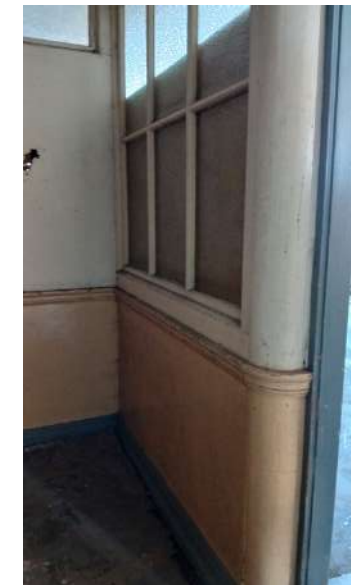
**Plate 62:** Original partition walls, with curved corner detail.

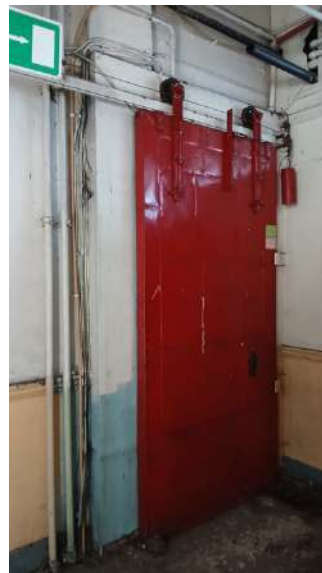
**Plate 63:** Typical steel fire door, on sliding mechanism, separating Independent House and Emerald Chambers.

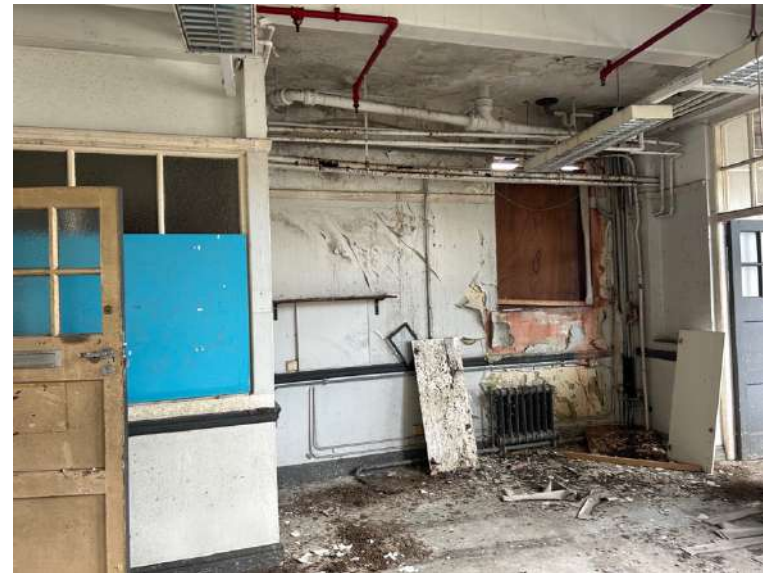
**Plate 64:** Rear room, facing west. Panelled door with glazed upper panel.

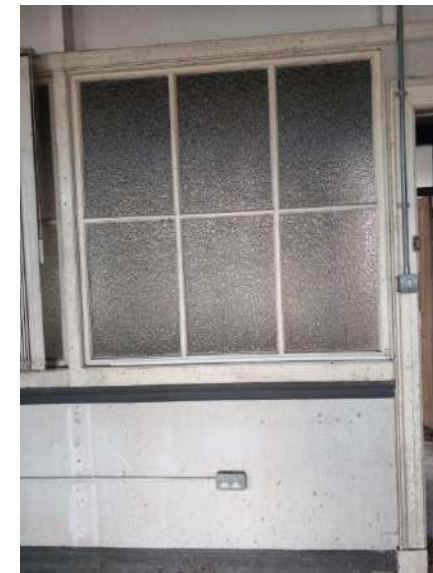
**Plate 65:** Typical glazed screen on upper level of internal partitions.

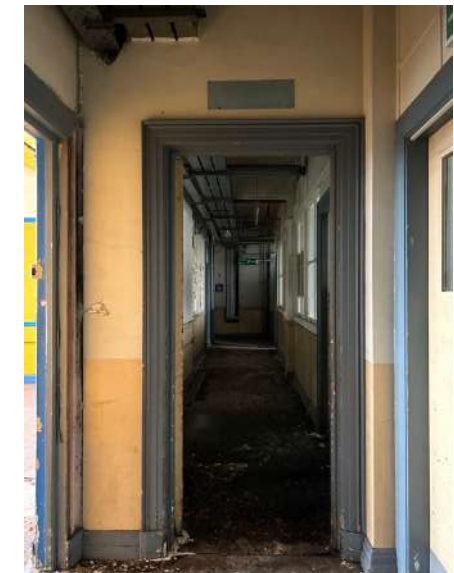
**Plate 66:** Original moulded timber architrave on blocks with stepped skirting. View down central spine corridor beyond, with original partition walls within interior multipaned screens. Exposed contemporary services throughout.

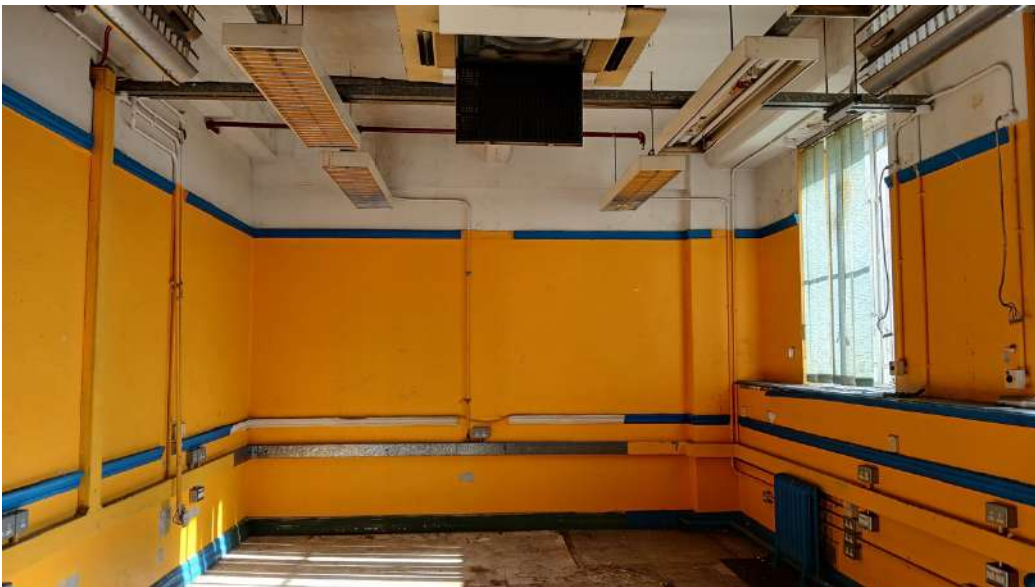
**Plate 67:** Typical cellular office, with concrete bressummers. Exposed contemporary services throughout. Note the continuous sill detail to the windows.

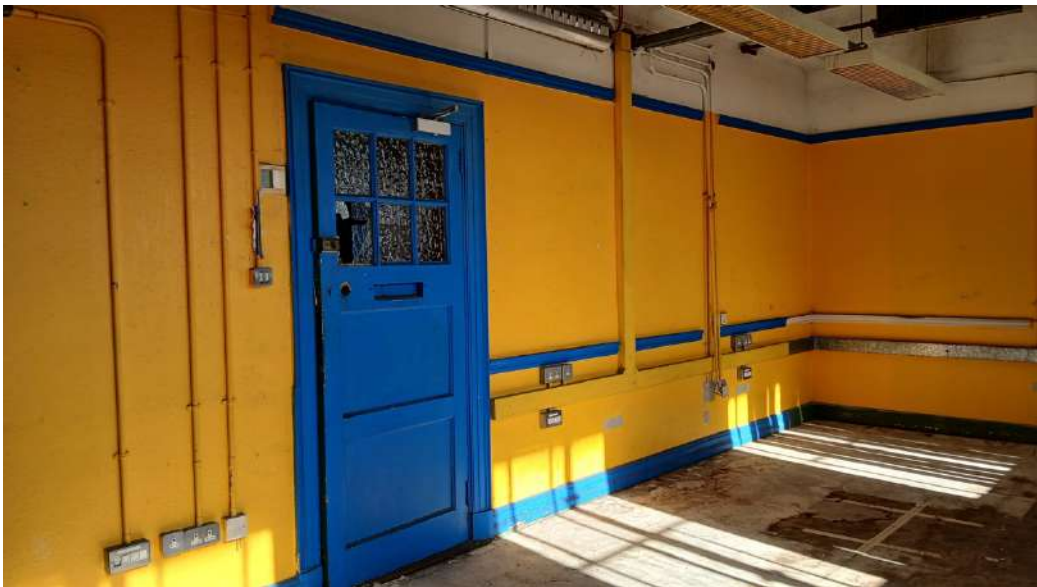
**Plate 68:** Original three panelled door

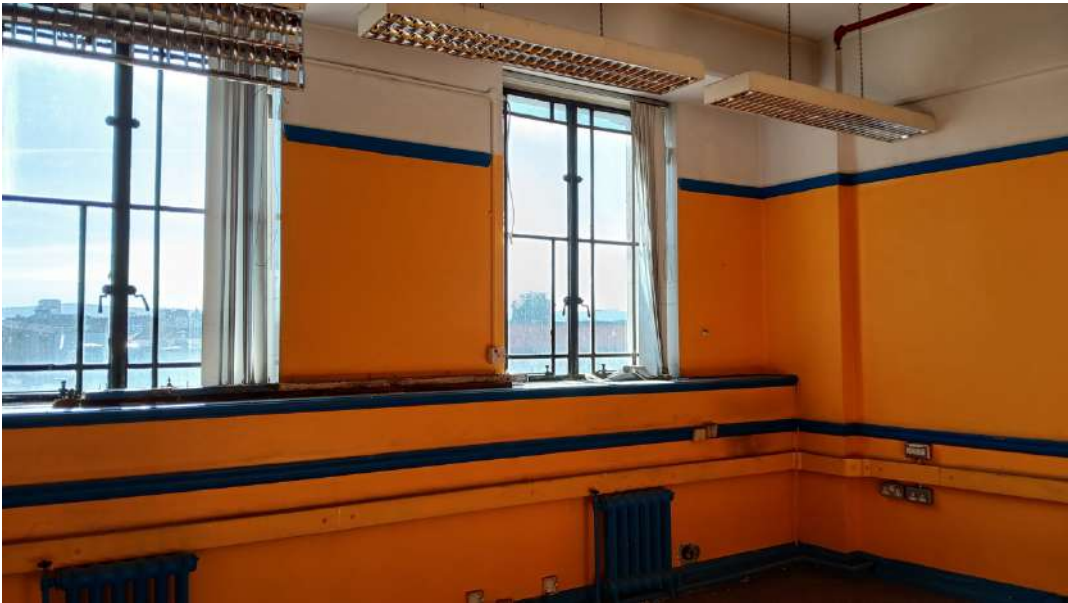
**Plate 69:** Cast iron casement windows with margin lights, original ironmongery. Continuous window sill along length of room.

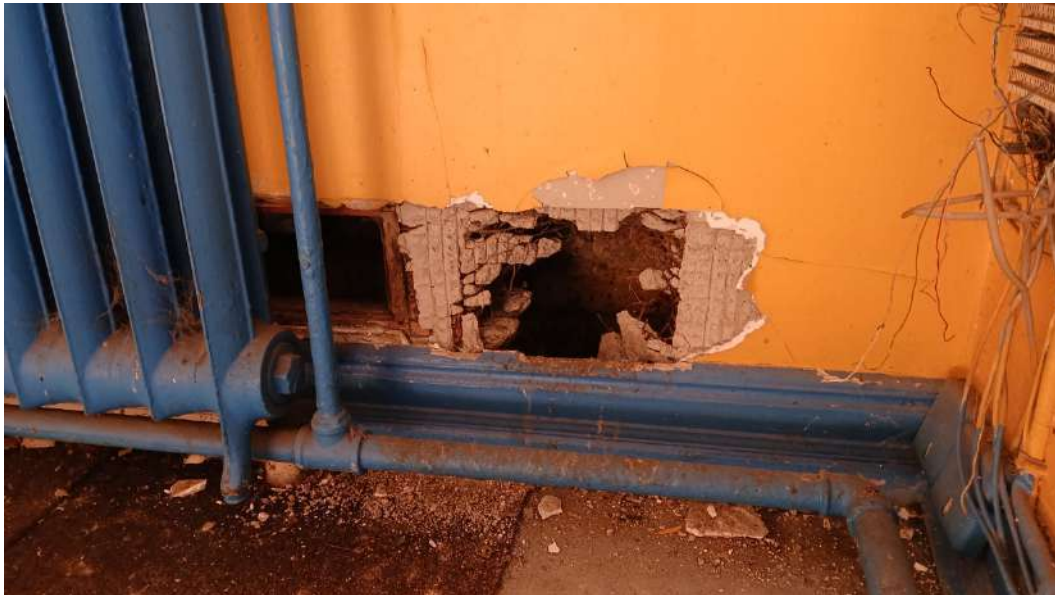
**Plate 70:** Installation of later services, heating system and pipework, routed indiscriminately through original joinery, partition walls etc. Breach in wall fabric exposing composition of front wall: masonry structure with timbered framed wall lining internally.

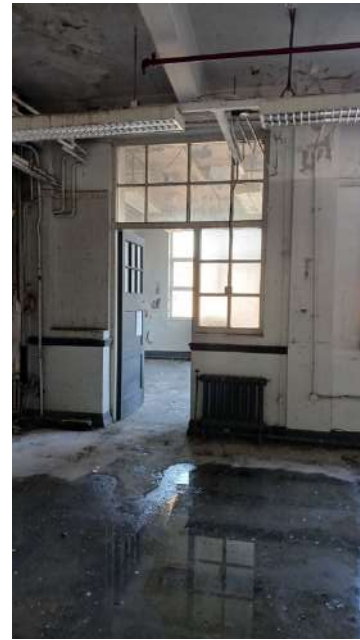
**Plate 71:** Modified opening in rear elevation through to later rear return.

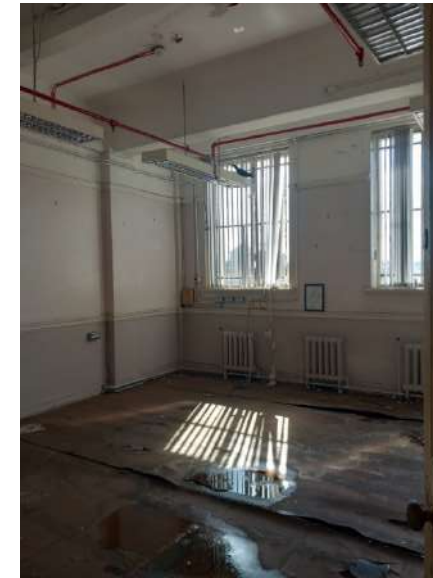
**Plate 72:** Typical cellular office facing south onto Middle Abbey Street. Original metal window frames. Original skirting, dado and picture rails. Evidence of water damage internally.

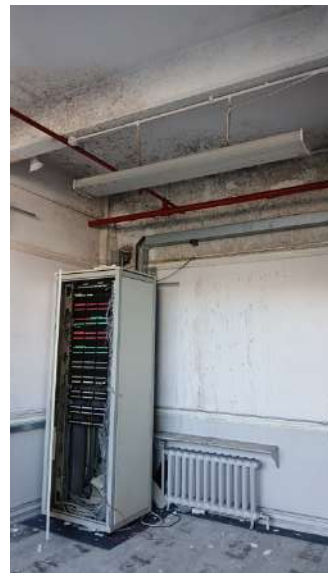
**Plate 73:** Typical office interior with original skirtings, dado and picture rail, exposed concrete frame structure. Later surface mounted services throughout.

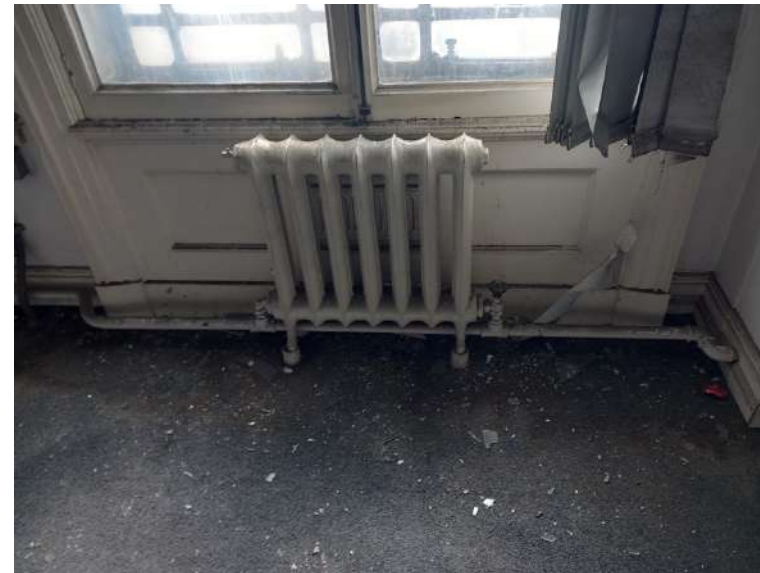
**Plate 74:** Panelled window apron. Later cast-iron radiators, irregularly positioned under windows with distribution pipework exposed throughout.

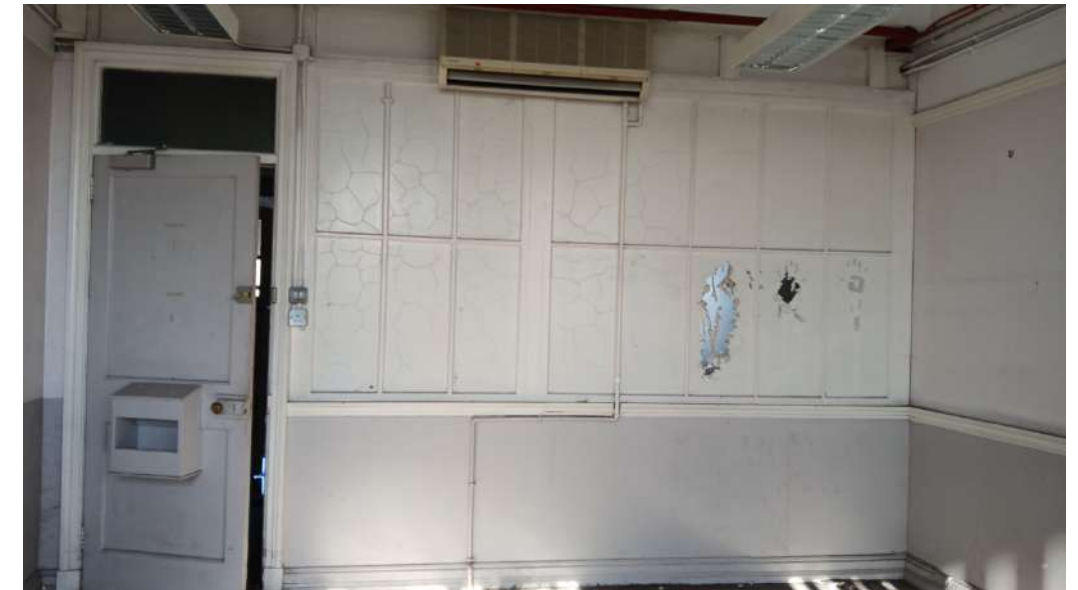
**Plate 75:** Panelled screen wall to central corridor.

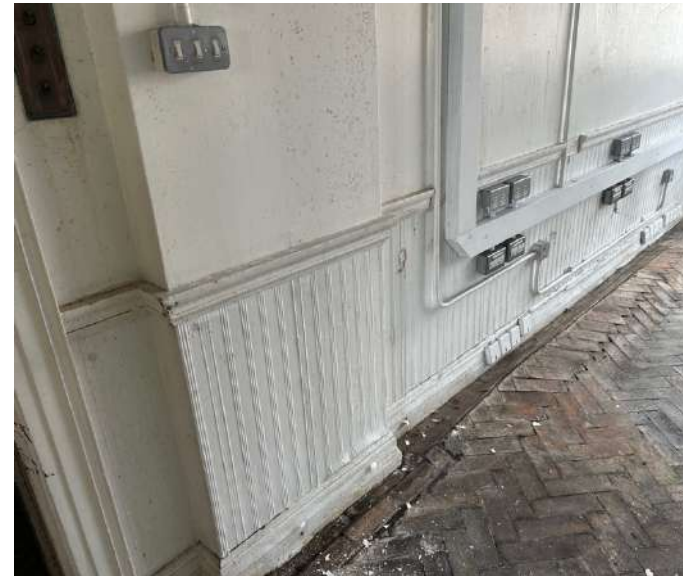
**Plate 76:** Moulded timber skirting, dado and picture-rail. Neo-classical plasterwork to ceiling in regency style. Original parquet floor, damaged by water ingress.

**Plate 50** Decorative elements in the former boardroom including the low-relief plaster ceiling and the parquet floor will be repaired where

possible or repaired and reinstated within the new development. relocate it within the development as a decorative feature.

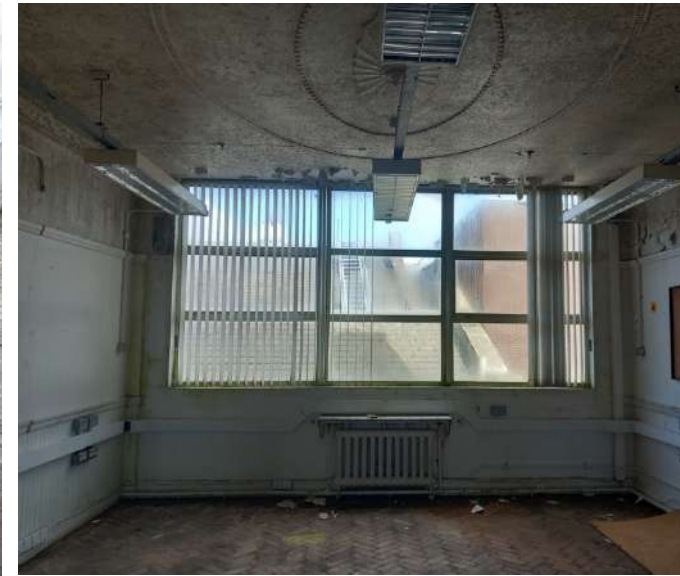
**Plate 77:** View facing north in former boardroom. Replacement uPVC windows and exposed contemporary services throughout. Moulded timber skirting, dado and picture-rail. Neo-classical plasterwork to ceiling in regency style. Original parquet floor, damaged by water ingress.

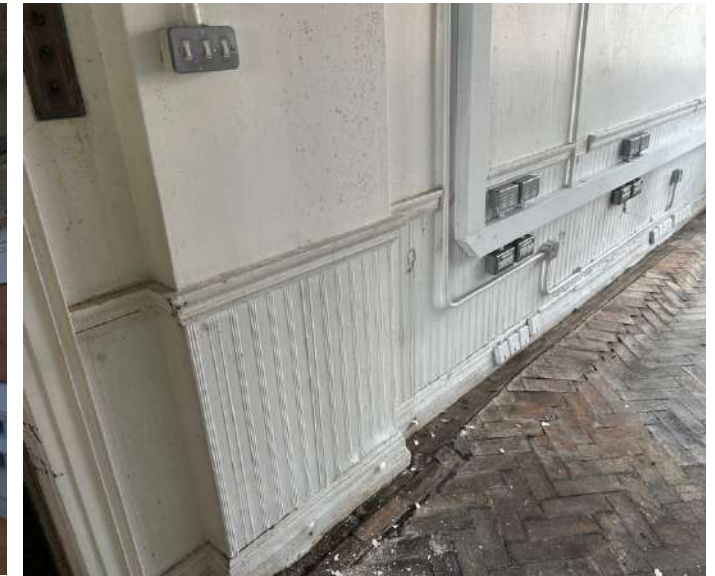
**Plate 78:** Moulded timber skirting, dado and picture-rail. Neo-classical plasterwork to ceiling in regency style. Original parquet floor, damaged by water ingress.

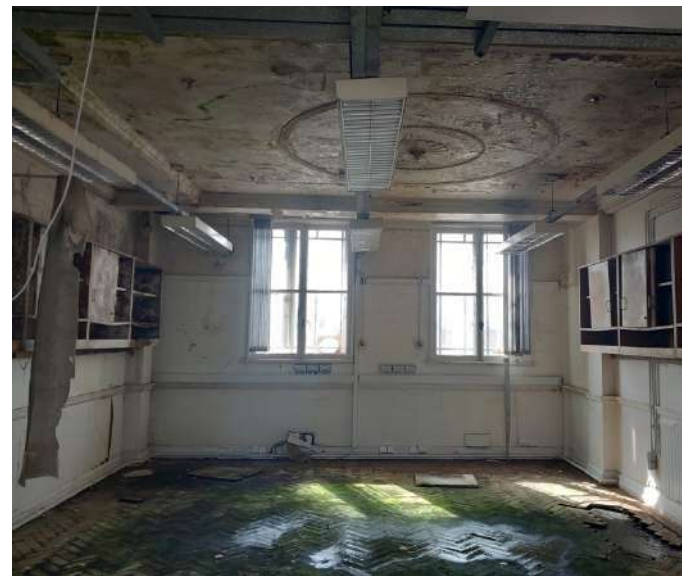
**Plate 79:** View facing north in former boardroom. Original secondary glazing system on Middle Abbey Street. Timber casements internally with cast iron frames externally, all with original ironmongery. Moulded timber skirting, dado and picture-rail. Neo-classical plasterwork to ceiling in regency style. Original parquet floor, damaged by water ingress. Exposed contemporary services throughout.

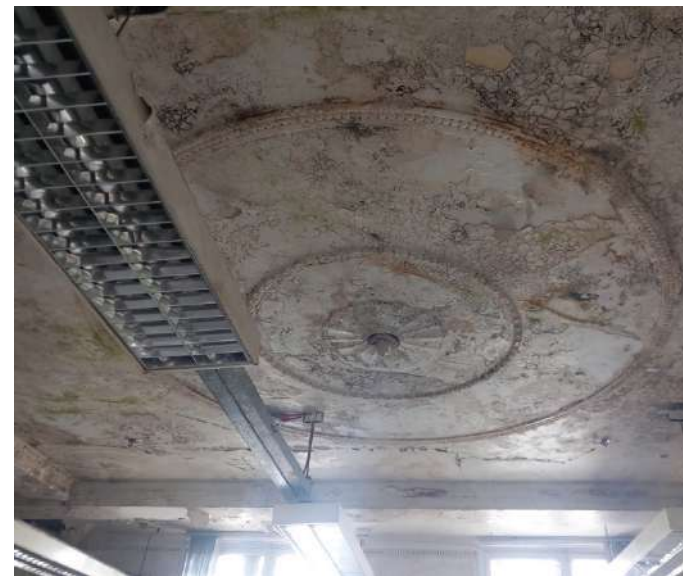
**Plate 80:** Neo-classical plasterwork to ceiling in regency style, damaged by water ingress from roof.
