INDEPENDENT HOUSE STUDENT ACCOMMODATION  
87-93 MIDDLE ABBEY STREET  
**LRD PLANNING SUBMISSION - ARCHITECTURAL HERITAGE IMPACT ASSESSMENT**

MARCH 2025

**MOLLOY & ASSOCIATES**  
CONSERVATION ARCHITECTS

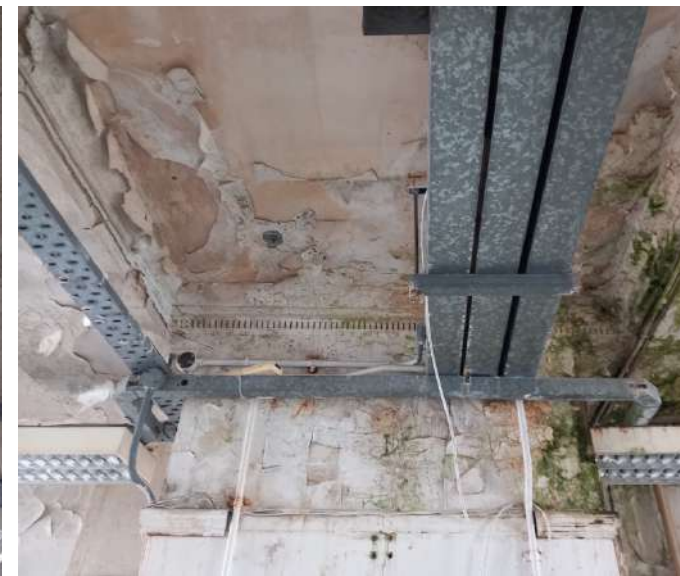
**Plate 81:** Neo-classical plasterwork to ceiling in regency style, damaged by water ingress from roof. Downstand beams with decorative cornice. Exposed contemporary services fixed through ceiling fabric.

**Plate 50** Decorative elements in the former boardroom including the low-relief plaster ceiling and the parquet floor will be repaired where

possible or repaired and reinstated within the new development. relocate it within the development as a decorative feature.

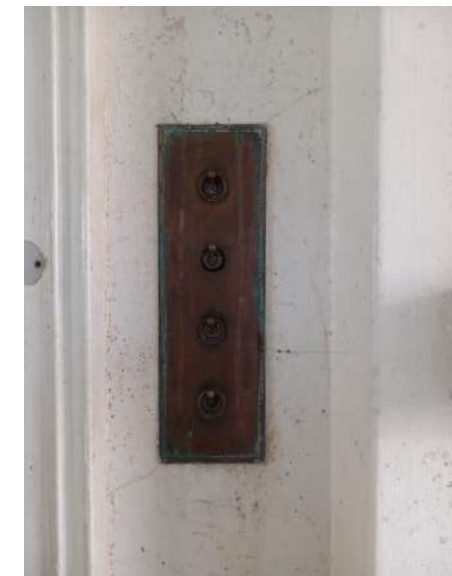
**Plate 82:** Bronze switch plate with toggle switches in former boardroom.

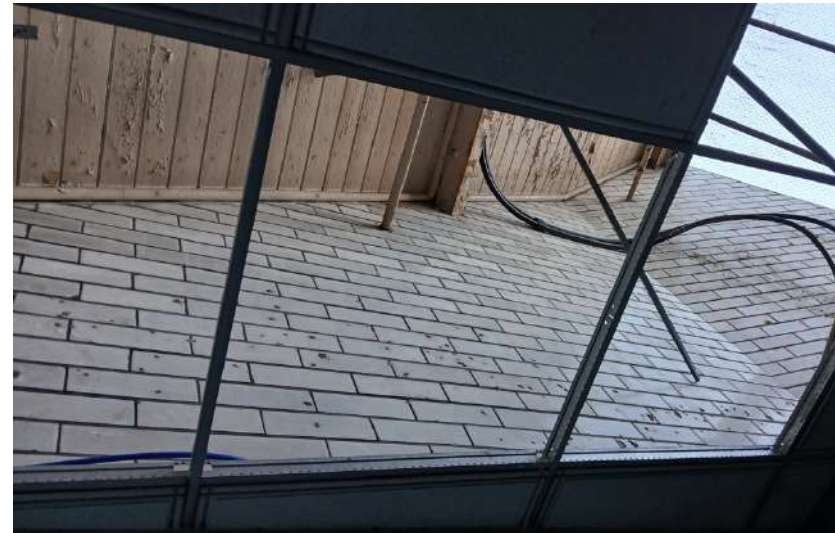
**Plate 83:** Glazed white tile finish to flanking walls of pitched roof. (Rear section of main roof). Painted timber boarding to underside of roof structure.

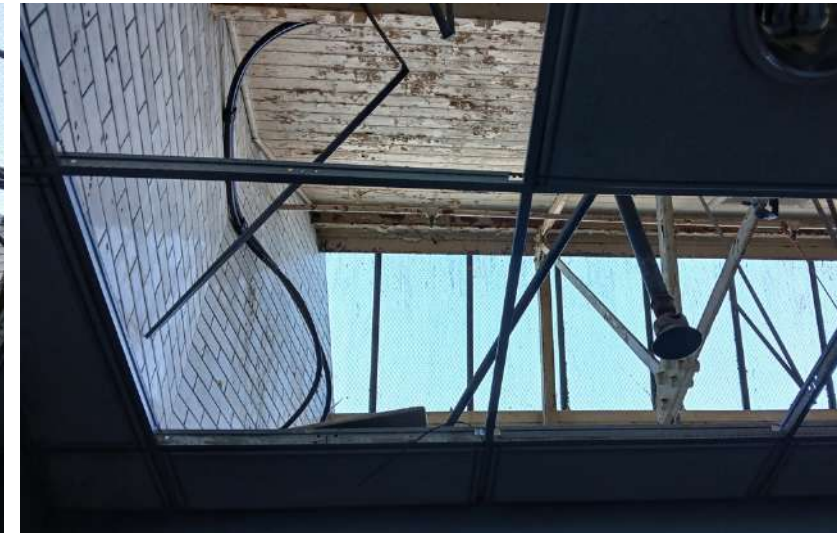
**Plate 84:** Concealed above contemporary suspended ceiling: the pitched roof at the rear of the main roof. Patent glazing system with replacement wired glass panels. Lightweight metal truss roof structure.

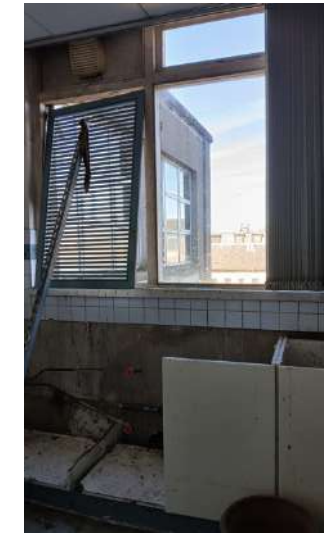
**Plate 85:** Later non original timber windows at fourth floor level.

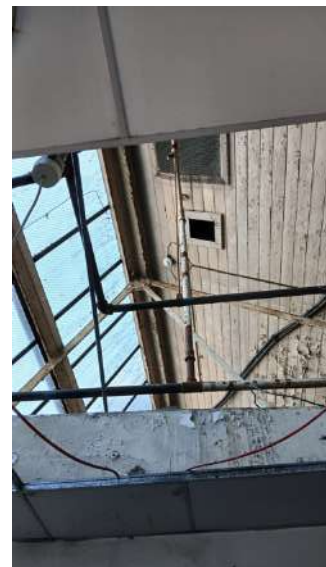
**Plate 86:** Underside of pitched roof above Independent House, Lightweight steel truss, timber boarding with slate lining externally, patent glazing system to north pitch.

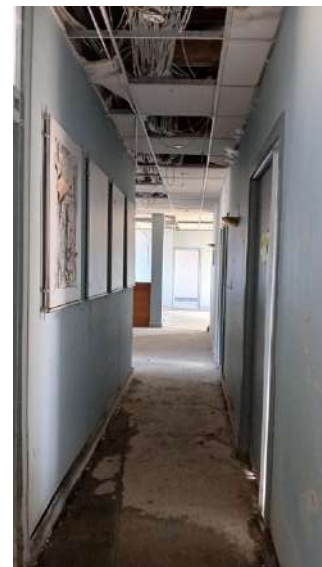
**Plate 87:** Contemporary partitions and doors on fourth floor level.

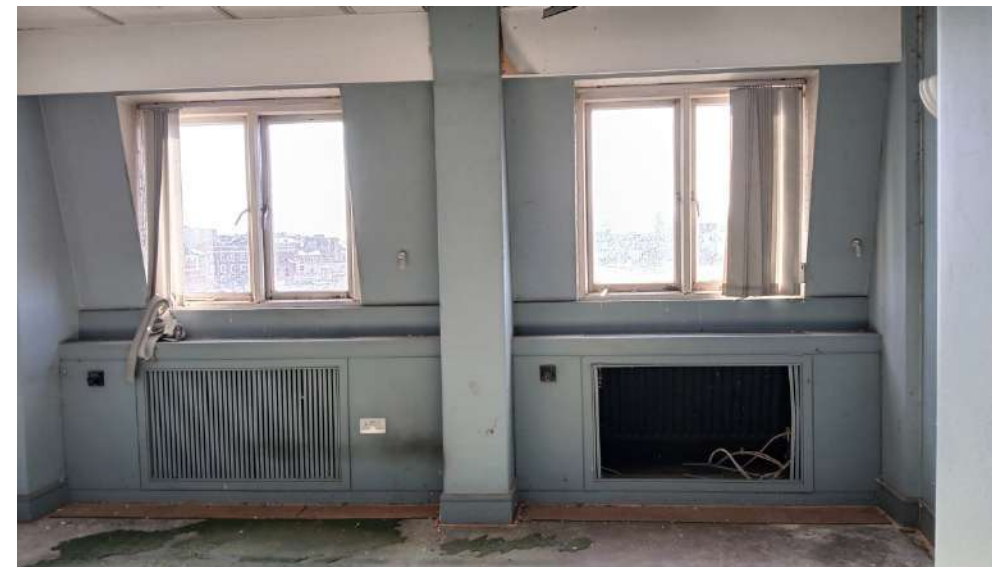
**Plate 88:** Replacement timber windows at fourth floor level. Contemporary wall linings.

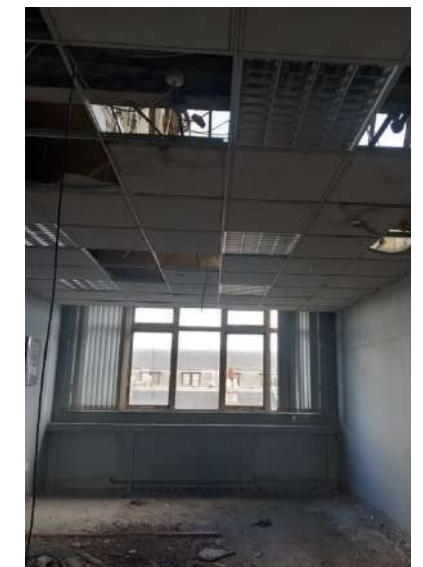
**Plate 89:** Contemporary ceiling on top floor, concealing original rooflights over.

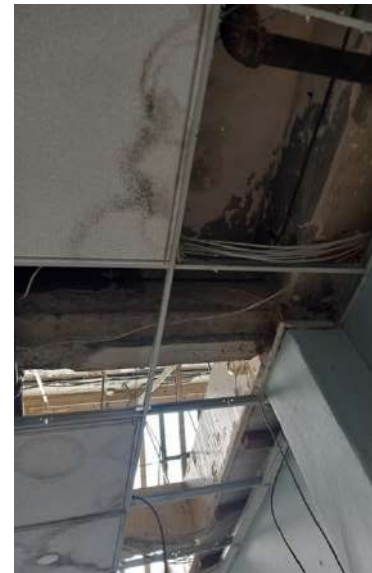
**Plate 90:** Contemporary ceiling on top floor, concealing original sawtooth rooflights over.

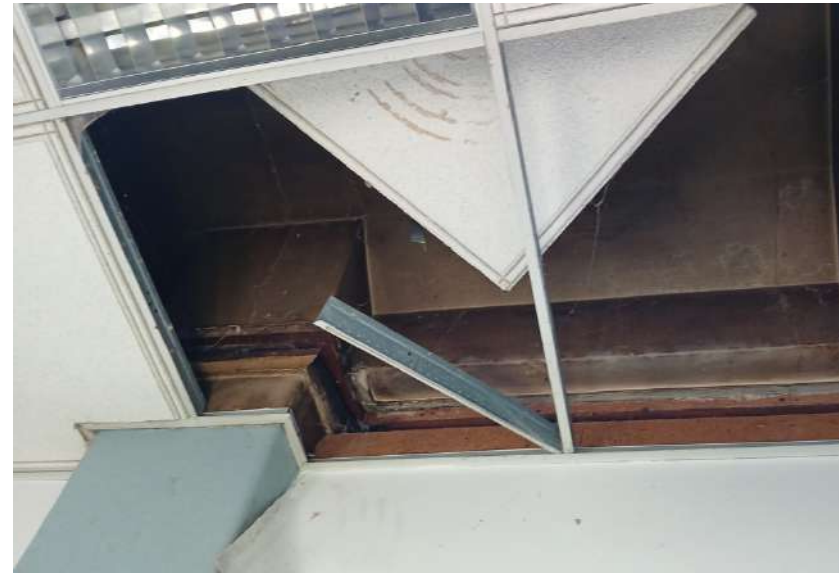
**Plate 91:** Original concrete roof structure above contemporary suspended ceiling.

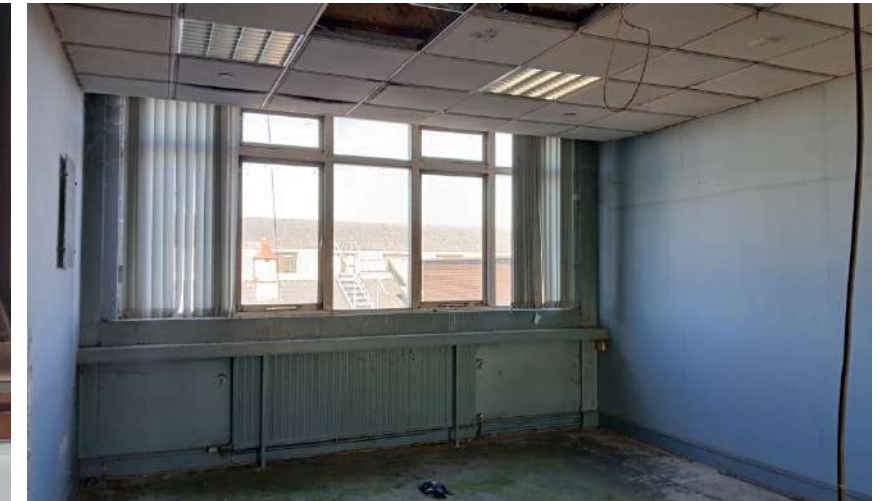
**Plate 92:** Replacement windows, contemporary wall linings and suspended ceiling at level 4.

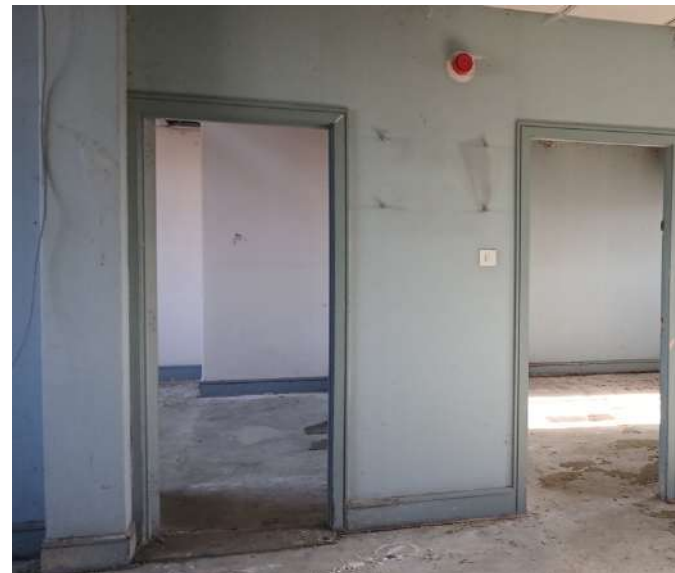
**Plate 93:** Contemporary joinery, contemporary wall linings and suspended ceiling at level 4.

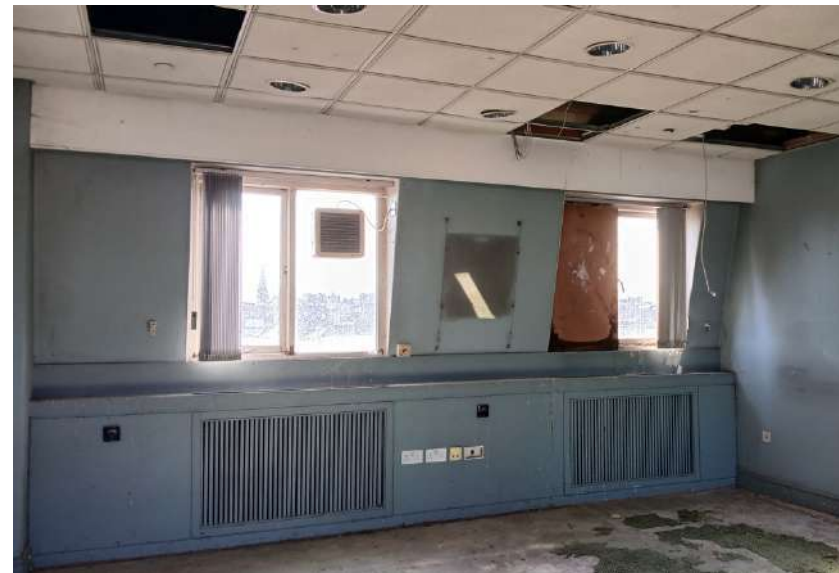
**Plate 94:** Replacement timber windows at fourth floor level. Contemporary wall linings.

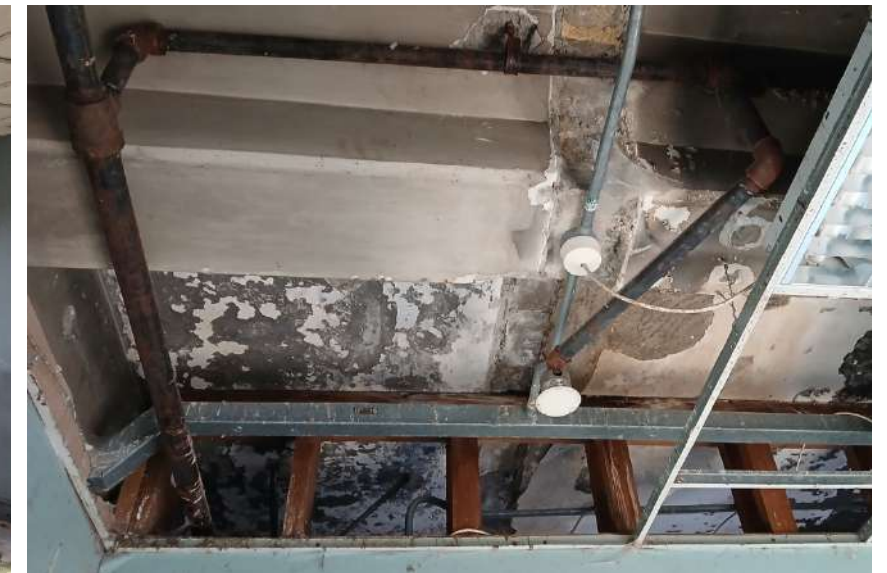
**Plate 95:** Scarring in concrete roof structure indicates position of original dividing walls internally.

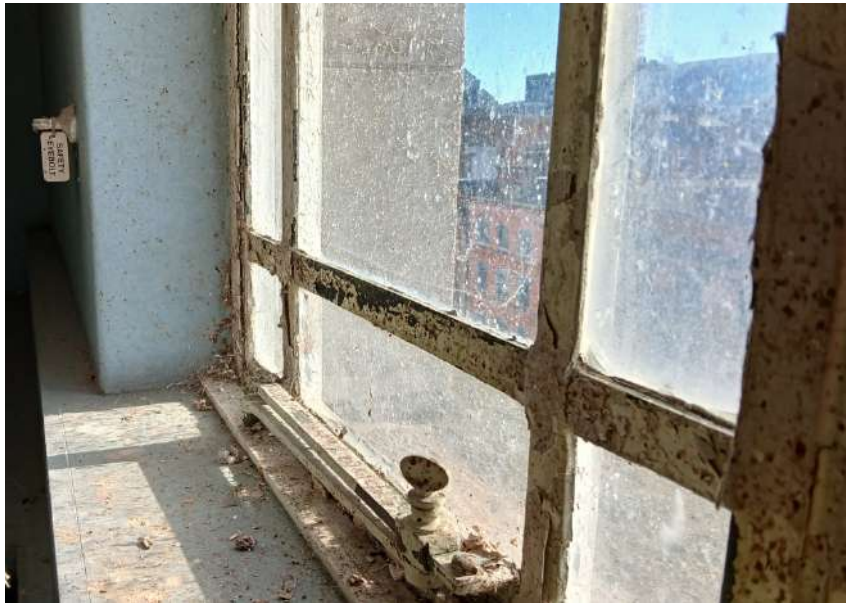
Plate 96: Detail of original metal casement window with margin lights.

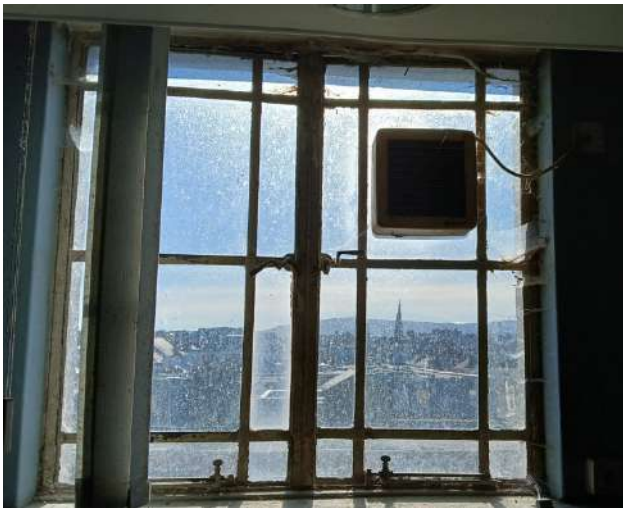
Plate 98: Only one original window remains at level 4, all others have been replaced,

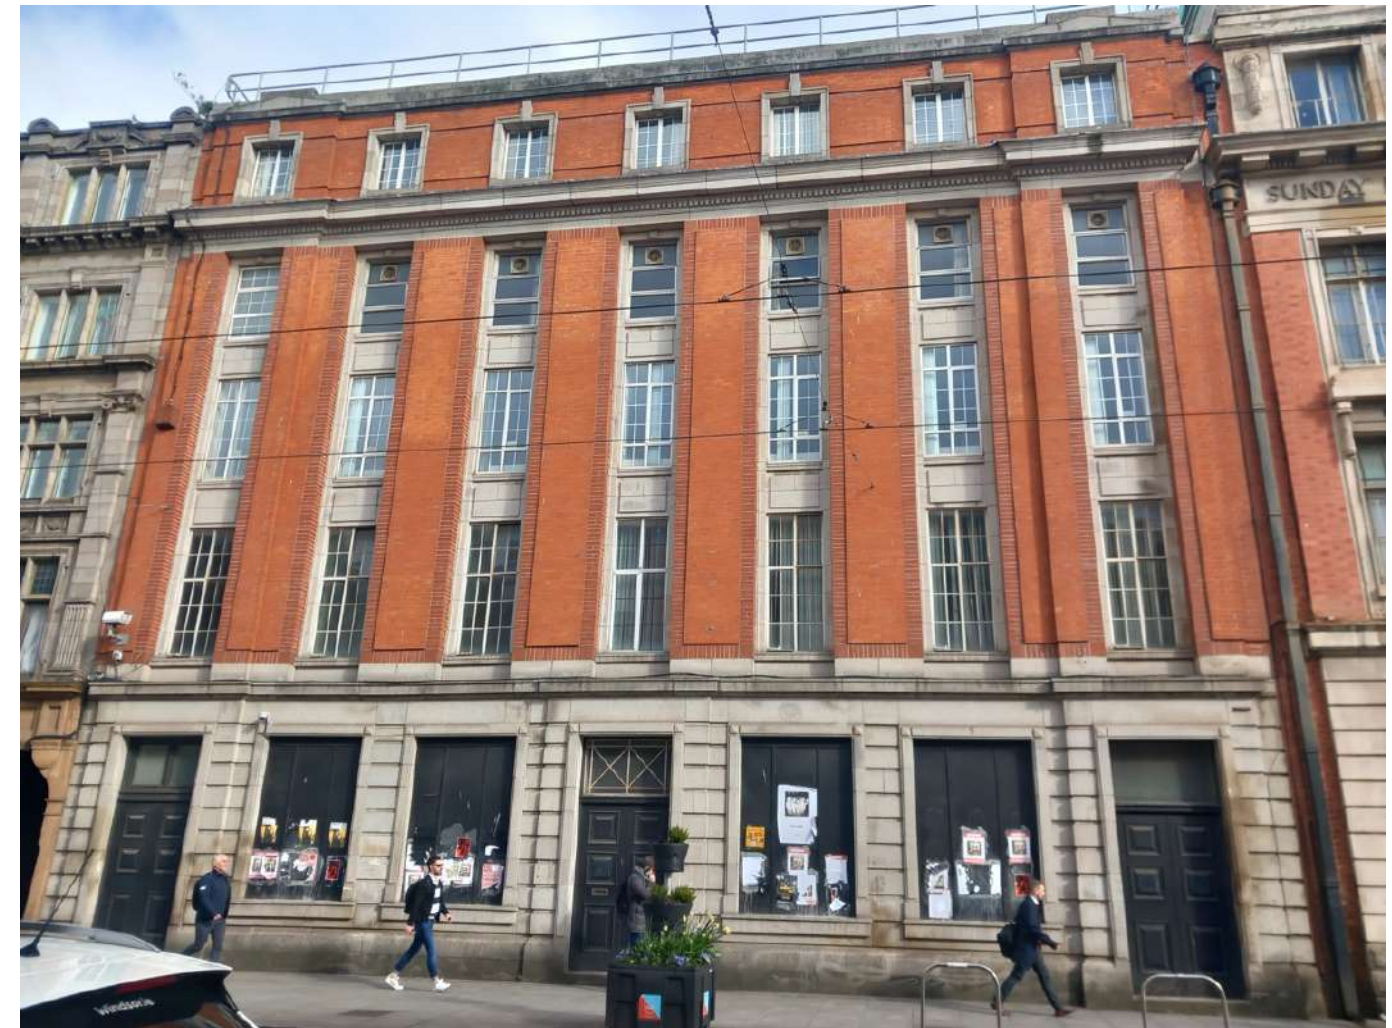
**Plate 101:** Front façade of 91-93 Middle Abbey Street.

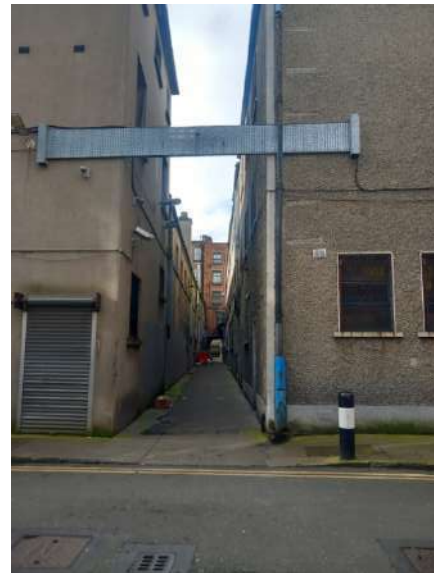
**Plate 103:** Entrance to William's Lane off Princes Street. Note face-fixed services over lane at high-level

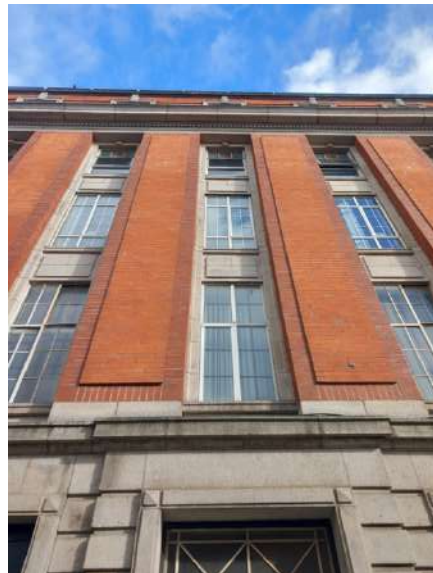
**Plate 113:** Detail of central bay. Raised brick panel laid in Flemish bond framed by soldier course. Mixture of uPVC replacement windows and original multipaned steel windows.

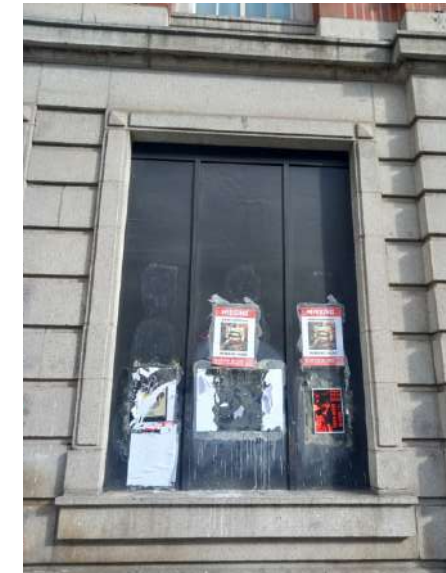
**Plate 116:** Ground floor window, boarded up windows, opening framed with cut granite architrave with diamond faced blocks.

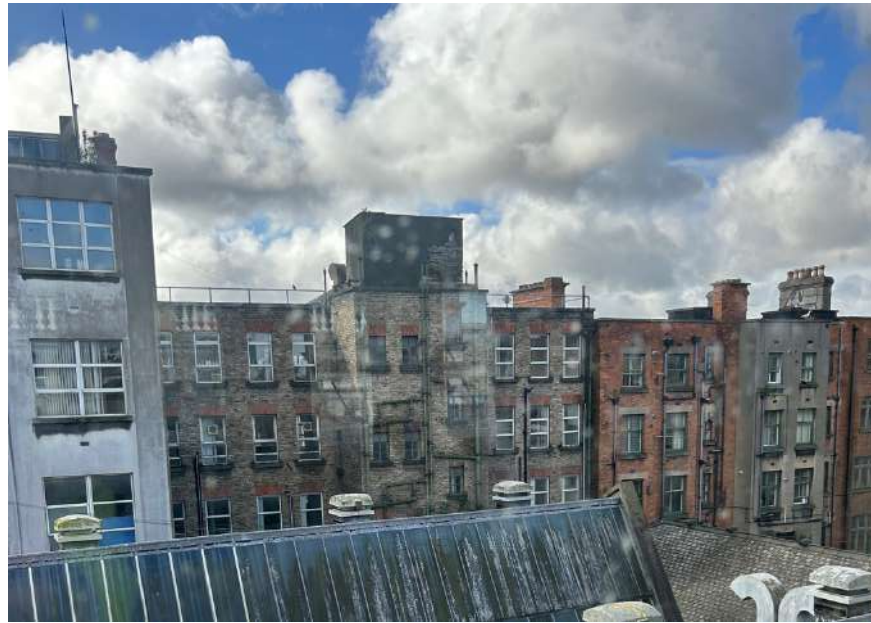
**Plate 117:** Rear façade of 87-90 Middle Abbey Street comprised of buff coloured brick with contrast red brick lintels. The rear windows have been replaced with contemporary frames throughout, except for the bathrooms on the return which have original steel multipaned frames.

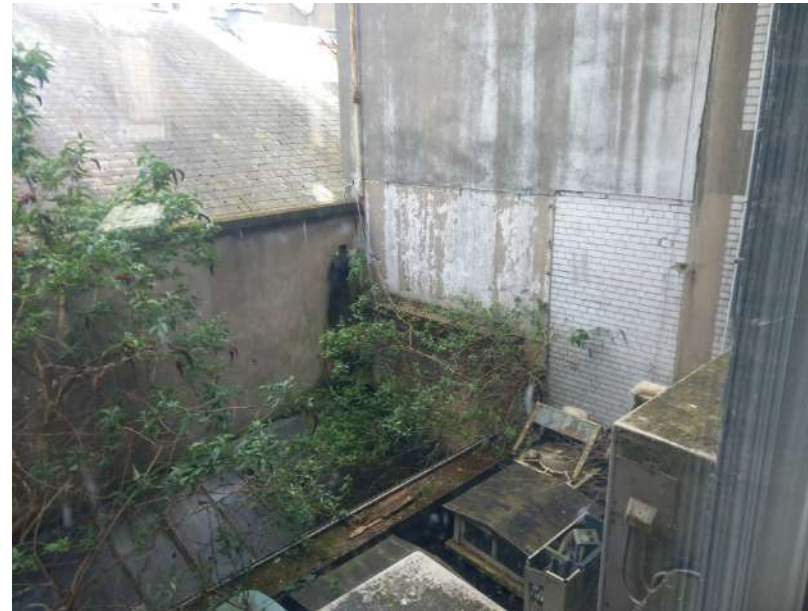
**Plate 118:** A series of lightwells introduce daylight between the rear range of buildings. The external walls are typically faced in a glazed white brick. This lightwell is positioned to the west of the return of Independent House, between the rear (south) wall of the Machine Room and 87-90 Middle Abbey Street.

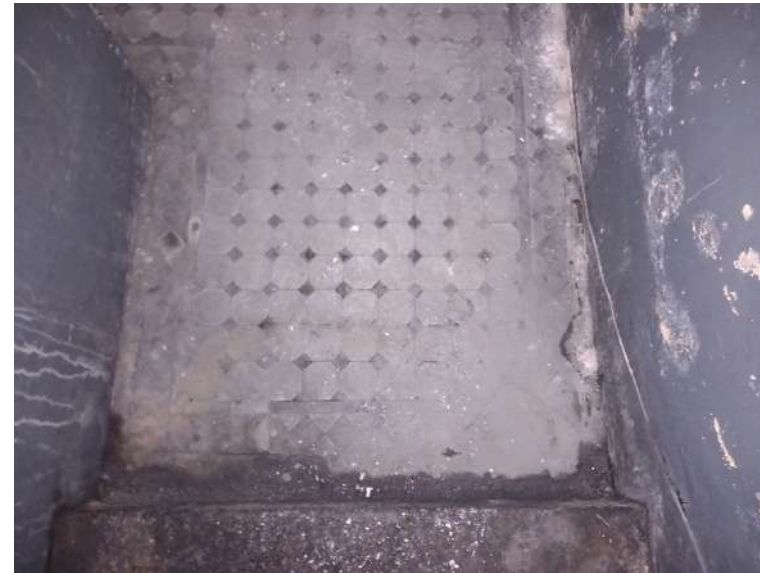
**Plate 120:** Black and white tile floor to basement hall off central granite stairs, with diamond boundary.

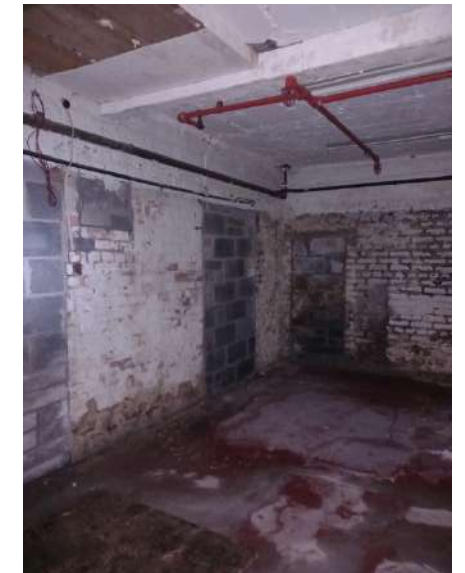
**Plate 122:** Block infilled openings brick wall.

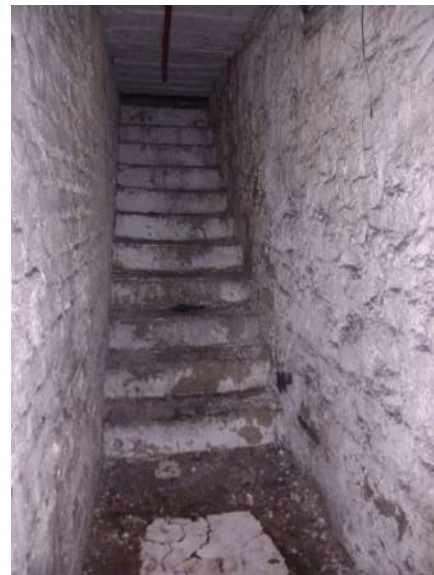
**Plate 123:** Granite stair from basement level, behind main central stair is aligned with rear Calp limestone basement wall. Access is obstructed at ground level.

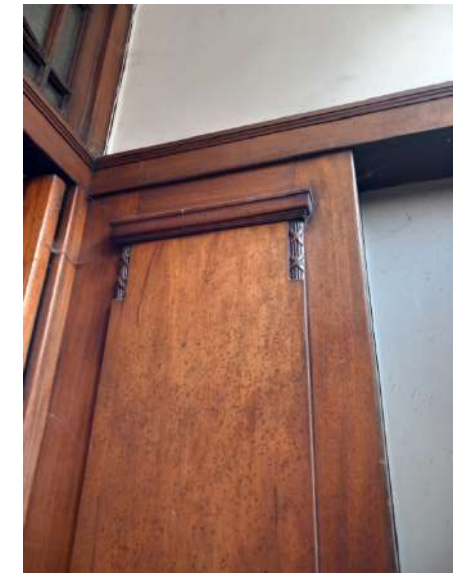
**Plate 128:** Detail of carved joinery with reeded and cable moulding motif to reveals of entrance lobby.

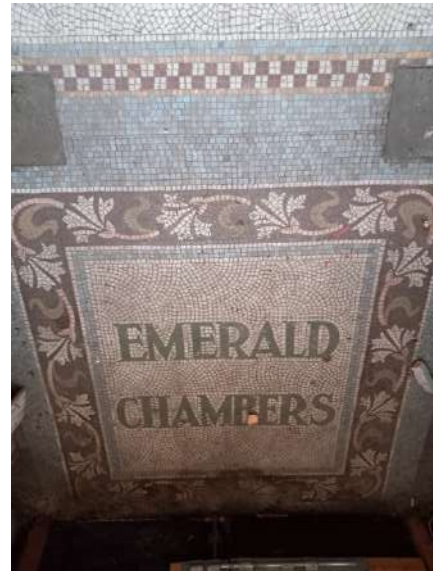
**Plate 129:** Mosaic floor in entrance lobby, with the name of the building 'Emerald Chambers'.

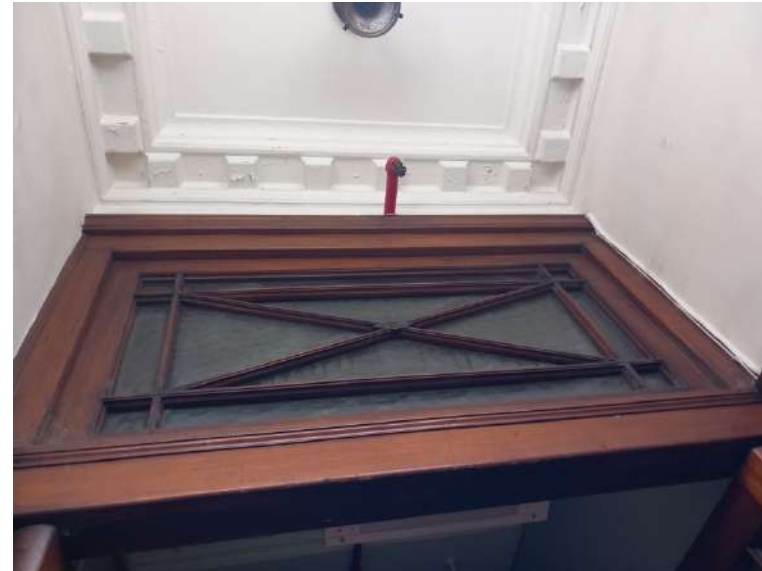
**Plate 130:** Timber frame transom light above internal lobby door with margin lights and cross bracing.

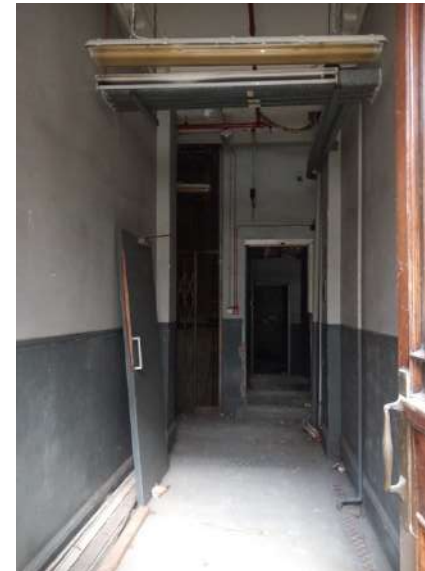
**Plate 131:** Entrance Hall, original mosaic floor with contrast colour boarder, original moulded timber skirting, rendered walls with inset dado, modillion cornice. Surface mounted contemporary services throughout.

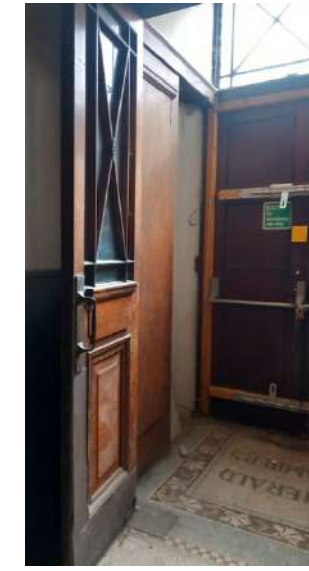
**Plate 132:** Internal lobby doors comprised of glazed upper panel with margin lights and diagonal cross bracing, raised and fielded panel at lower level, original ironmongery; pull handles and kickplate with floor springs.

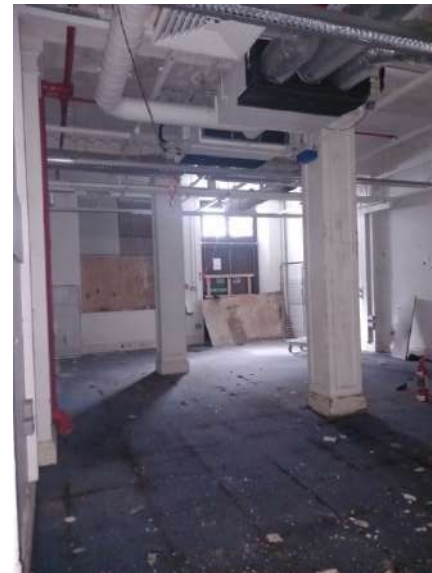
**Plate 133:** Modillion cornice above contemporary services and ceiling fixtures. Panelling to columns. Windows boarded up.

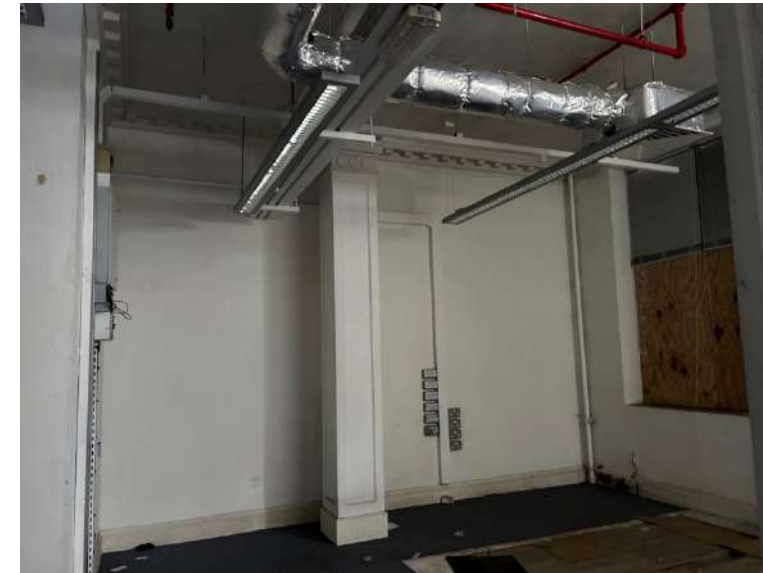
**Plate 134:** Modillion cornice above contemporary services and ceiling fixtures. Panelling to columns.

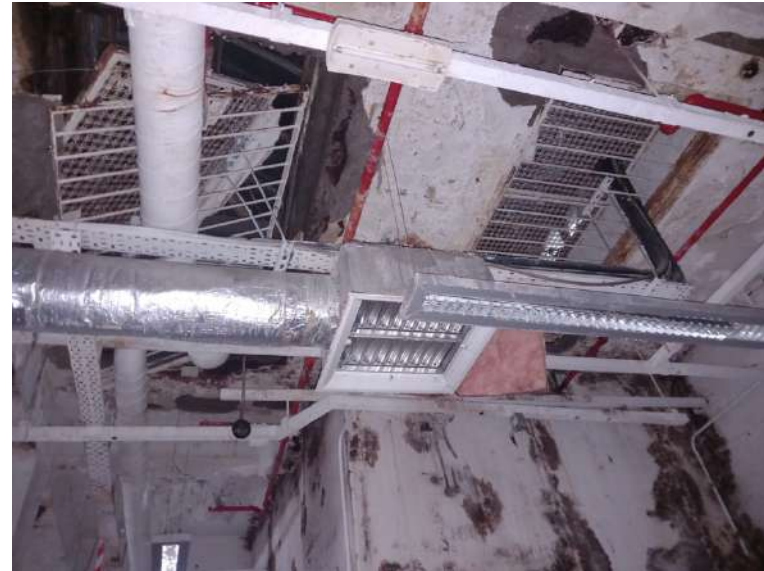
**Plate 135:** Concrete frame structure impacted by water ingress. Contemporary services throughout.

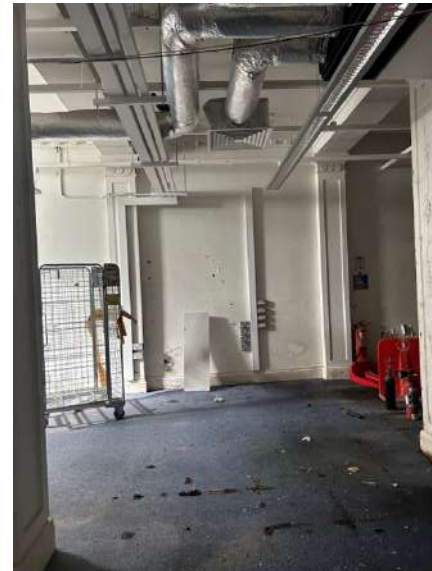
**Plate 136:** Modillion cornice above contemporary services and ceiling fixtures. Panelling to columns.

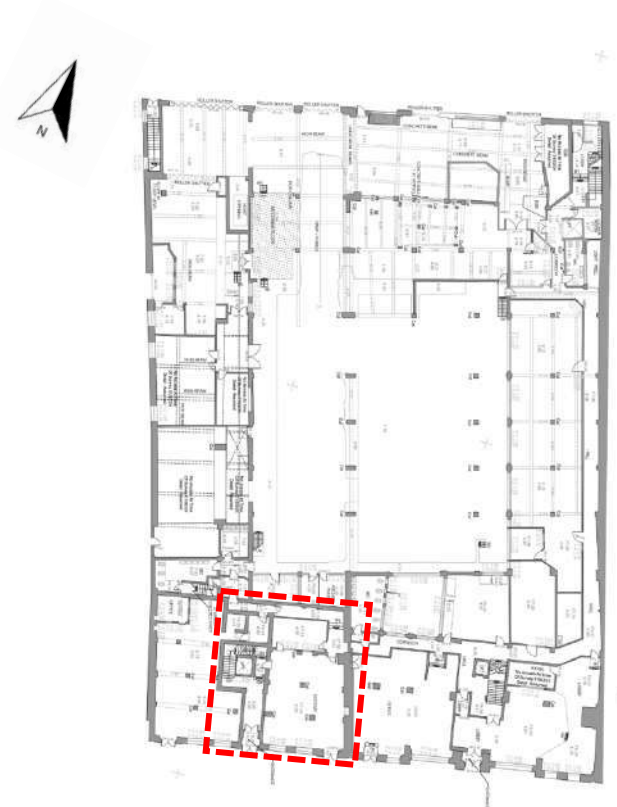
87-90 Middle Abbey Street Lobby - Ground Floor Plan

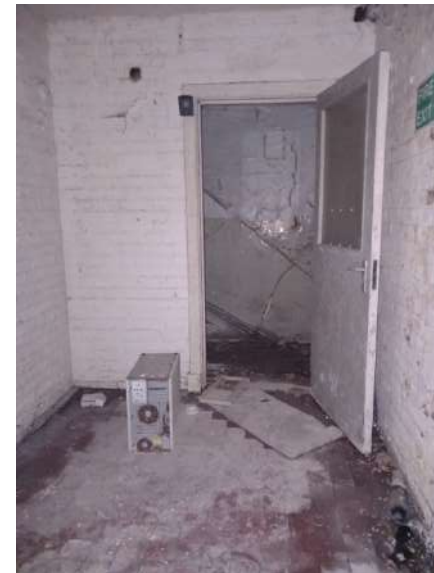
**Plate 138:** Moulded timber architrave on blocks. Painted brick walls and terracotta tiled floor. Area is in poor condition due to sustained water ingress.

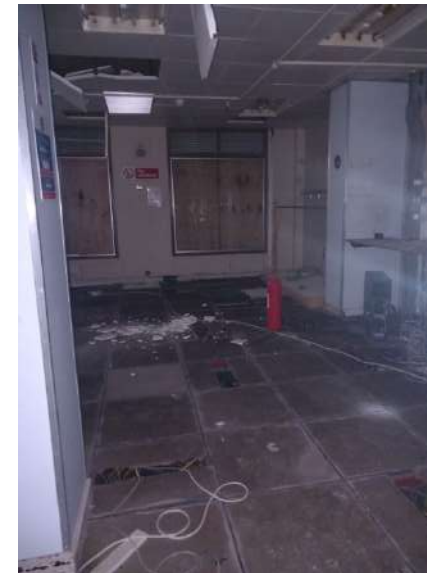
**Plate 139:** Contemporary linings throughout; raised access floor, suspended ceiling, windows are boarded up.

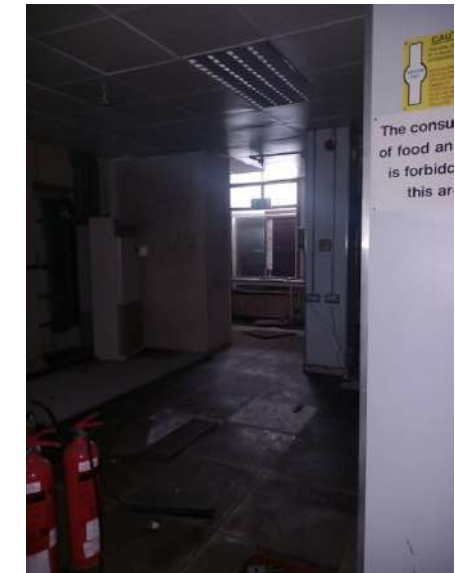
**Plate 140:** Contemporary linings throughout; raised access floor and suspended ceiling.

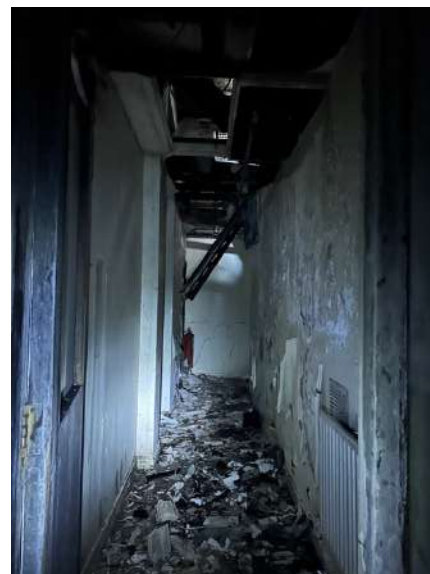
**Plate 141:** The derelict condition of the rooflights has resulted in extensive damage to the building fabric.

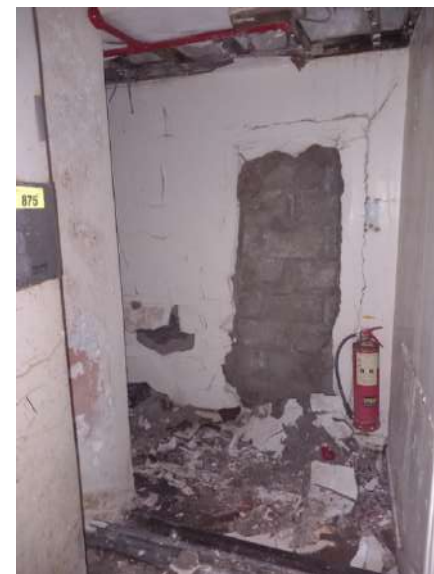
**Plate 142:** Rear ground floor of 87-90 Middle Abbey Street. Blockwork infilled opening.

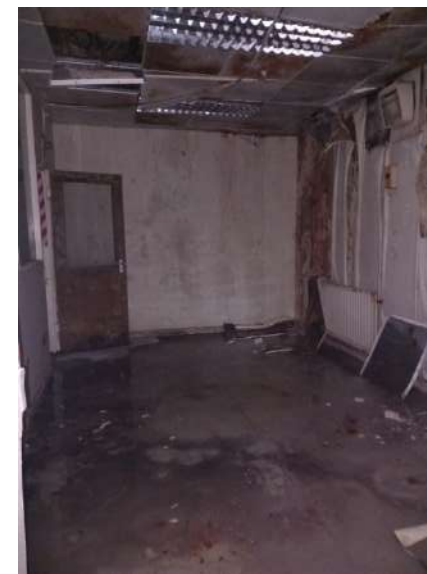
**Plate 143:** Rear ground floor of 87-90 Middle Abbey Street. Area is in poor condition due to water ingress.

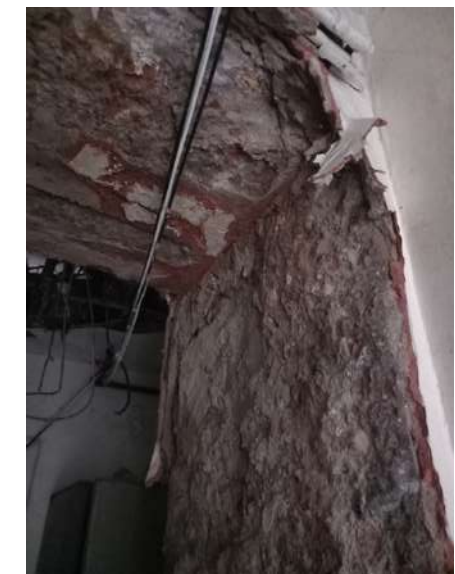
**Plate 144:** Opening through the party wall between 91-92 and 87-90 Middle Abbey Street (Independent House) is crudely formed through concrete structure.

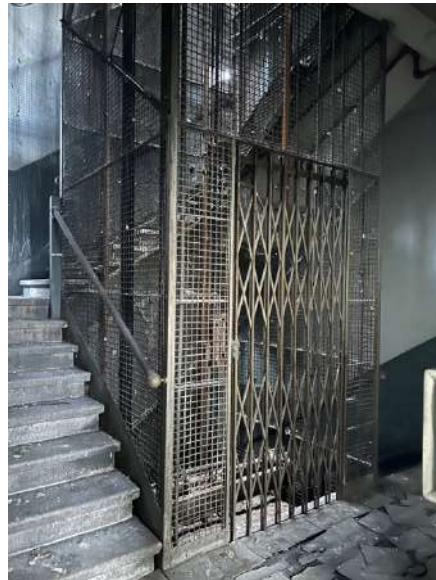
**Plate 145:** Projecting nosings on granite stair treads. Passenger lift with traditional cage structure rising through stairwell by Waygood Otis Ltd. Circular profile handrail fixed to lift enclosure.

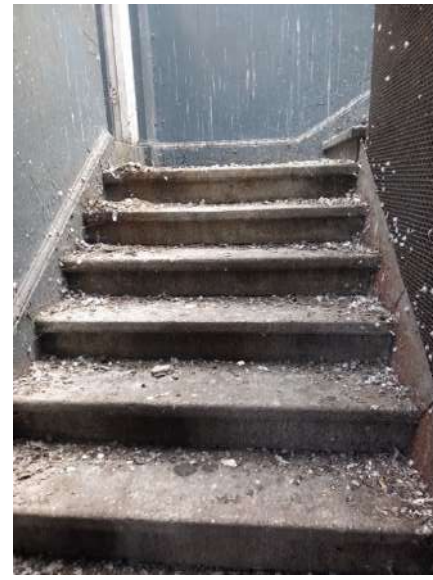
**Plate 146:** Granite threads to main stairs, with moulded timber skirting. Original lift, enclosed in steel cage positioned in central stairwell.

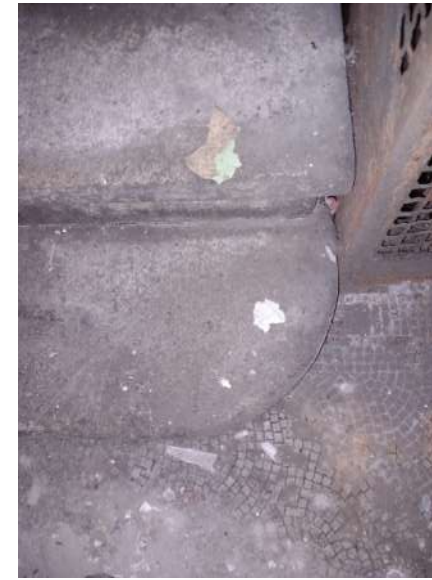
**Plate 147:** Granite stairs from ground to fourth floor level, with bullnose bottom step. Original mosaic floor in entrance laid in fan scallop pattern, with contrast boarder.

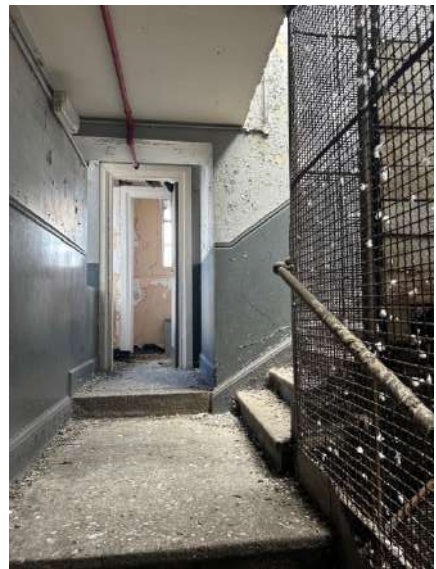
**Plate 149:** View from top of stairs towards sanitary facilities on quarter landing.

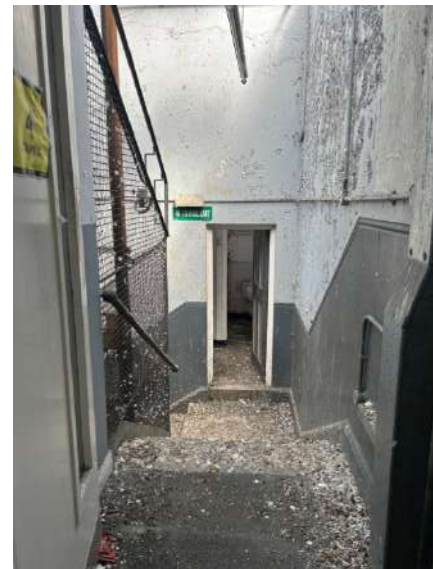
**Plate 150:** View from top of stairs towards quarter landing. Moulded timber skirting, dado integrated into wall render. Handrail fixed to lift enclosure.

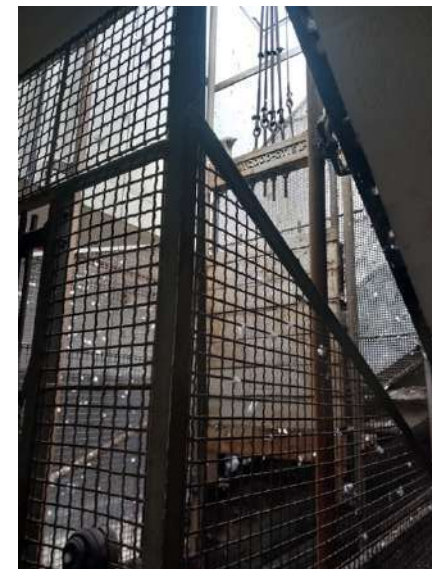
**Plate 151:** Passenger lift with traditional cage structure rising through stairwell stamped 'Waygood Otis Ltd.'

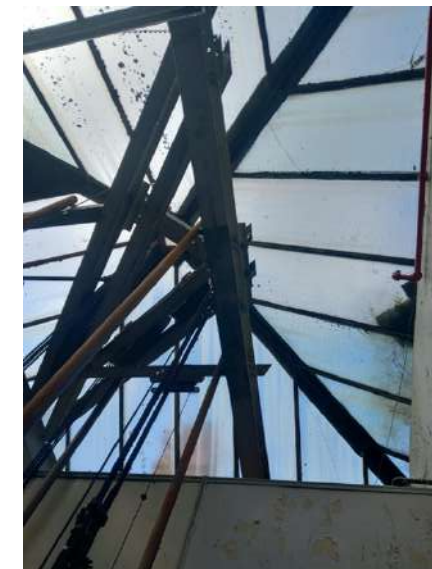
**Plate 152:** Pyramidal roof lantern above stair enclosure.

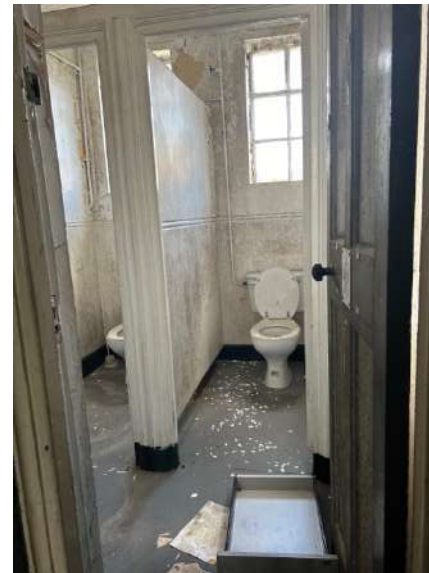
**Plate 153:** Sanitary facilities access off the quarter landings on the stairs. Mounded architraves, four panelled doors to cubicles, dado detail on rendered walls throughout. Steel framed multipaned windows with inward opening casements. Linoleum floor finish.

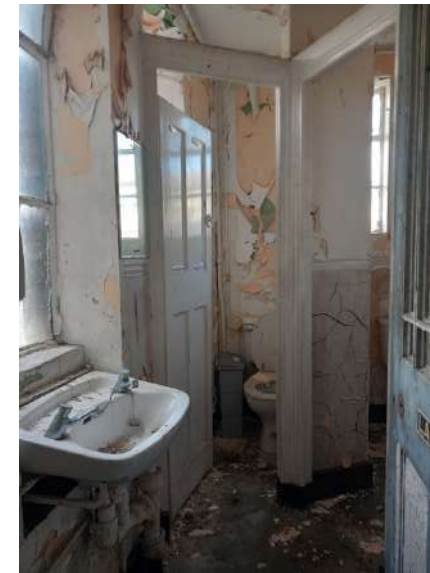
**Plate 154:** Cubicle doors are arranged in an angled layout on the lower-level quarter landing.

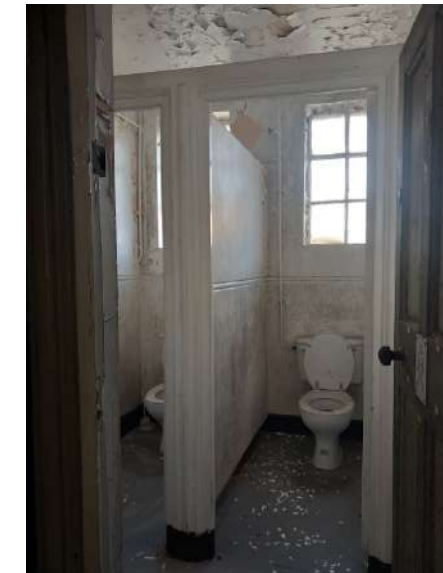
**Plate 155:** Typical layout of cubicles on the upper-level quarter landing. Mounded architraves, four panelled doors to cubicles, dado detail on rendered walls throughout. Steel framed multipaned windows with inward opening casements. Linoleum floor finish.

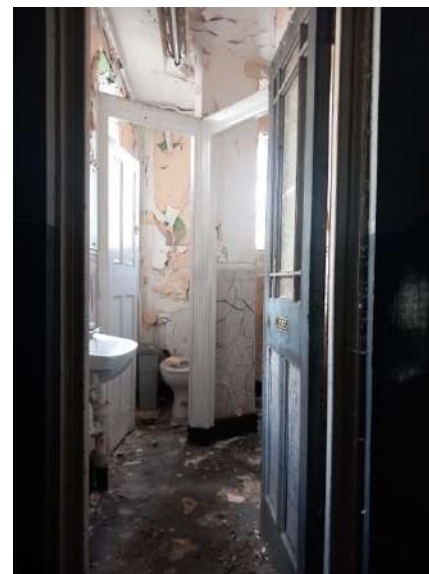
**Plate 156:** Door to sanitary facilities have glazed upper panels with margin lights, and two panels at the lower level.

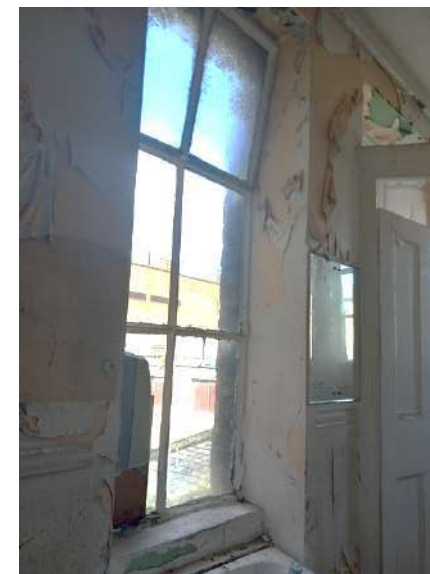
**Plate 157:** Multipaned steel framed windows.

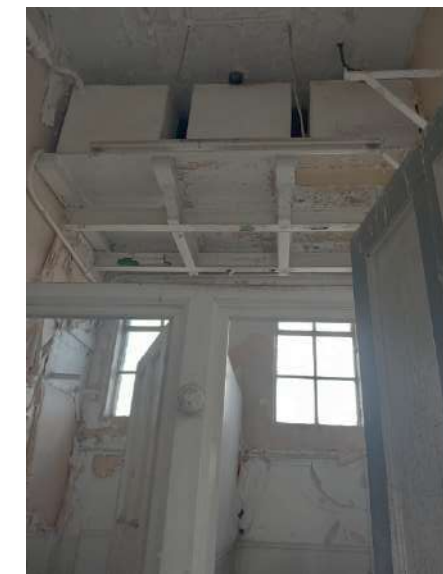
**Plate 158:** Water tanks supported above cubicles on the top floor level.

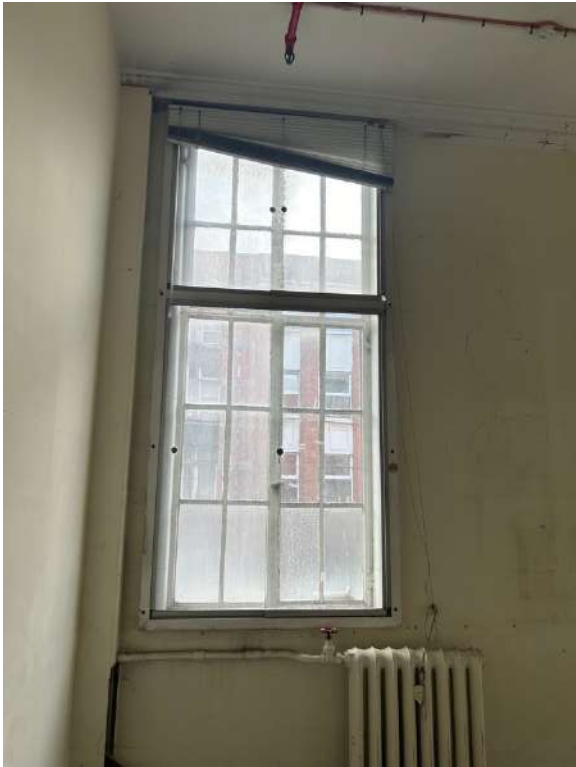
**Plate 159:** Cellular office. Plain run cornice, original metal windows with contemporary secondary glazing, surface mounted services. Later partition walls subdividing spaces.

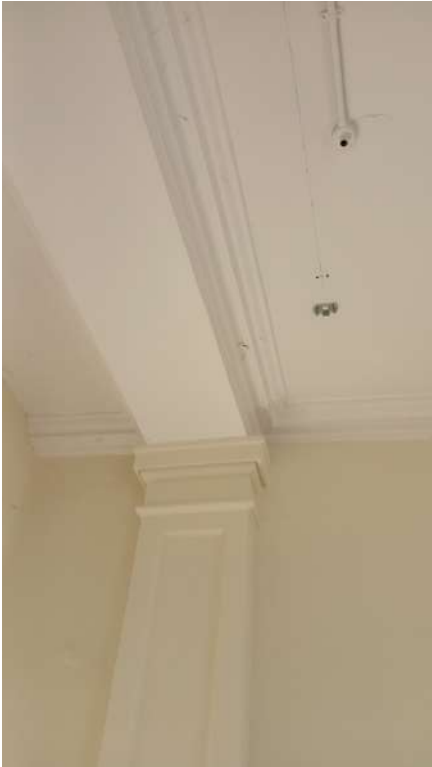
**Plate 160:** Cornices and panelling details to columns and pilasters and bressummer beams.

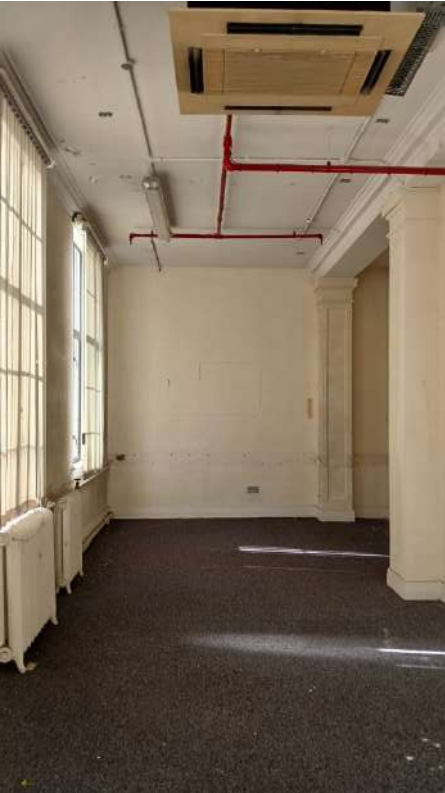
**Plate 161:** Open plan office. Plain run cornice, original metal windows, surface mounted services. Concrete floor slab.

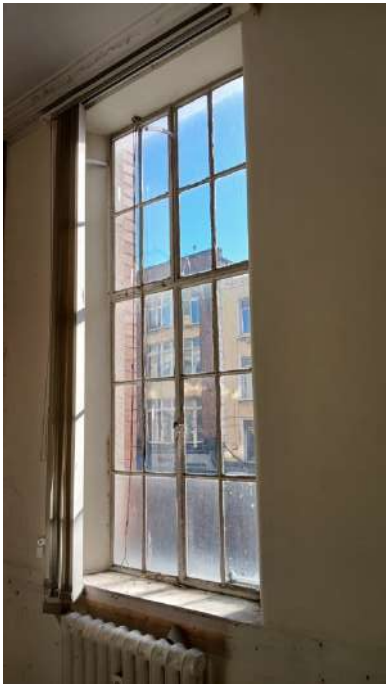
**Plate 162:** Metal frame windows with original ironmongery, rendered reveals with gently rounded rendered reveals.

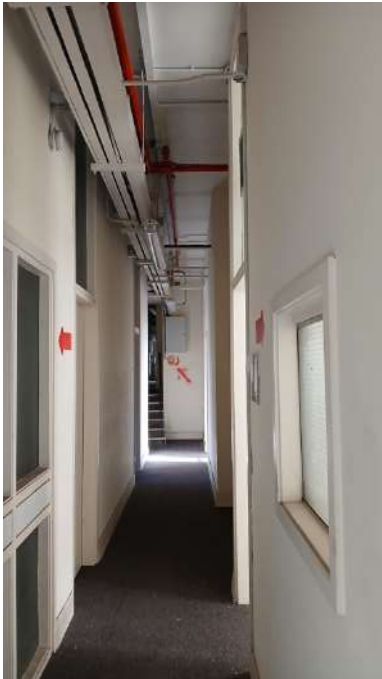
**Plate 163:** Contemporary partition walls along central corridor.

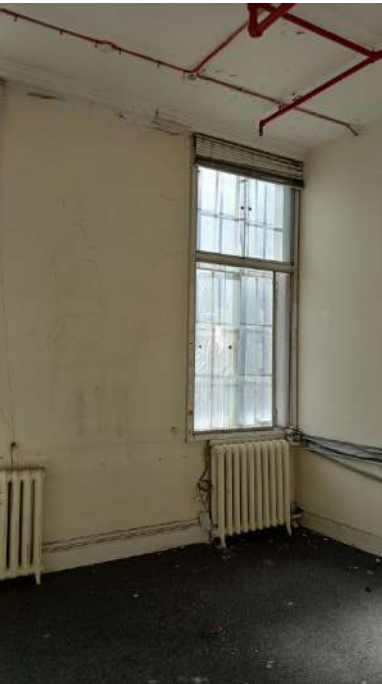
**Plate 164:** Cellular office. Plain run cornice, original metal windows with contemporary secondary glazing, surface mounted services. Later partition walls subdividing spaces.
