INDEPENDENT HOUSE STUDENT ACCOMMODATION  
87-93 MIDDLE ABBEY STREET  
**LRD PLANNING SUBMISSION - ARCHITECTURAL HERITAGE IMPACT ASSESSMENT**

MARCH 2025

**MOLLOY & ASSOCIATES**  
CONSERVATION ARCHITECTS

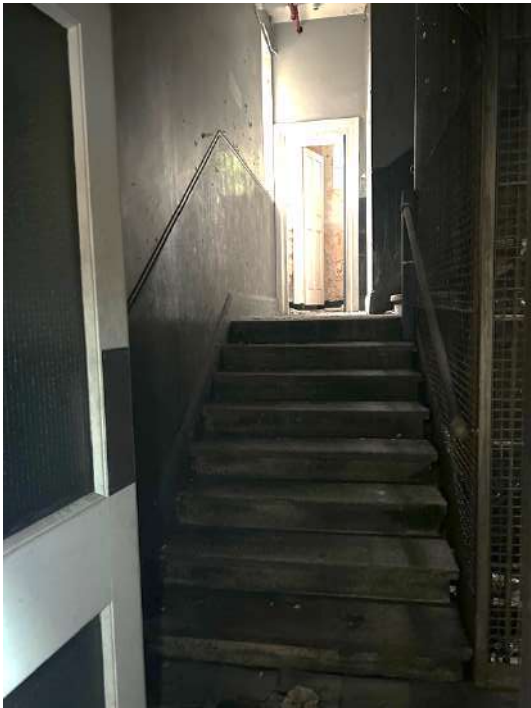
**Plate 165:** Contemporary doors to stairs. Walls to stair has a plaster bead detail at dado level.

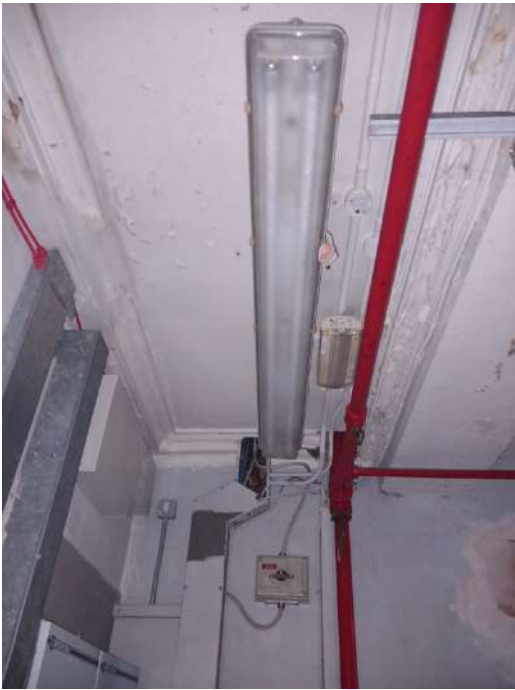
**Plate 166:** Plain run cornice on stair landing, interrupted by proliferation of later services.

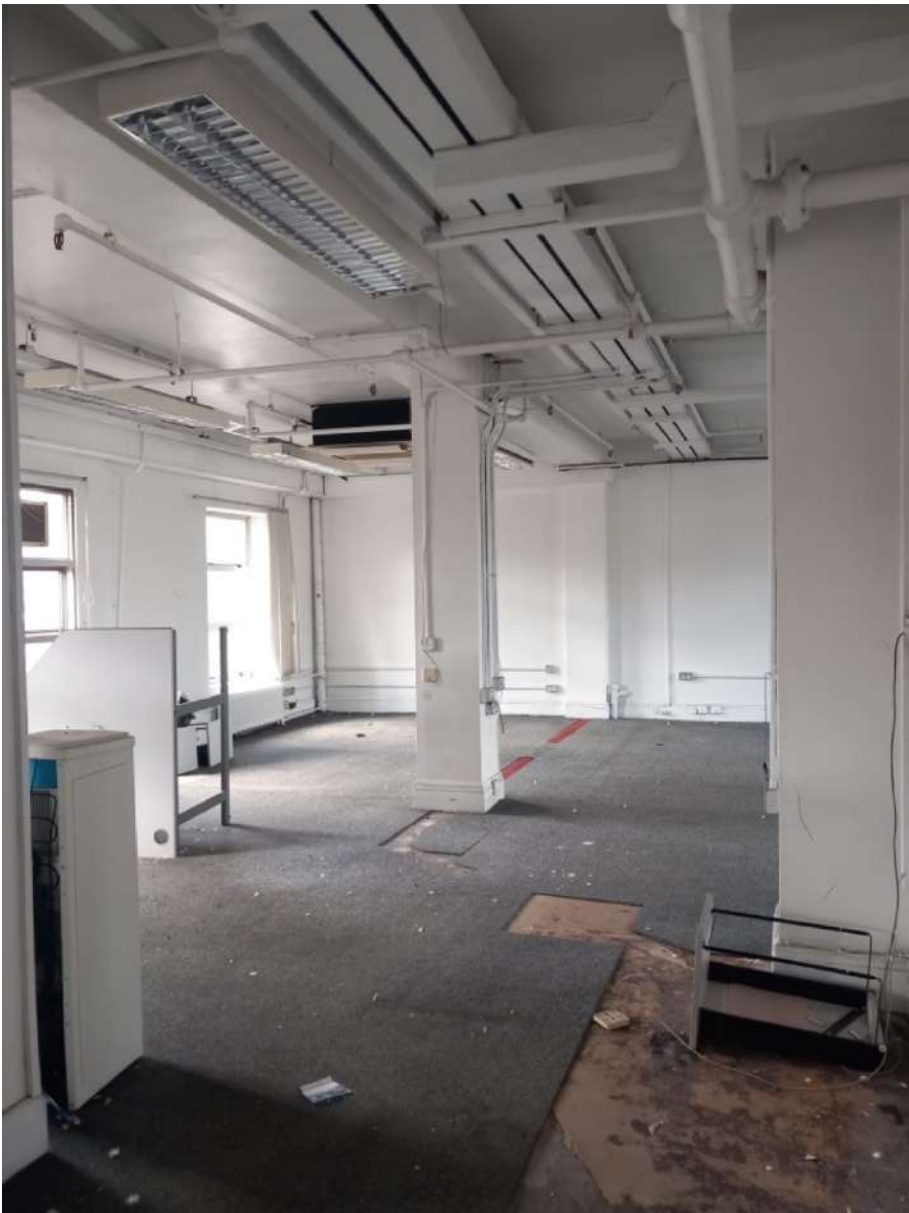
**Plate 167:** Open plan office. Plain run cornice, original metal windows, surface mounted services. Cornices and panelling details to columns and pilasters.

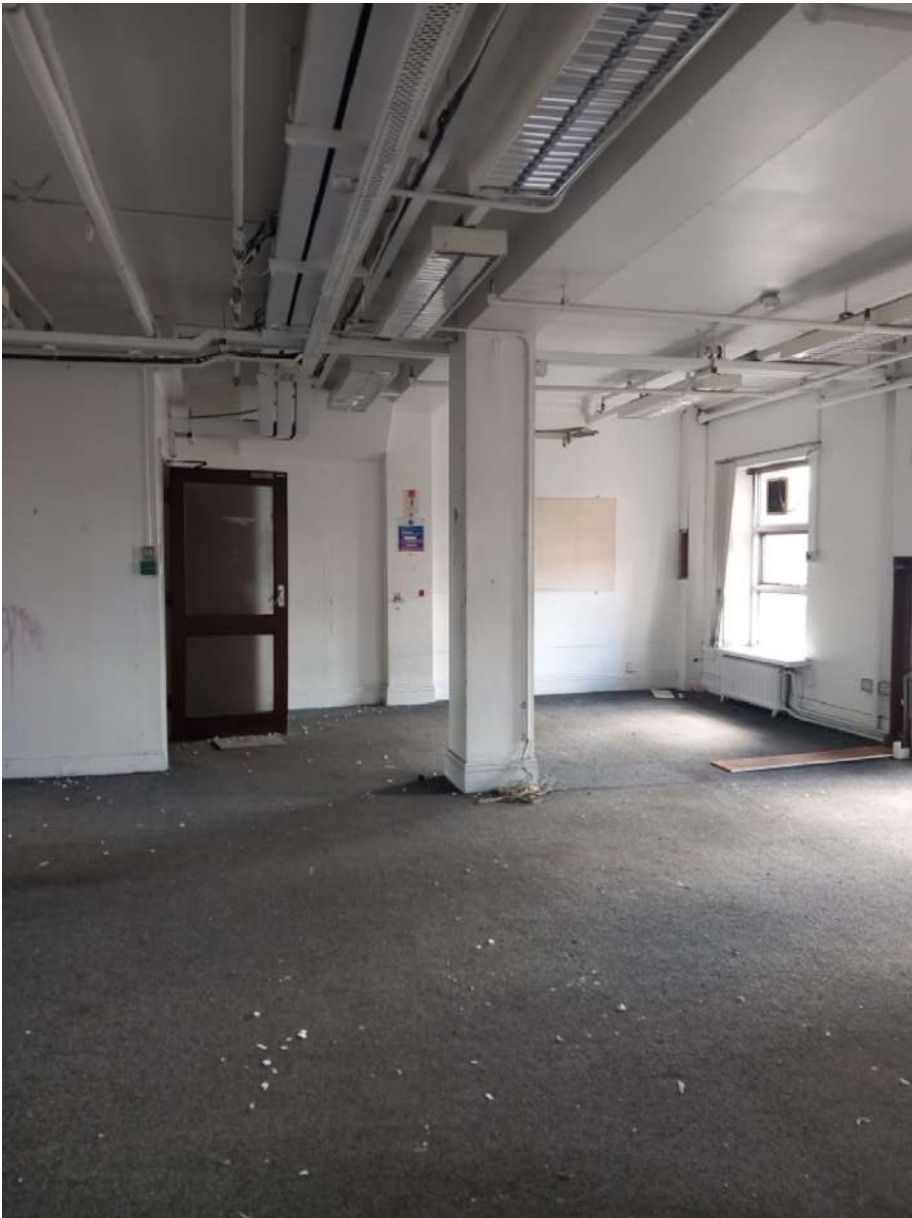
**Plate 168:** Open plan office. Plain run cornice, original metal windows, surface mounted services. Concrete floor slab.

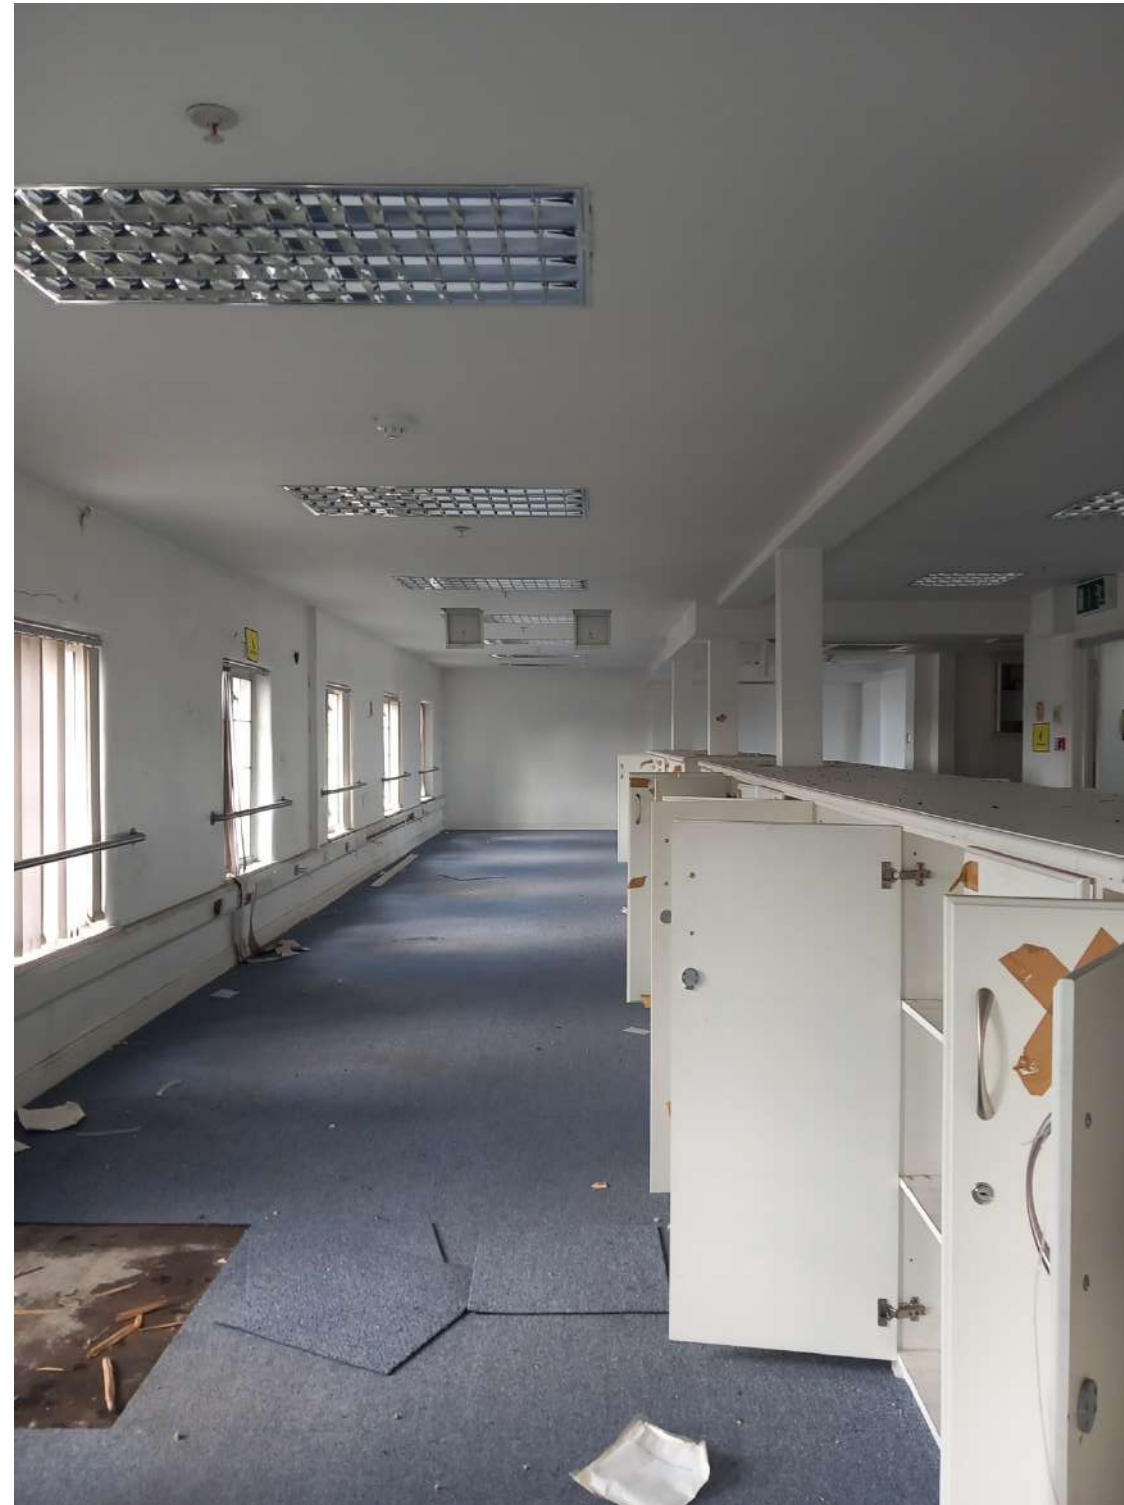
**Plate 169:** Open plan office. Aside from the stairs at the rear, no features of architectural interest were observed on this level. The open plan offices are lined with contemporary materials.

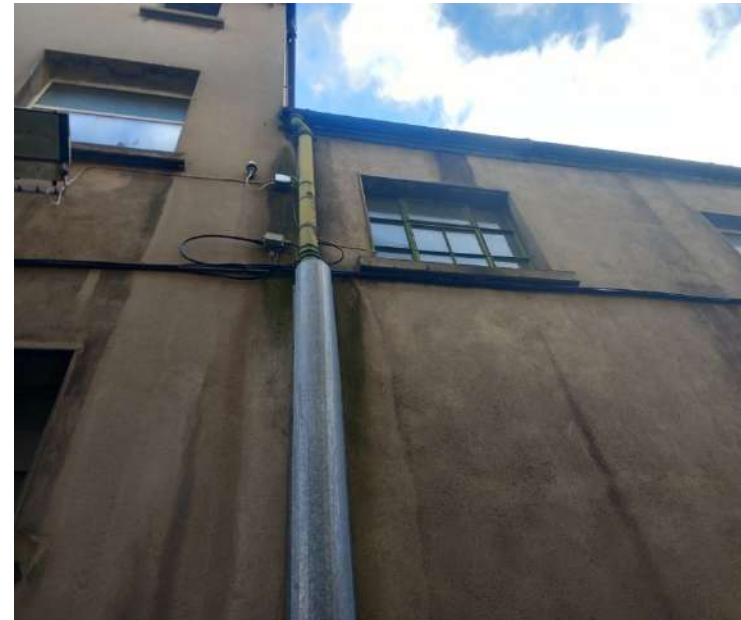
**Plate 171:** Mixture of original multi-paned metal windows and contemporary replacements in Zone 5. Cast iron rainwater goods, with replacement sections to lower levels.

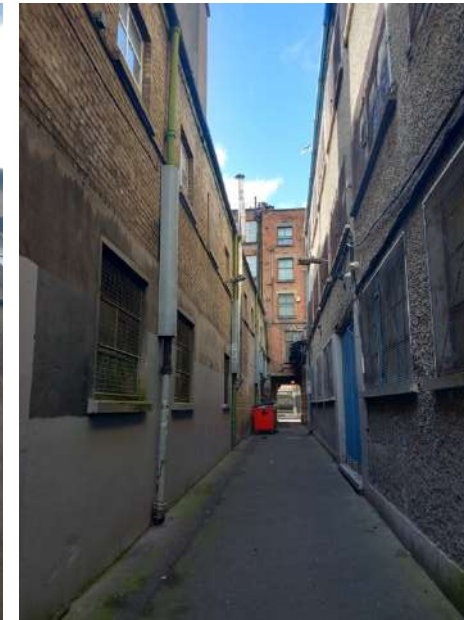
**Plate 172:** View of Williams Lane facing south towards Middle Abbey Street. West elevation of Zone 5 (left), forming the eastern boundary of Williams Lane. Stock brick wall finish, laid in English garden wall bond. The northern end of Williams Lane is covered with a smooth cement render.

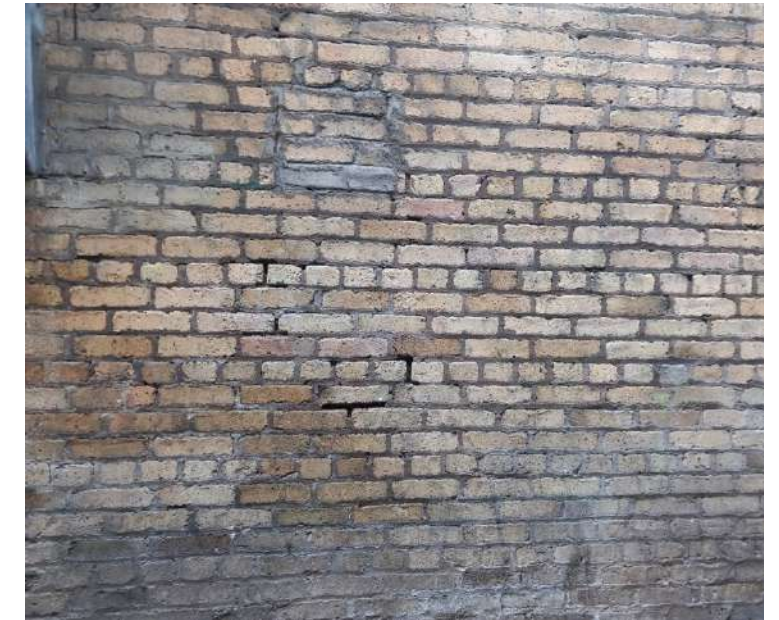
**Plate 173:** Detail of brick finish on Williams Lane, stock brick laid in a garden wall bond, cementitious pointing.

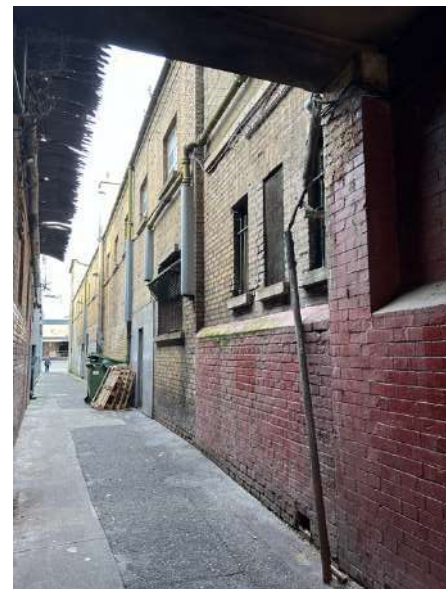
**Plate 174:** Stock brick wall finish, with contemporary windows on upper level.

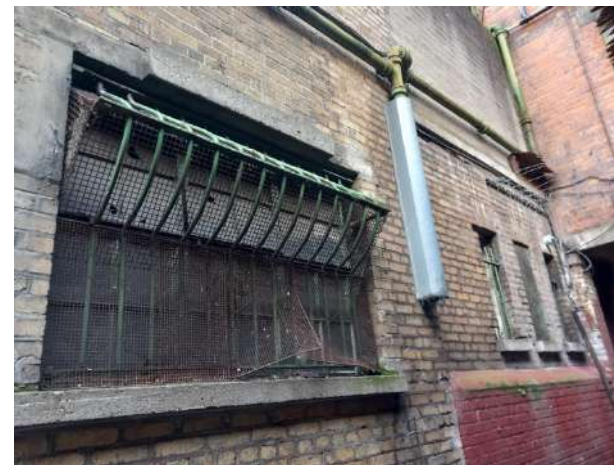
**Plate 175:** Original, multi-paned metal windows and southern end of Williams Lane.

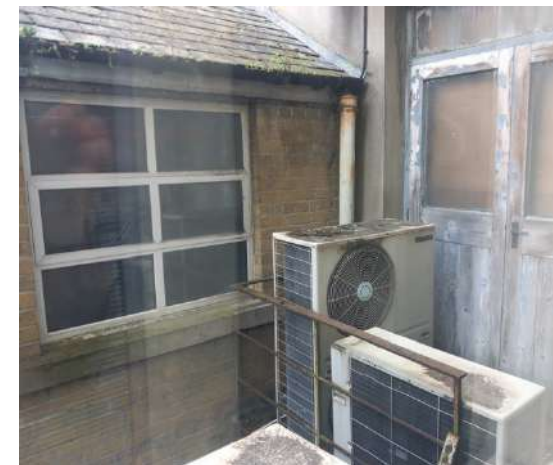
**Plate 176:** Lightwells and roof access between Zone 5 and the Machine Room used to accommodate contemporary building services.

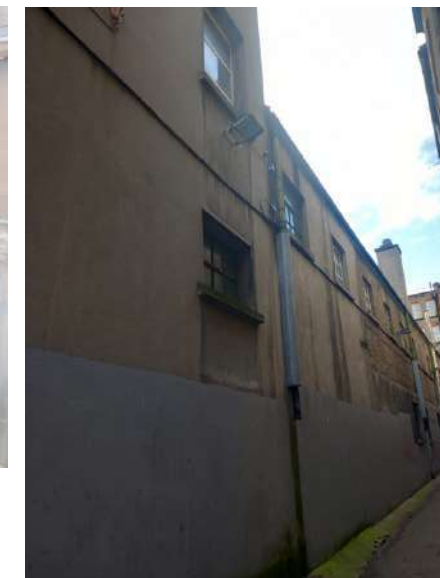
**Plate 177:** West elevation of Zone 5, forming the eastern boundary of Williams Lane. Stock brick wall finish, with areas of cement render.

Original access doors and steel gantry rails. uPVC Windows on eastern elevation Machine Room.

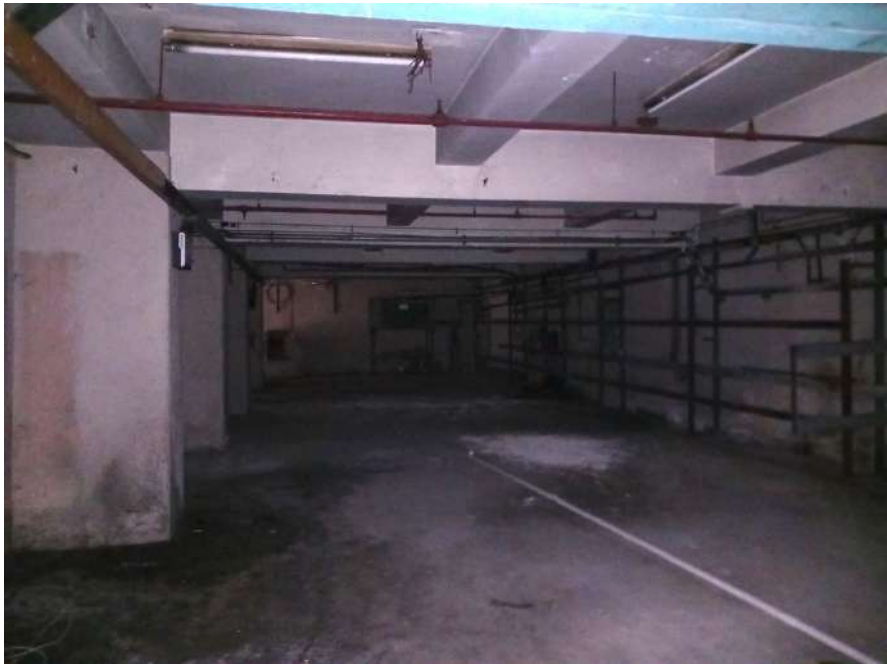
**Plate 178:** Lower level of Zone 5 facing south towards the rear wall of 91-92 Middle Abbey Street. It is an undercroft area, accessed via the Printing Hall. Masonry piers supporting steel girders and concrete frame over. No particular features of architectural interest identified.

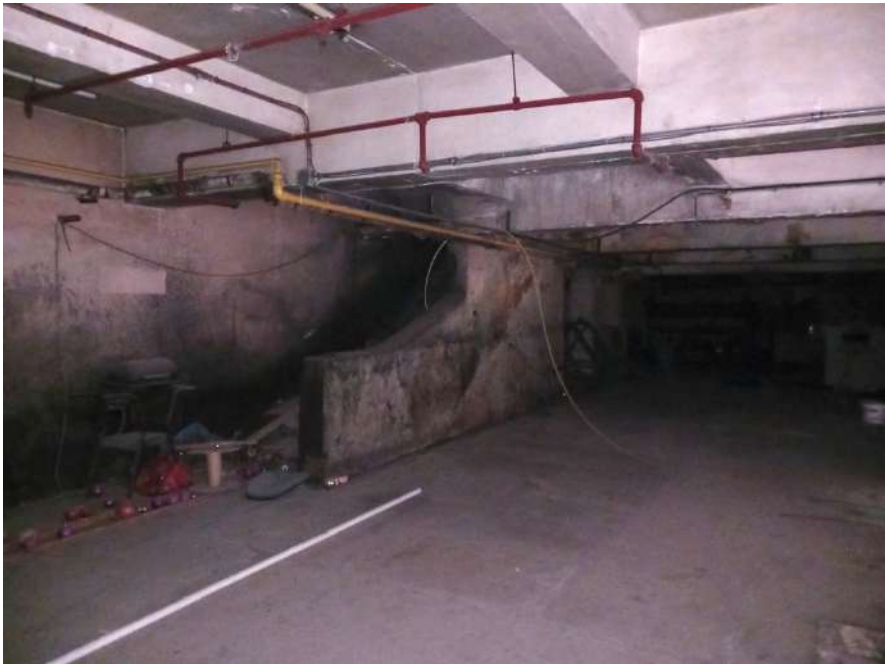
**Plate 179:** Lower level of Area of Zone 5, facing north-west. Exposed steel and concrete structure. Concrete floor finish. No particular features of architectural interest identified.

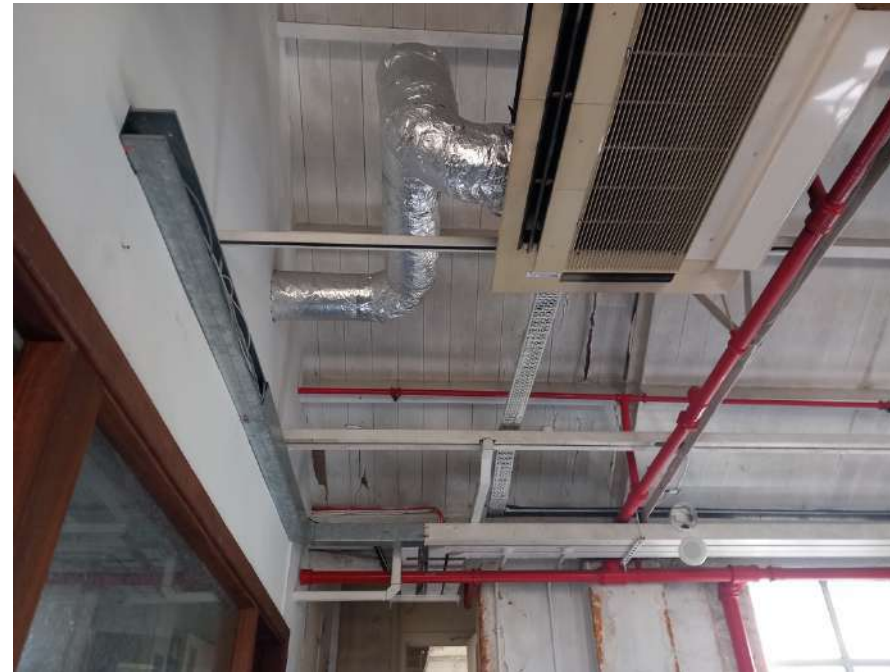
**Plate 180:** Painted sarking boards to underside of pitched roof.

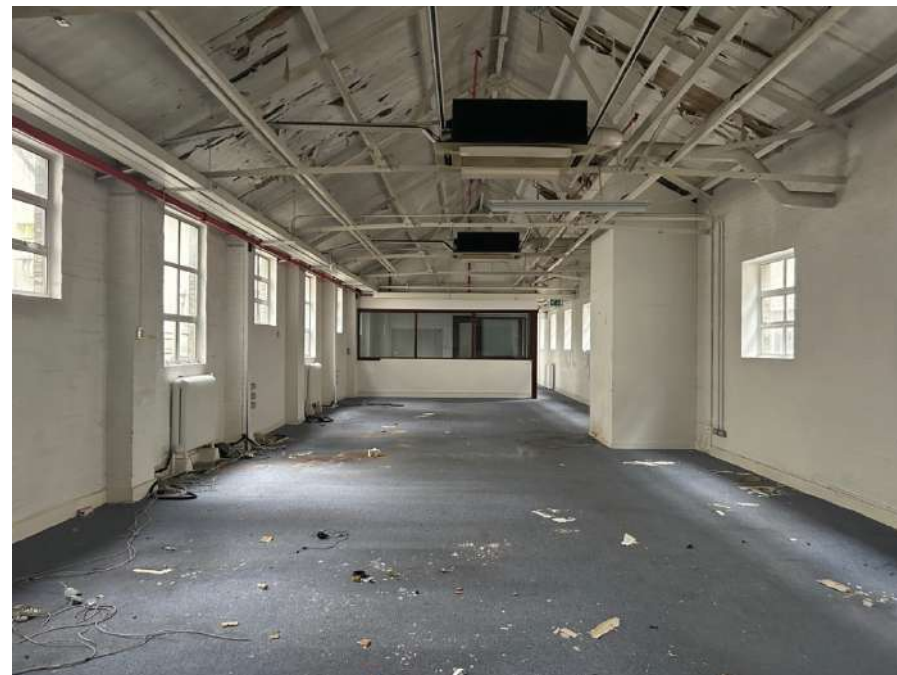
**Plate 182:** Upper floor of Zone 5 with steel roof trusses exposed internally. Replacement uPVC windows to east and west elevations. Partitions to wall plate height forming a series of offices on the southern end of the room. Contemporary services throughout.

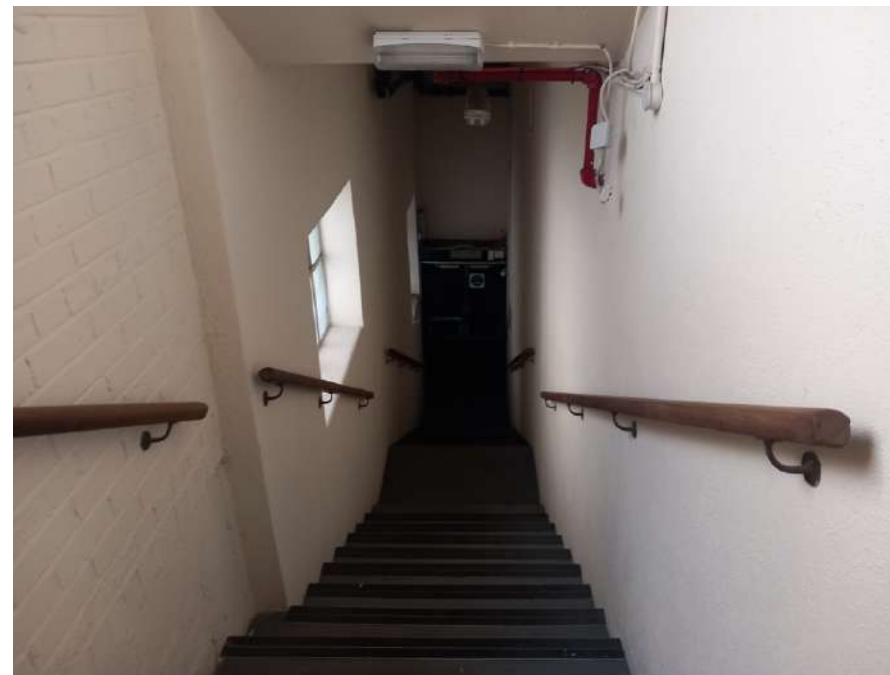
**Plate 183:** Stair from Prince's Street North to upper level of Zone 5. Contemporary handrails, original steel window frames. Painted brick finish exposed internally. Contemporary services. Vinyl finish to stair.

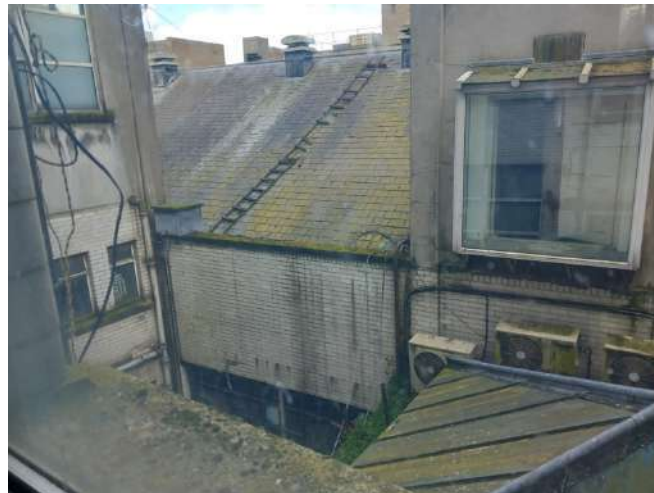
**Plate 185:** Lightwell to south of Former Printing Hall, attached to rear return of Independent House and Zone 4. Slate finish to south-facing pitch of sawtooth roof. Glazed white brick finish to lightwell. The lower levels of the deep lightwells were lined with glazed brick due to their light-reflecting attributes.

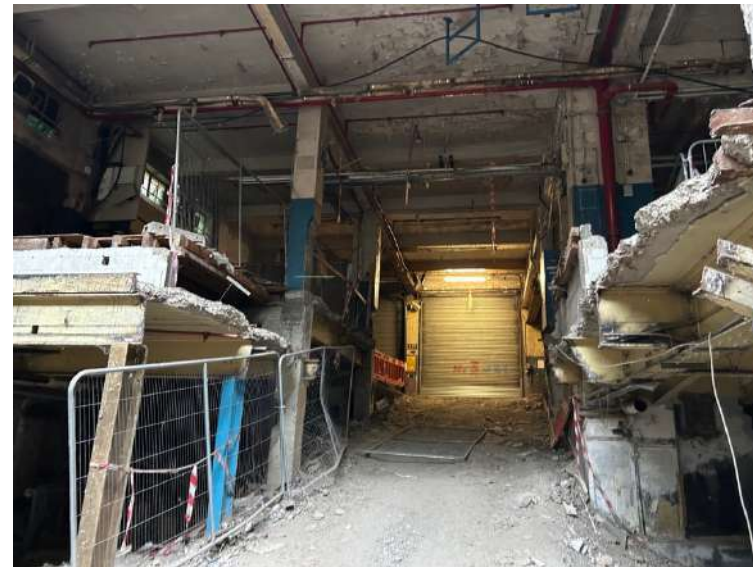
**Plate 187:** View from within former Printing Hall facing north towards ramp to entrance (Zone 4) on Prince's Street North. The structure has been partially demolished in this area, revealing the composition of the floors to be reinforced mass concrete, supported on steel girders.

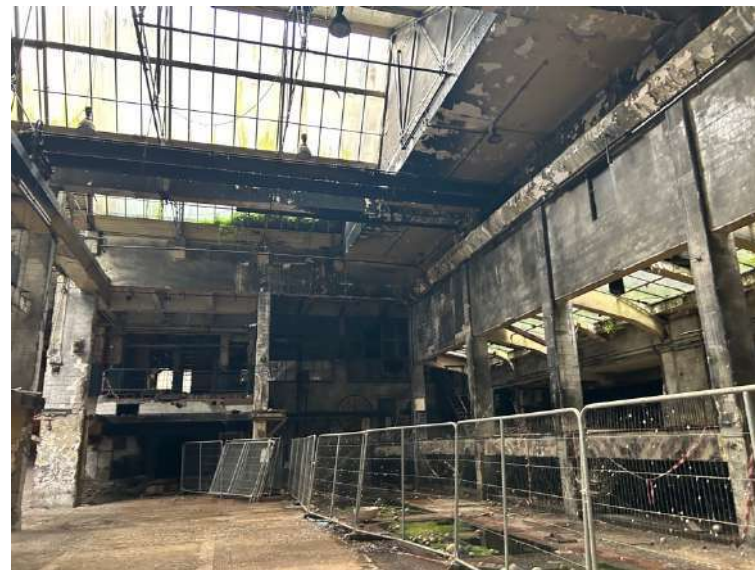
**Plate 188:** View facing north. Masonry columns clad in white (discoloured) glazed tile. Area to the east of the hall was inaccessible due to safety concerns. Historic maps suggest that this eastern side of the hall was constructed c1924, and subsequently extended post the acquisition of the adjoining site in 1936.

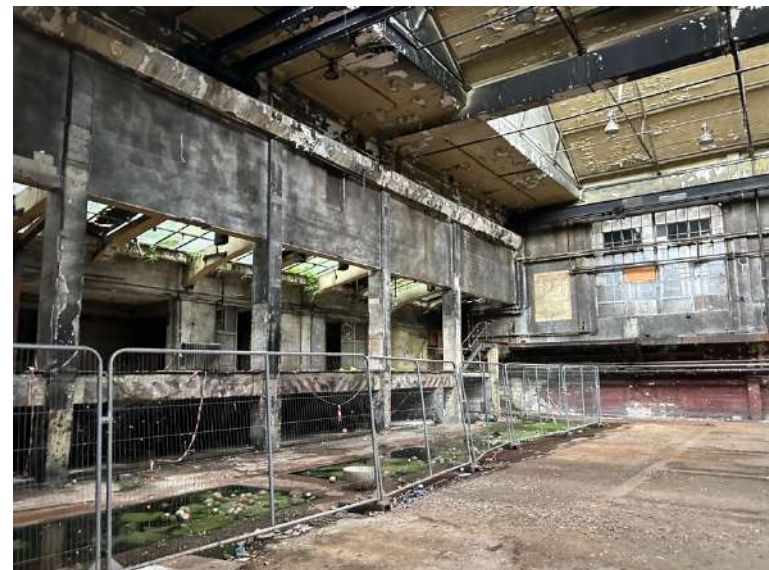
**Plate 189:** View facing southeast. Note: the undercroft to the eastern side of the hall was inaccessible.

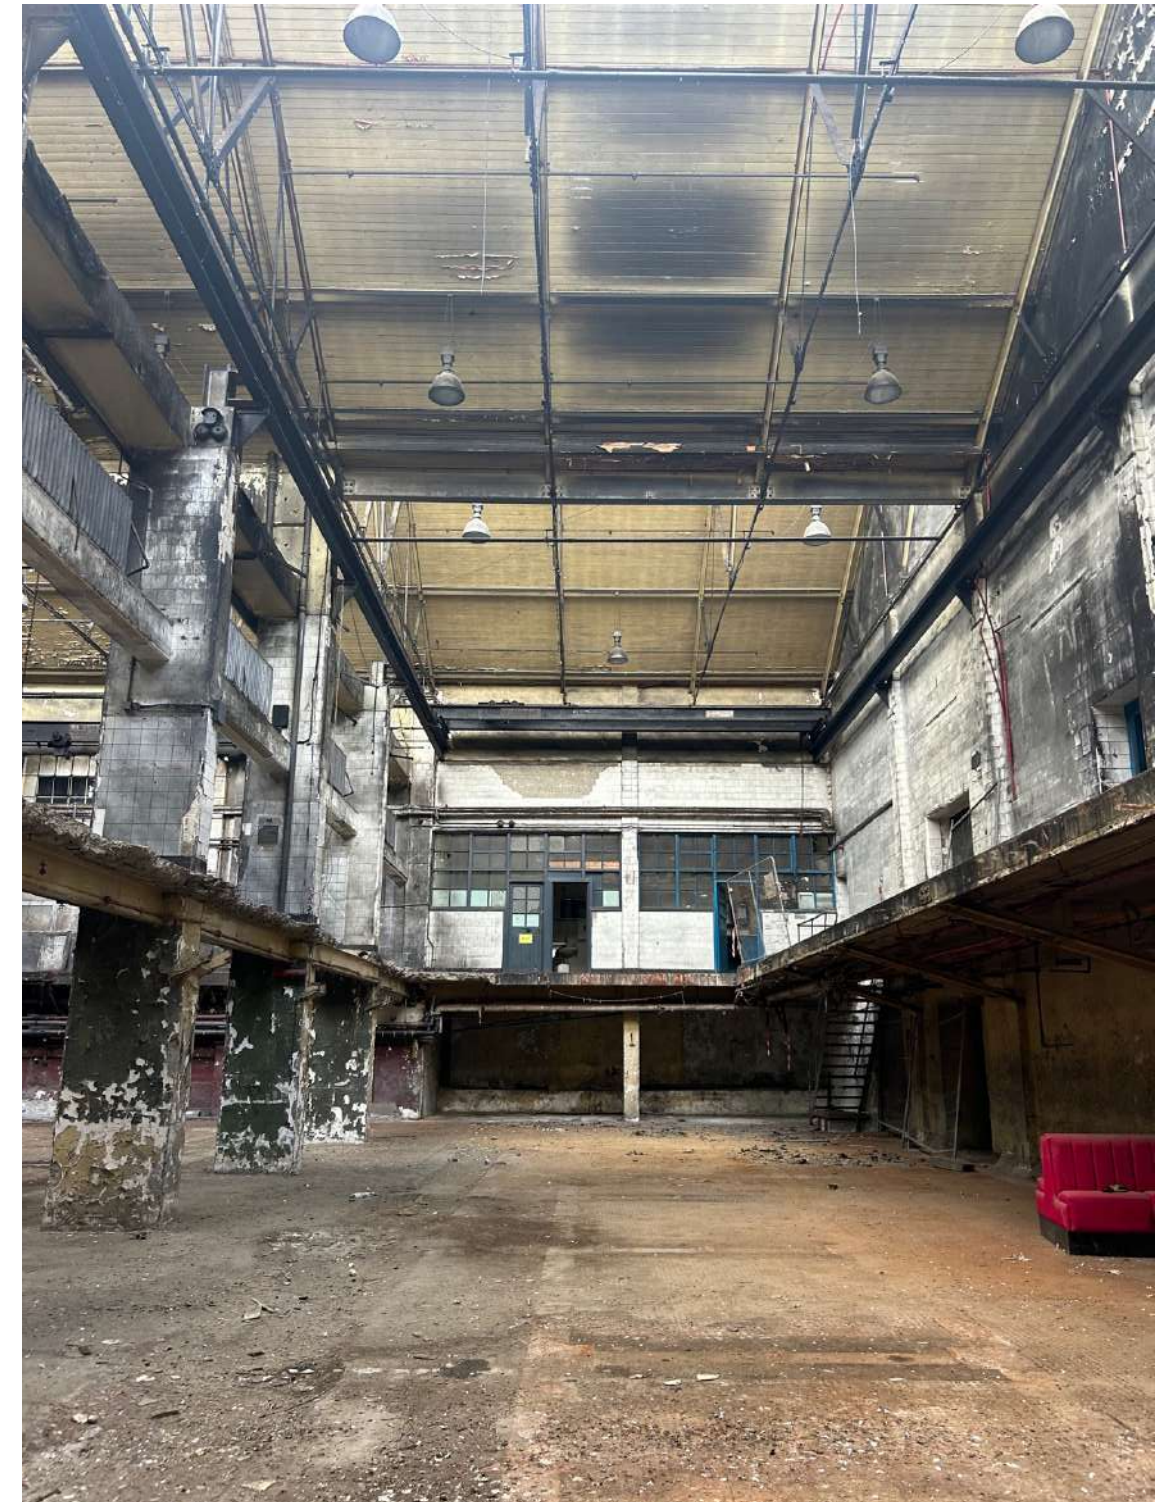
**Plate 190:** Western side of Printing Hall facing south. The upper ground floor gallery attached to the central row of columns has been demolished. Painted finish to lower ground level of walls and columns. Square format glazed brick tile to upper levels, with original doorsets and glazed screens at the southern end. Masonry piers and columns support heavy steel beams with lightweight steel trusses over forming the distinctive sawtooth roof profile.

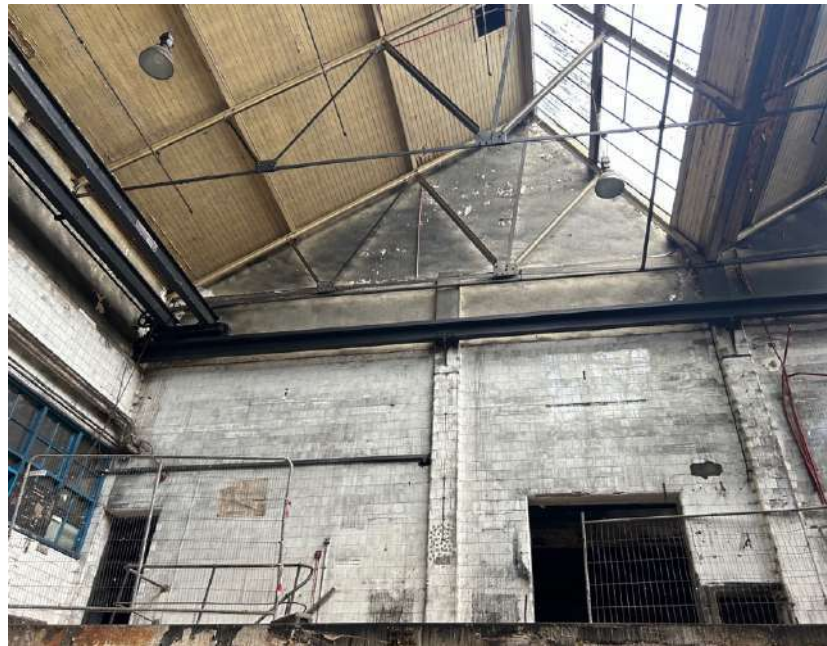
**Plate 191:** View from lower ground level, at south-western end of Printing Hall facing west towards upper ground level gallery. Masonry columns clad in white glazed tile supporting steel trusses of sawtooth roof.

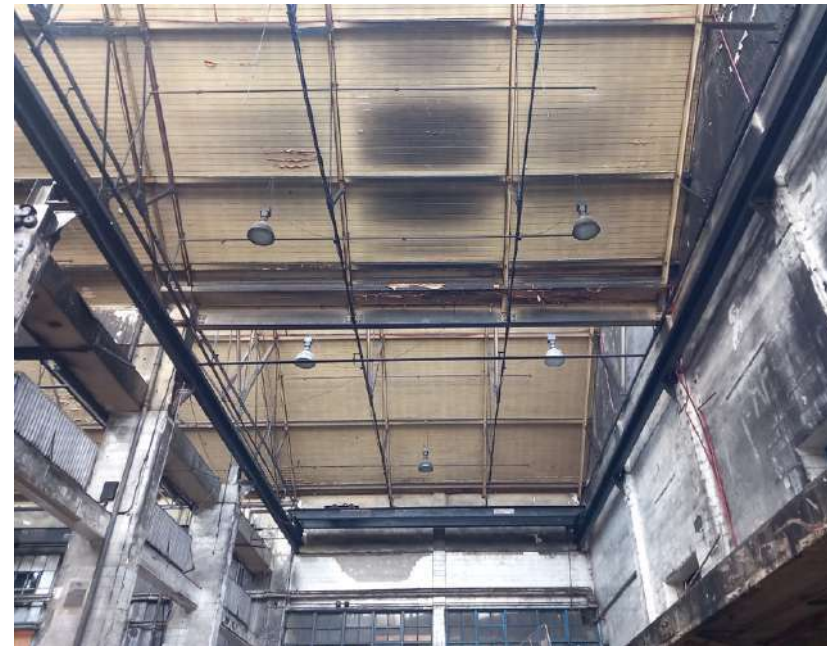
**Plate 192:** West side of Printing Hall roof, facing south. Heavy steel beams spanning east to west supporting a series of lightweight trusses of sawtooth roof. Original sarking boards and tiled finishes at upper level.

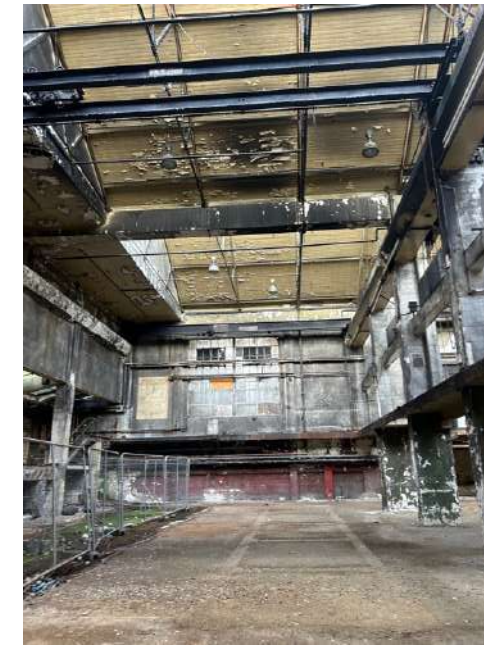
**Plate 193:** The western side of the Printing Hall, facing south. The roof fabric is visibly decayed due to water ingress. Inspection at high level was not possible.

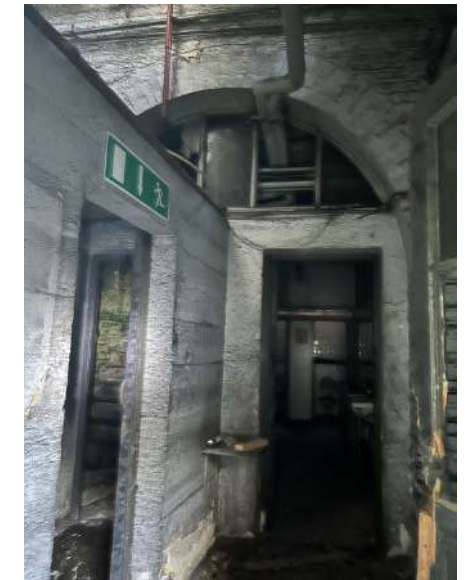
**Plate 194:** Rounded brick arch, with later walls in mass concrete in southwest corner at upper ground level, attached to the rear of 87-90 Middle Abbey Street

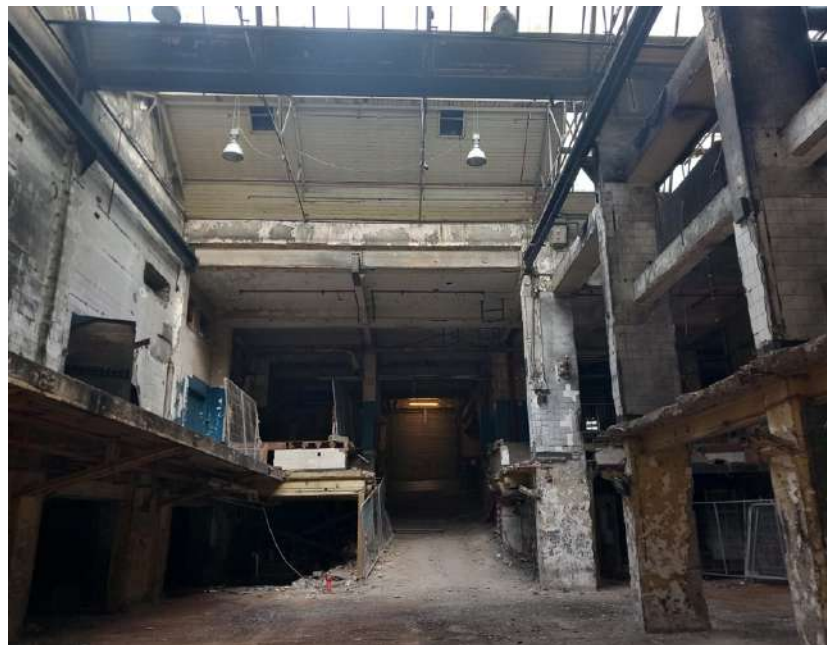
**Plate 195:** View from within former Printing Hall facing north towards recently formed ramp connecting to the entrance (Zone 4) on Prince's Street North. The structure has been partially demolished in this area, revealing the composition of the floors to be reinforced mass concrete.

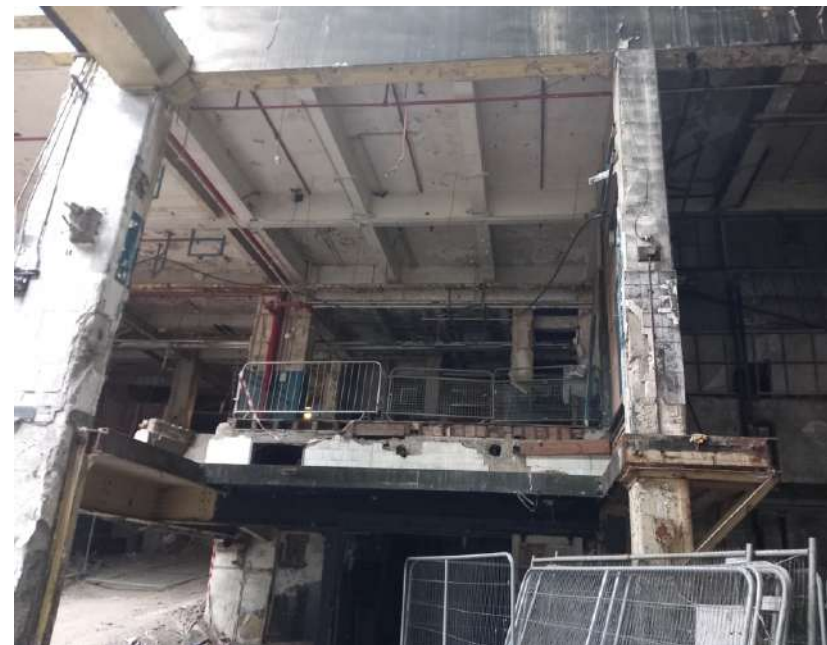
**Plate 196:** View from within former Printing Hall facing north and upwards towards ramp to entrance (Zone 4) on Prince's Street North. The gallery floor has been demolished in this area. The steel and concrete frame structure supporting upper floors of Zone 4 is visible to underside of floor above.

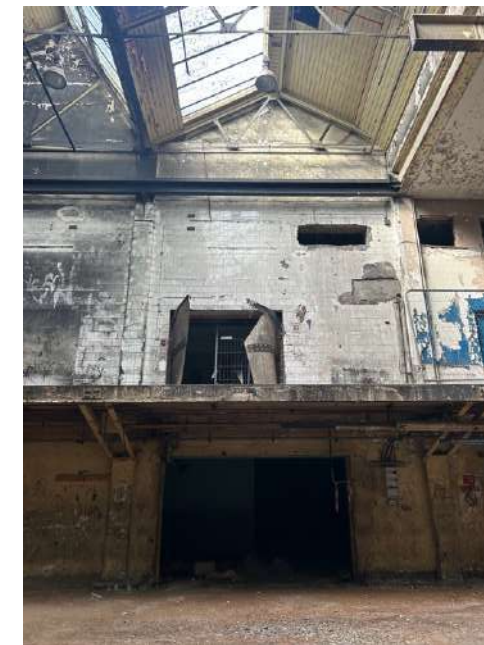
**Plate 197:** View facing west. Undercroft, beneath Zone 5 is accessed via the square headed opening under the upper ground floor gallery. Upper level walls are clad in glazed white tiles, in square format, laid in running brick bond.

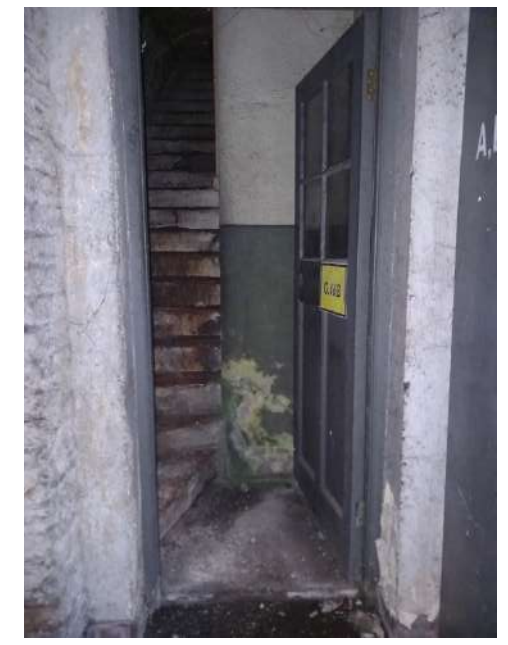
**Plate 198:** Granite stairs within bottom winder step in southwest corner at upper ground level, attached to the rear of 87-90 Middle Abbey Street. Door with two lower solid panels and glazed upper panels.

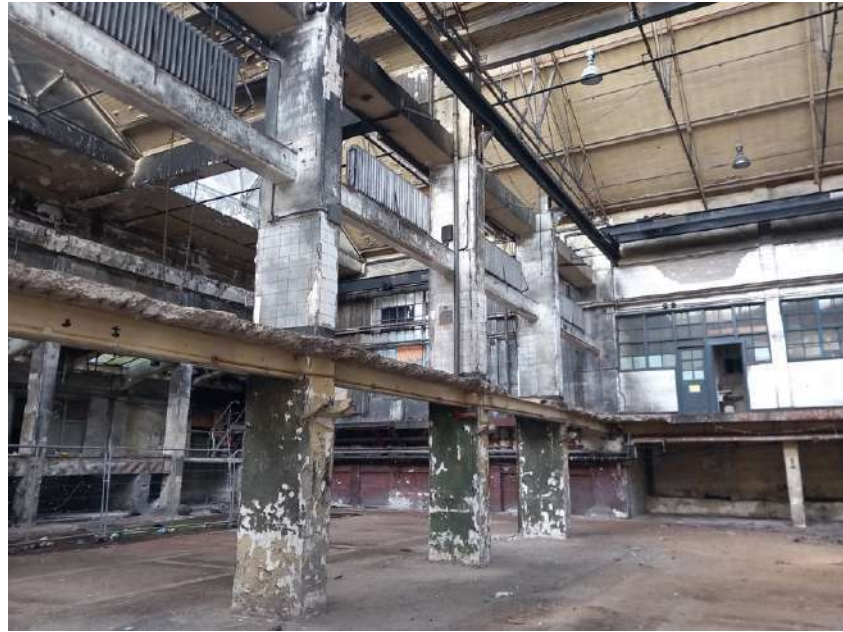
**Plate 199:** View from western side of Printing Hall towards south east. The central row of masonry column subdivide the hall; cartographic research suggests that the western side of the hall was a later addition. The columns supported a gallery at upper ground level, now demolished.

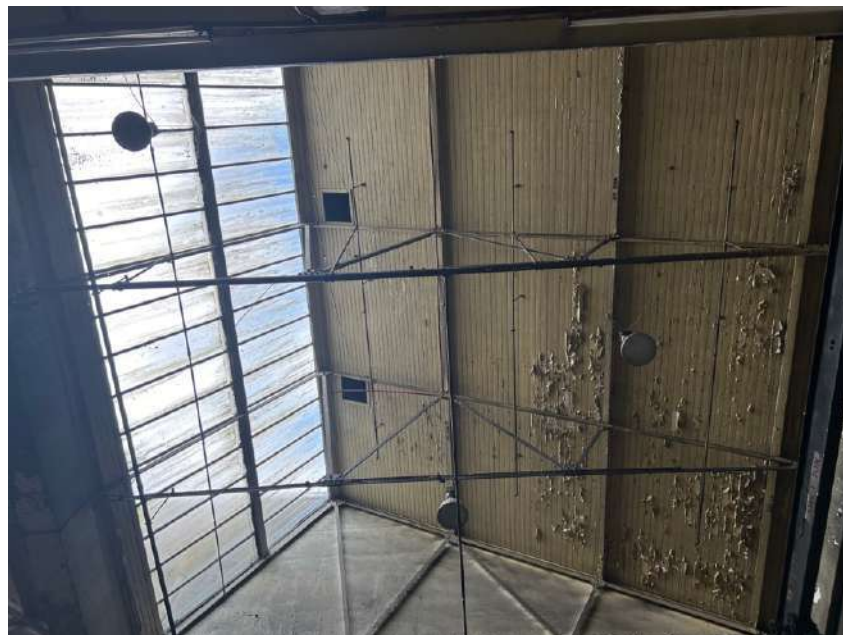
**Plate 200:** Typical roof bay; four lightweight steel trusses, with glazed panels to northern pitch (subdivided into 5 x 2 panels between trusses. Painted timber cladding to underside of south-facing pitch. Square opening section to roof vents. Original industrial light fittings.

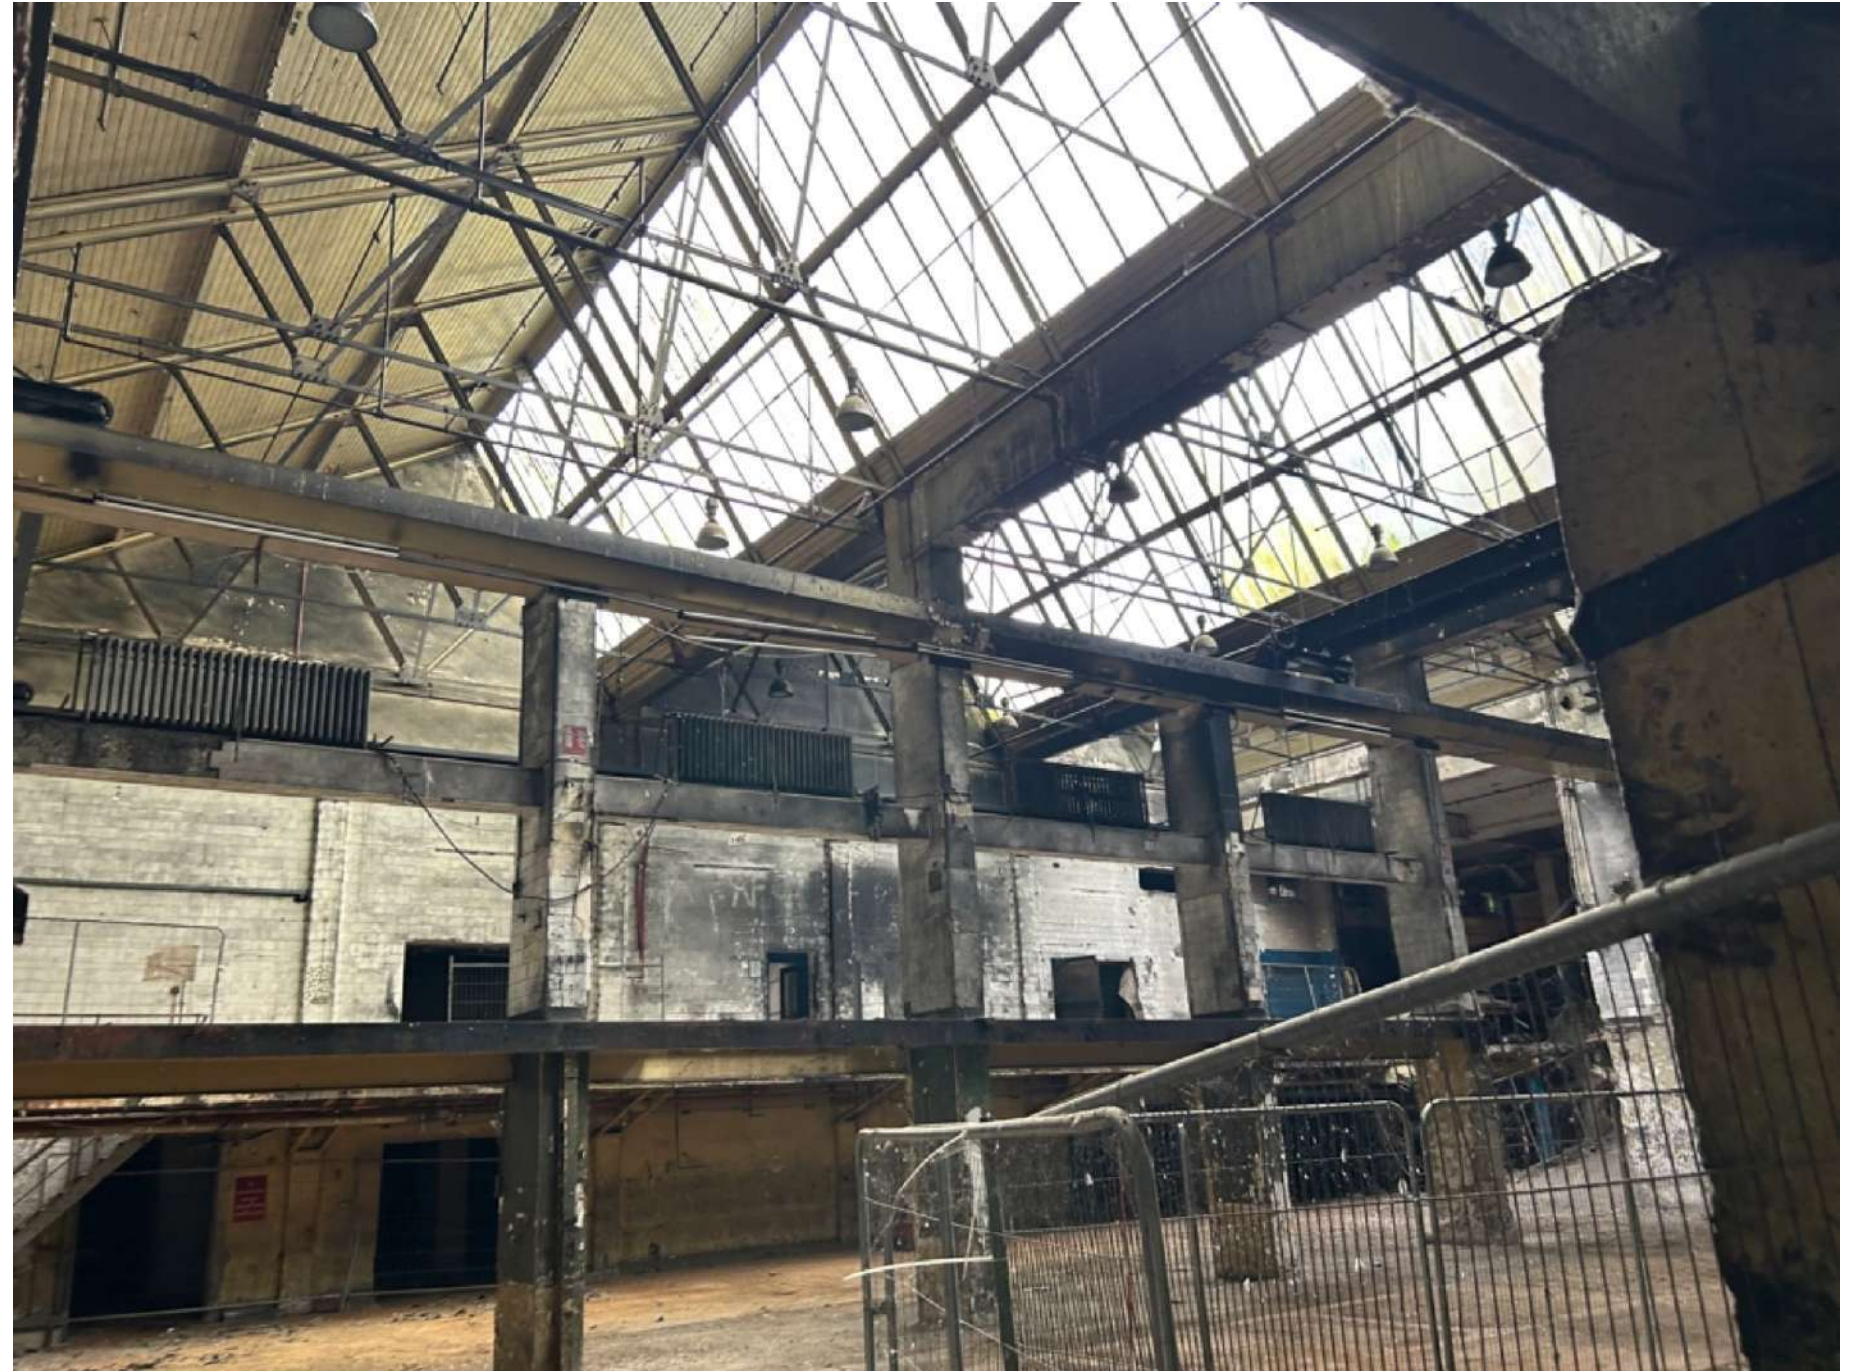
**Plate 201:** View of Printing Hall facing west. The hall is a single volume space, bisected by a structural frame. The industrial roof is comprised of three bays, the northernmost bay having a shorter span. All machinery associated with the former printing press appears to have been removed. The lower level was purpose built to accommodate large industrial printing presses, with galley and gantry access for the operators. The original ground floor slab has been removed.

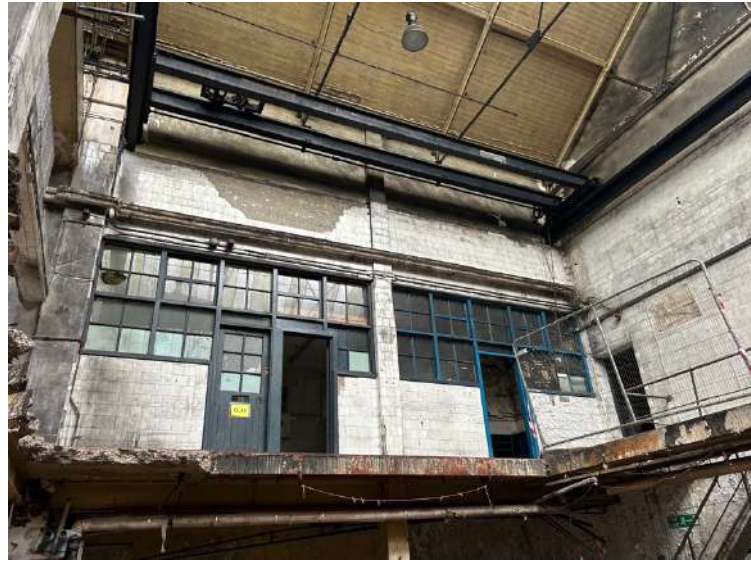
**Plate 202:** Offices at southern end of Printing Hall. The upper level ground floor slab has been partially demolished. Original timber screen walls and door-set with vertical boarded to lower panel and glazed upper panel, subdivided into six panes.

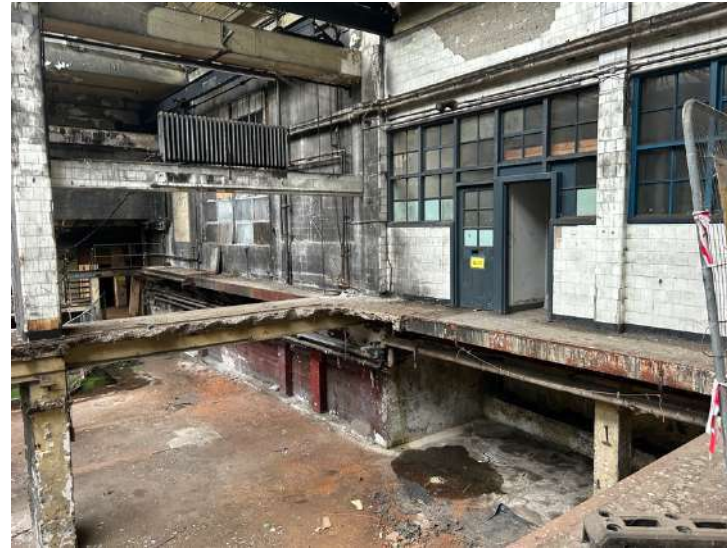
**Plate 203:** View from upper ground level facing south-west. The floor of the central gallery has been demolished.
