INDEPENDENT HOUSE STUDENT ACCOMMODATION  
87-93 MIDDLE ABBEY STREET  
**LRD PLANNING SUBMISSION - ARCHITECTURAL HERITAGE IMPACT ASSESSMENT**

MARCH 2025

**MOLLOY & ASSOCIATES**  
CONSERVATION ARCHITECTS

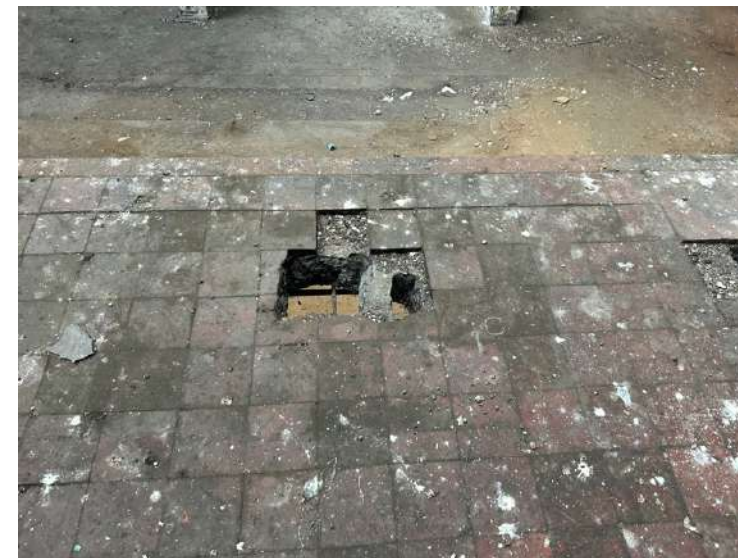
**Plate 208:** Detail of balcony overlooking machine room floor. Quarry tiles on concrete balcony overlooking Printing Hall. A number of balconies have been partially demolished.

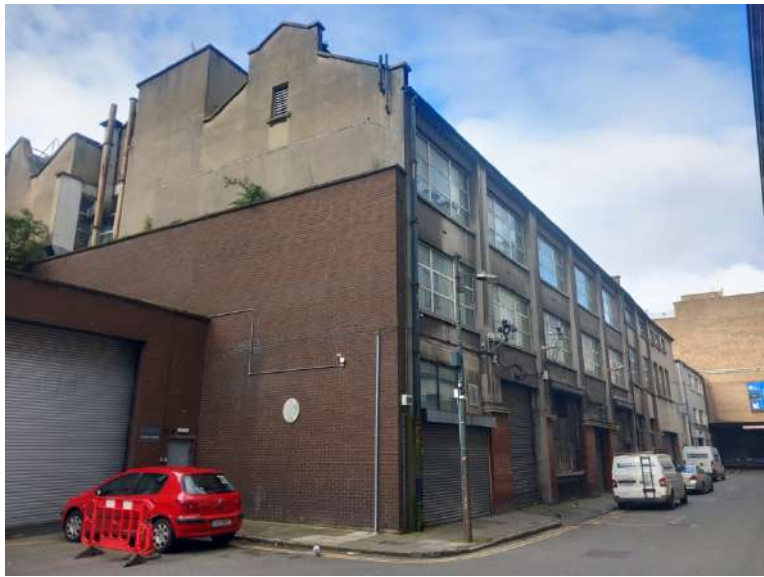
**Plate 212:** Zone 4, overlooking Prince's Street North, is three storeys in height, part four storeys with five regular bays subdivided by projecting piers. Replacement uPVC windows on upper levels. Elements original fabric surviving at street level.

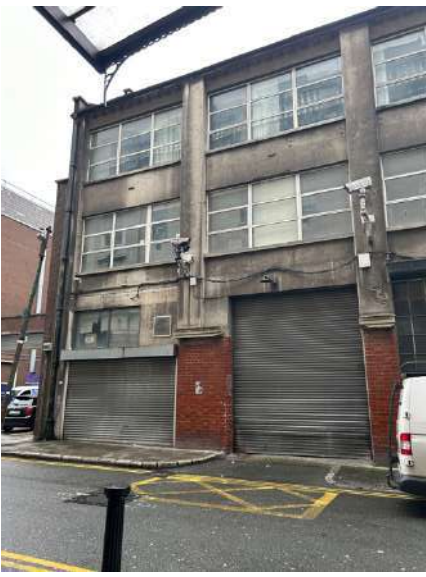
**Plate 213:** No original windows surviving on upper floors or first two bays (from LHS). Ground floor of first two bays have modified openings

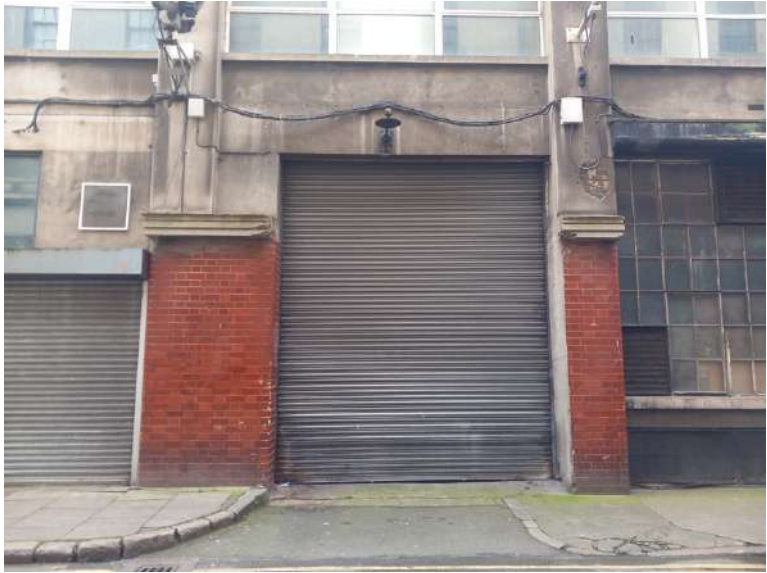
**Plate 215:** Granite kerbs (dropped on western side) leading to former vehicular entrance. This stepped cornice originally spanned across the full width of the opening, with a multipaned window over, but the

openings have been modified and the cornice removed to create a single larger opening. Original bronze wall light over surviving cornice. This entrance is the only one which retains its original composition, complete with rendered cornice.

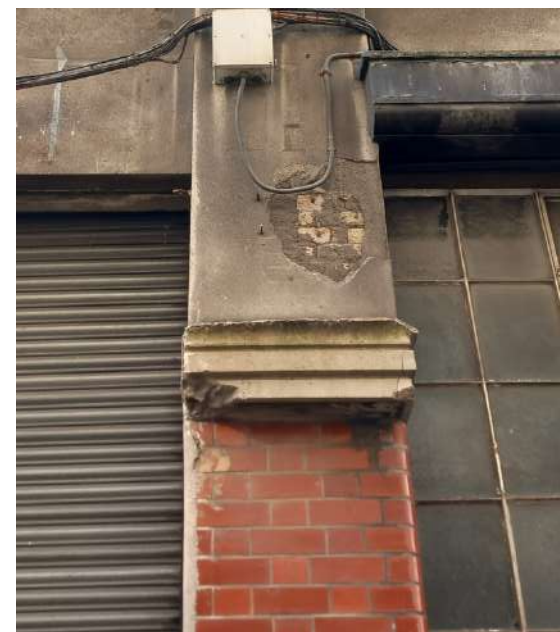
**Plate 219:** The external piers are comprised of brick; glazed ceramic at ground floor level, and localised failure in the render finish reveals the substrate at higher level to be buff brick. Impact damage to rendered cornice observed at openings and it is noted that the reveal to the secondary entrance has been faced in cement, adhered to the original ceramic brick face.

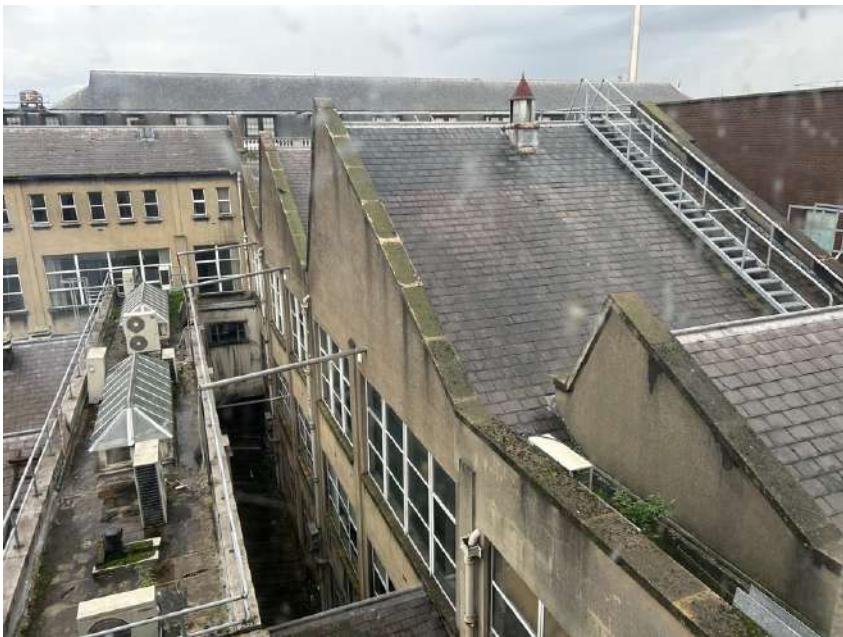
**Plate 224:** Rear Building range: Zone 4. Sawtooth roof profile with natural slate to south-facing pitch. Conical roof vent. Cement render finish. Contemporary roof maintenance gangway.

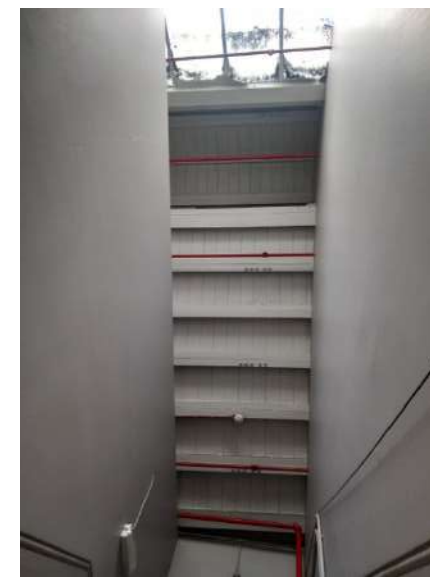
**Plate 233:** Saw-tooth profile rooflight above stair, with exposed sarking boards and rooflight to north facing aspect.

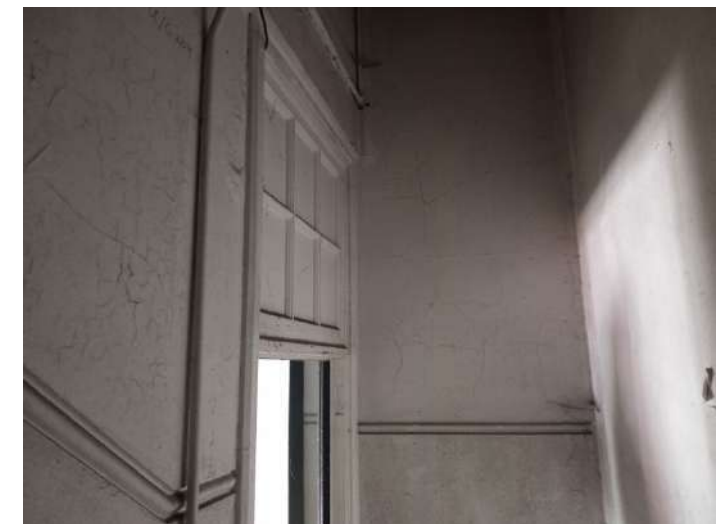
**Plate 234:** Dado profile integrated into wall render. Moulded timber door architrave with multipaned transom light, now boarded up.

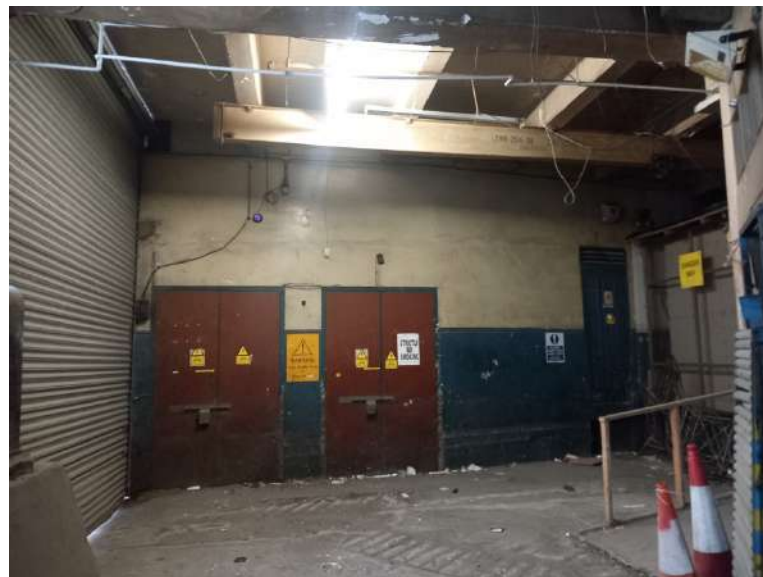
**Plate 235:** Zone 4, Ground Floor level, facing east. Former loading bay. Contemporary security shutter to Prince's Street. Girder is stamped 'Frodingham Iron and Steel Co Ltd. England.'

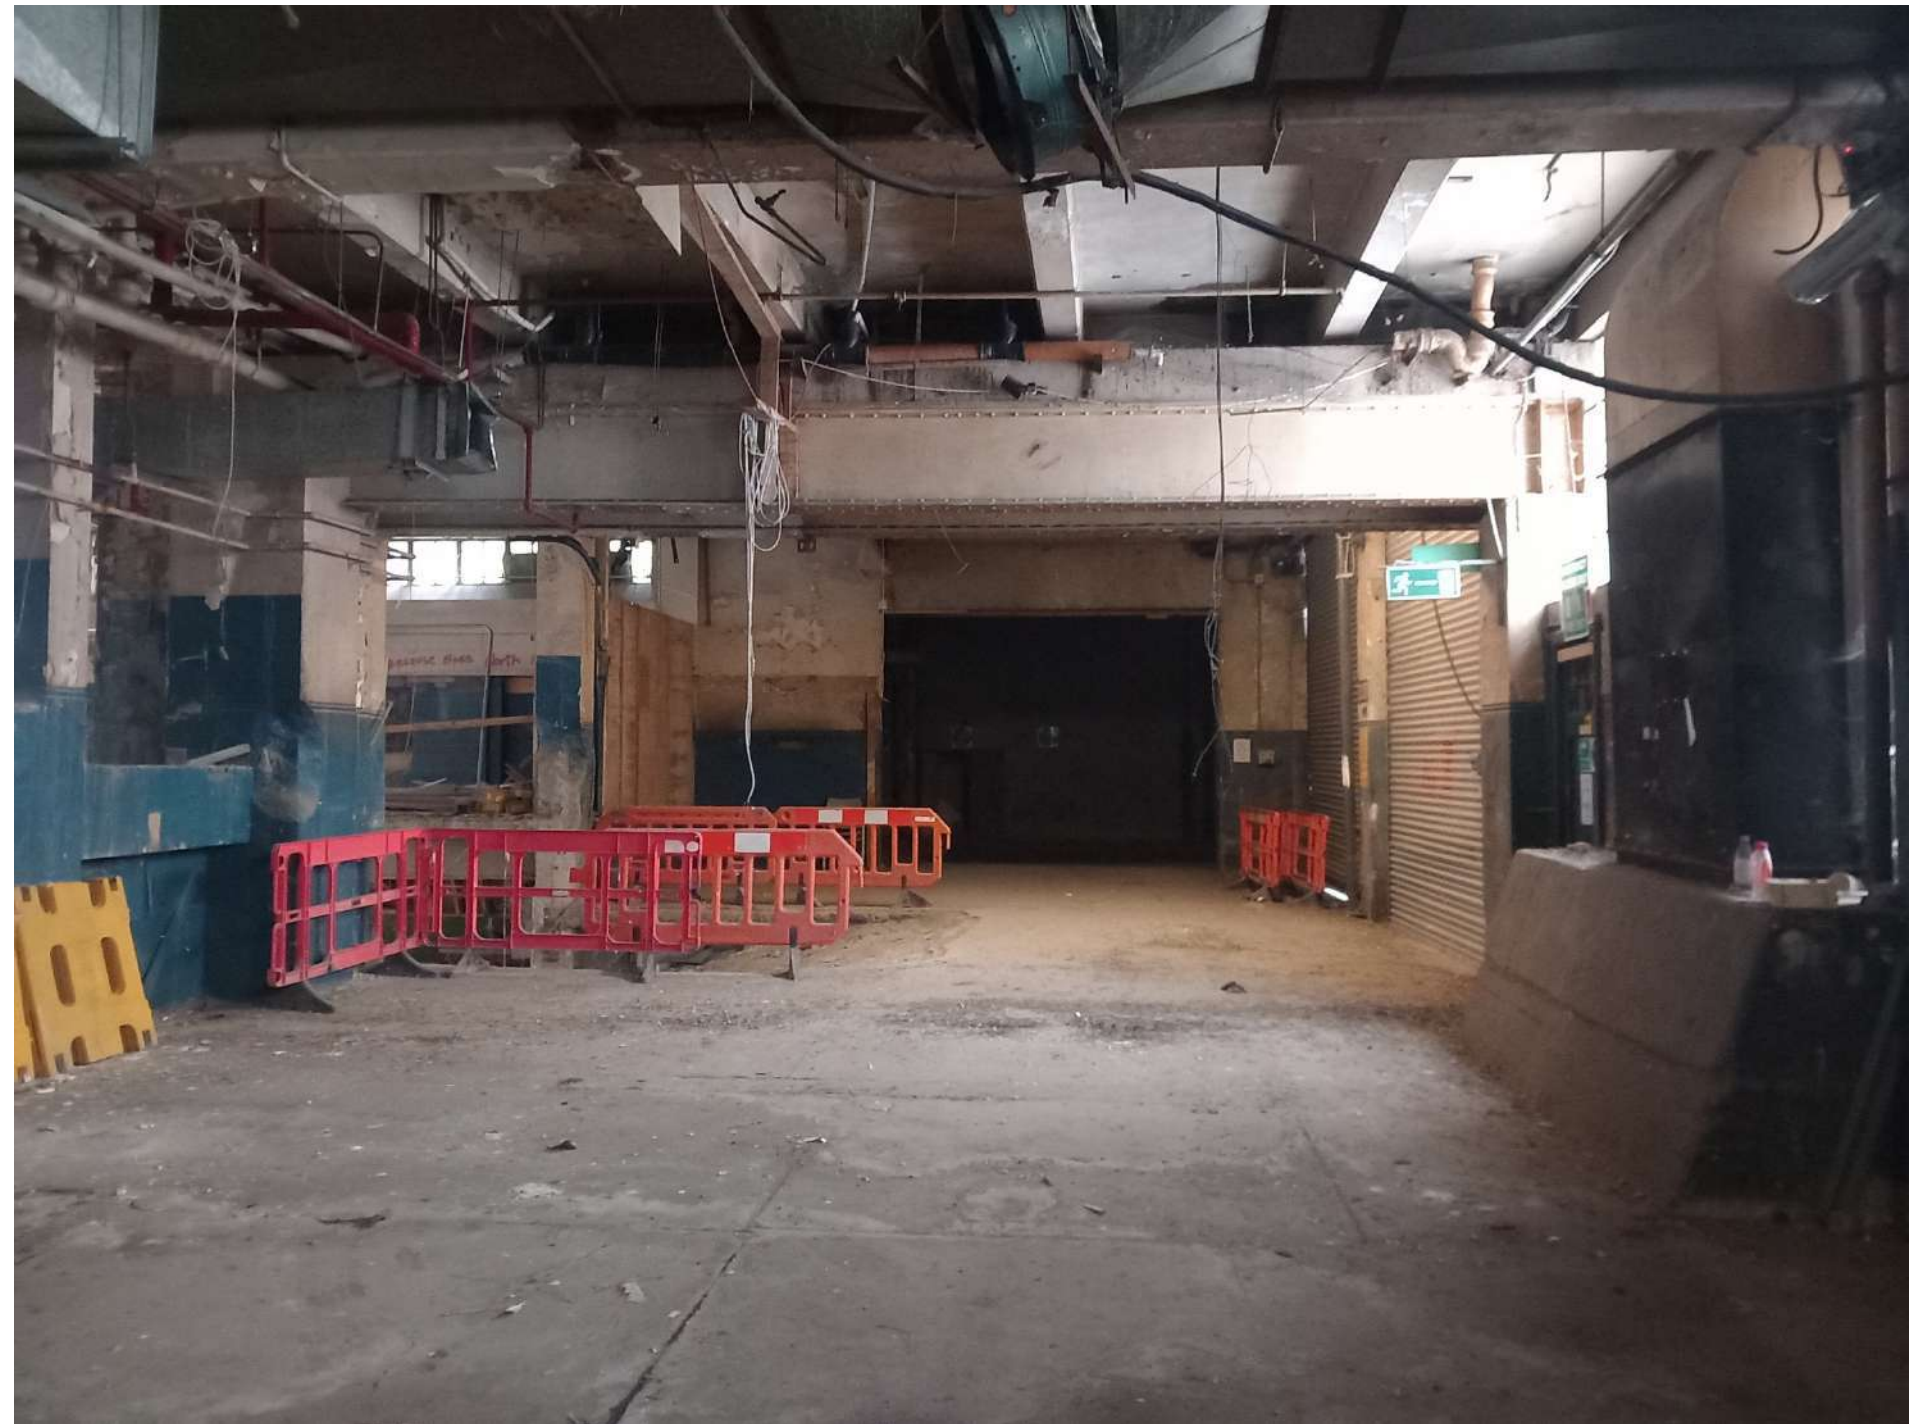
**Plate 236:** Zone 4, Ground Floor level, facing west. Steel girders spanning in an north-south direction, with concrete beams spanning east-west direction over.

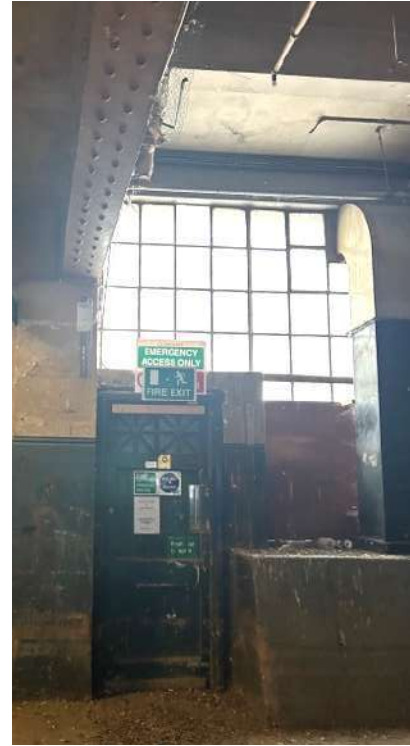
**Plate 237:** Former service entrance on Prince's Street North: Panelled door with decorative frame to transom light, multipaned metal framed window.

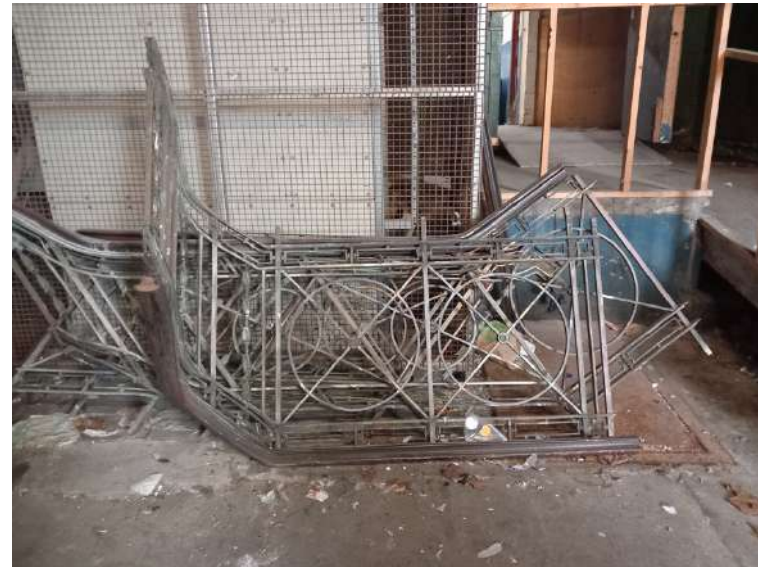
**Plate 238:** Salvaged stair / ramp balustrade with timber handrail stored within Zone 4. Original position was possibly within this service zone of the main stairs in Independent House.

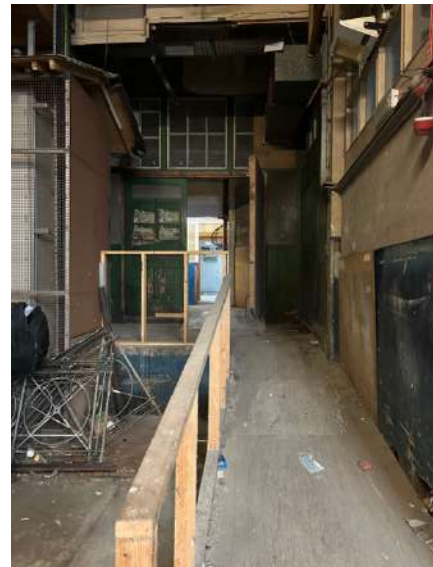
**Plate 239:** View of internal ramp, facing south. Original internal clerestory windows, and multiple contemporary interventions.

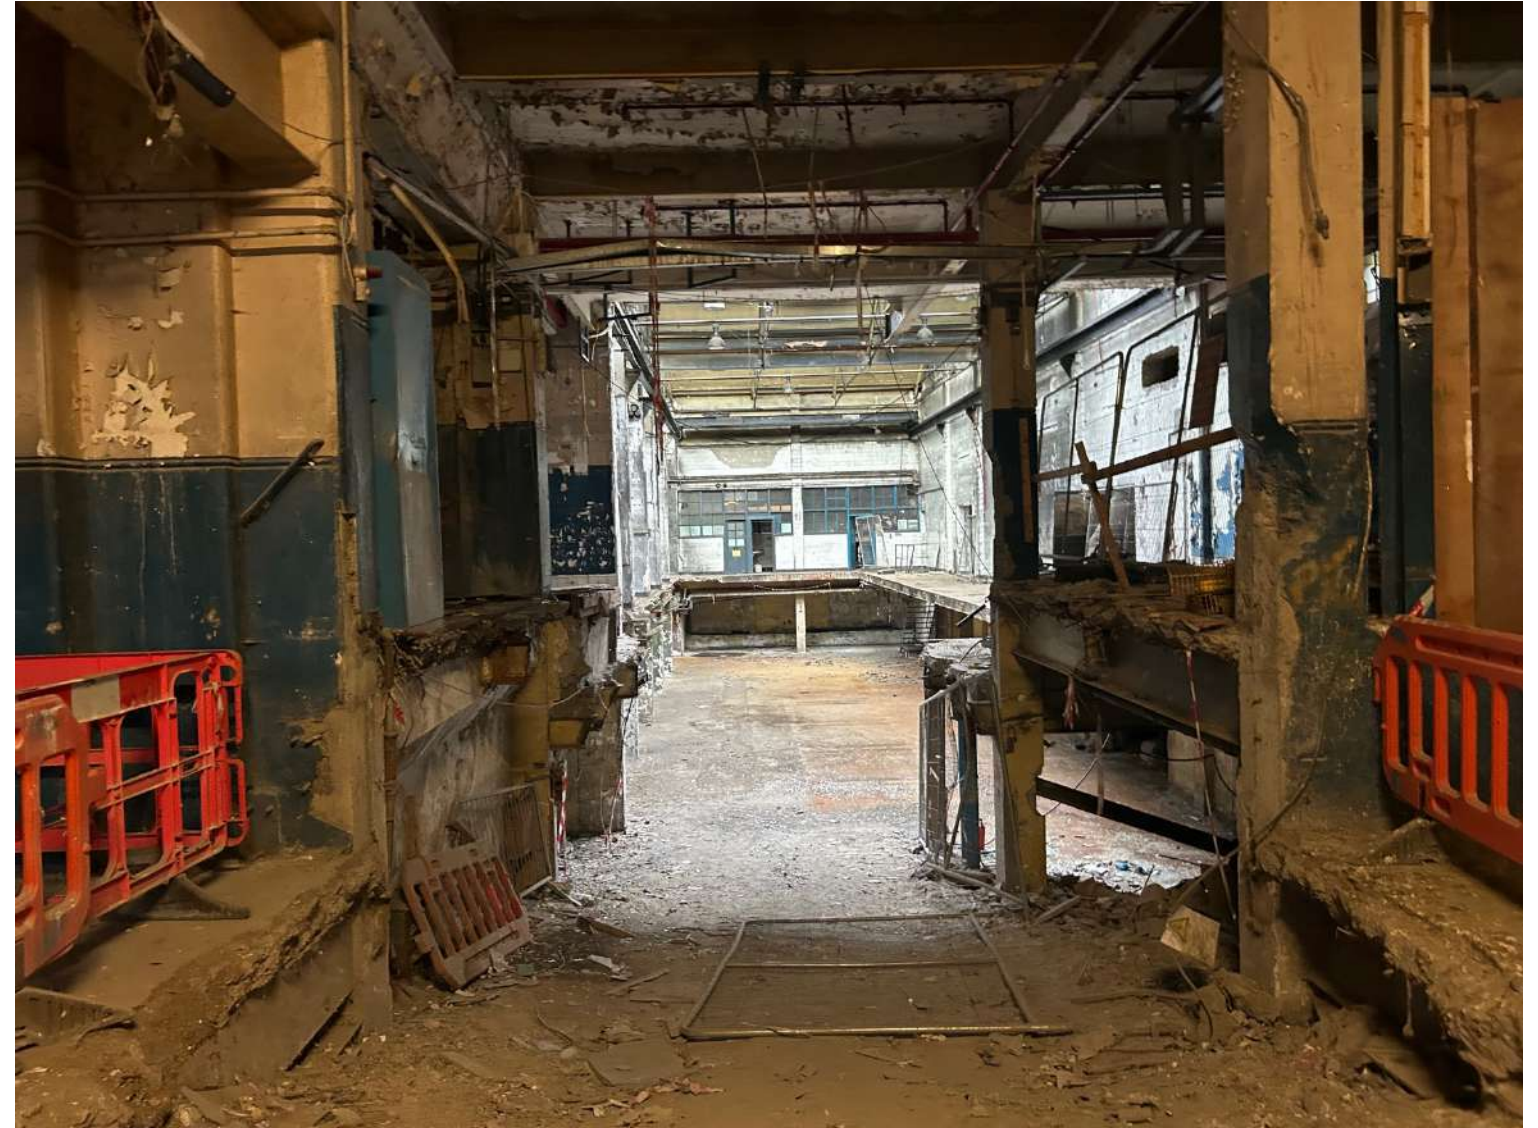
**Plate 240:** View facing north into former Machine room of the printing works. The floor in this area has been partially demolished, with a temporary ramped access to the Machine room, with is on a lower level.

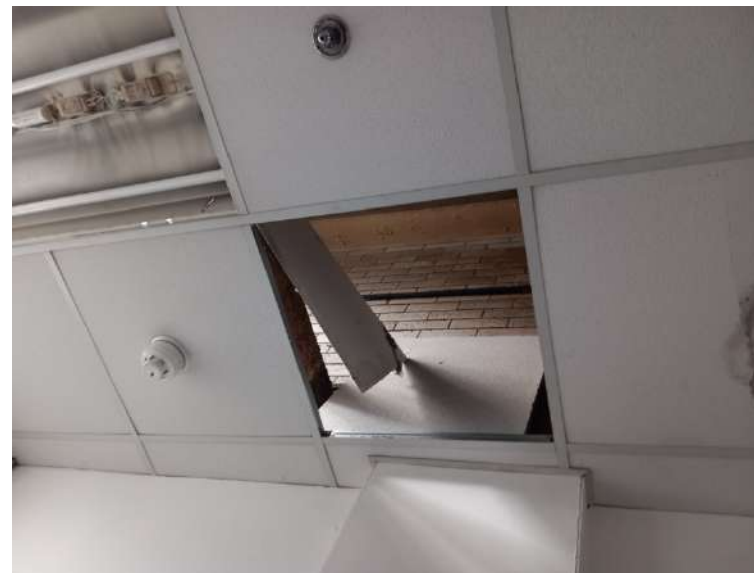
**Plate 256:** Detail of glazed brick finish to wall visible above contemporary suspended ceiling fabric in WCs.

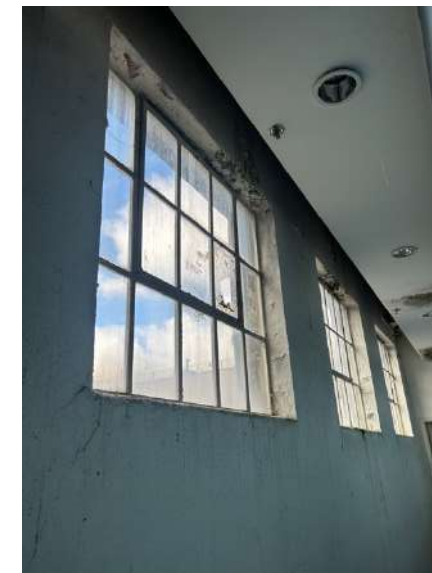
**Plate 257:** Original metal framed windows, 5 x 3 pane with 6 panel central pivot opening section.

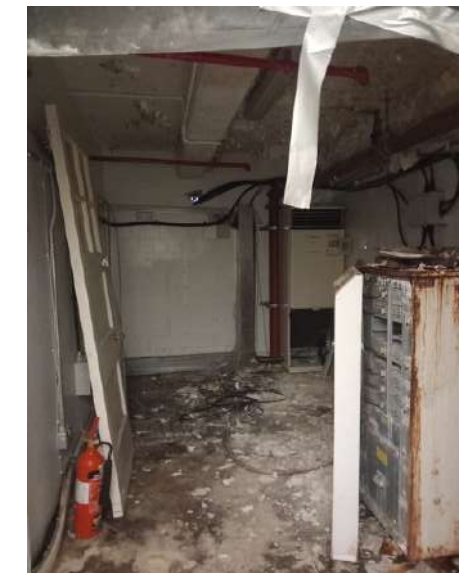
**Plate 258:** Level 2, Internal room. Room filled with debris and water damage evident. Original panelled door loose within room

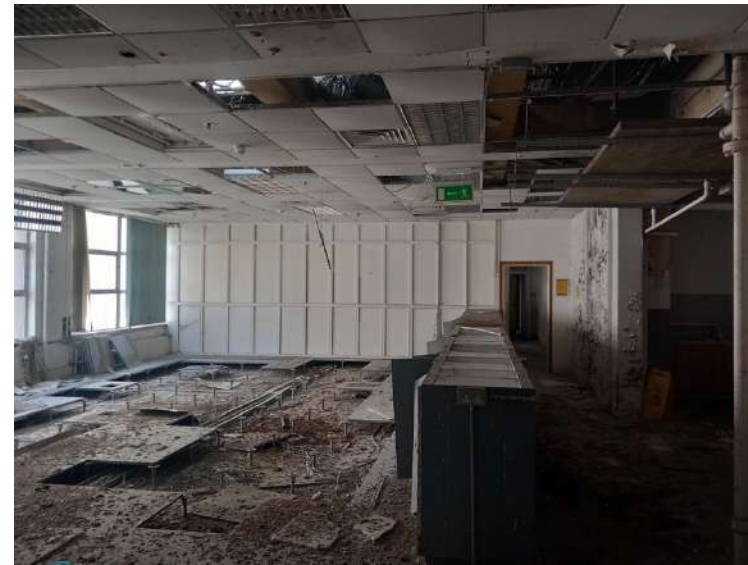
**Plate 263:** Offices on northern side of rear range buildings, facing east. Contemporary partition walls, wall finishes, windows, services and raised access floor throughout.

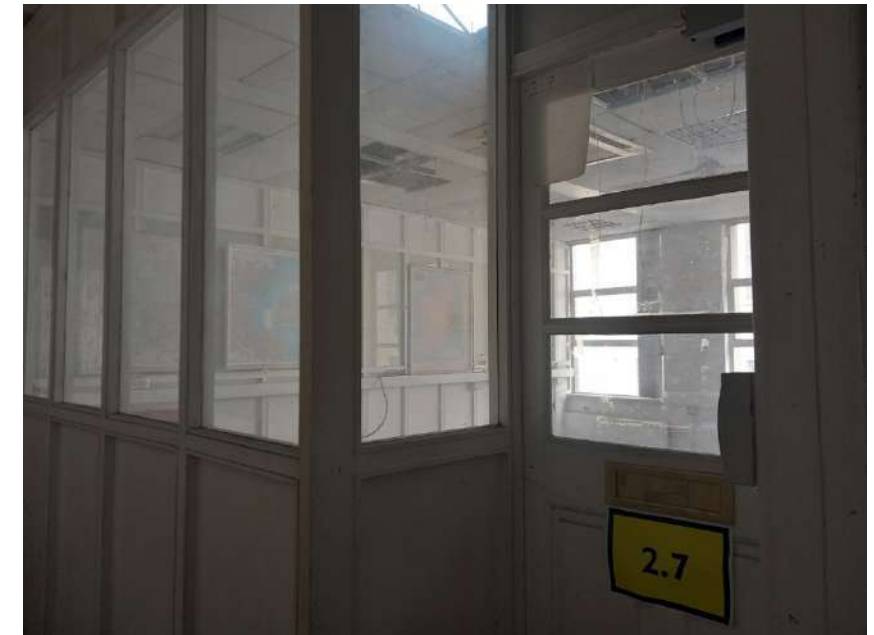
**Plate 264:** Contemporary partitions and wall linings on Level 2.

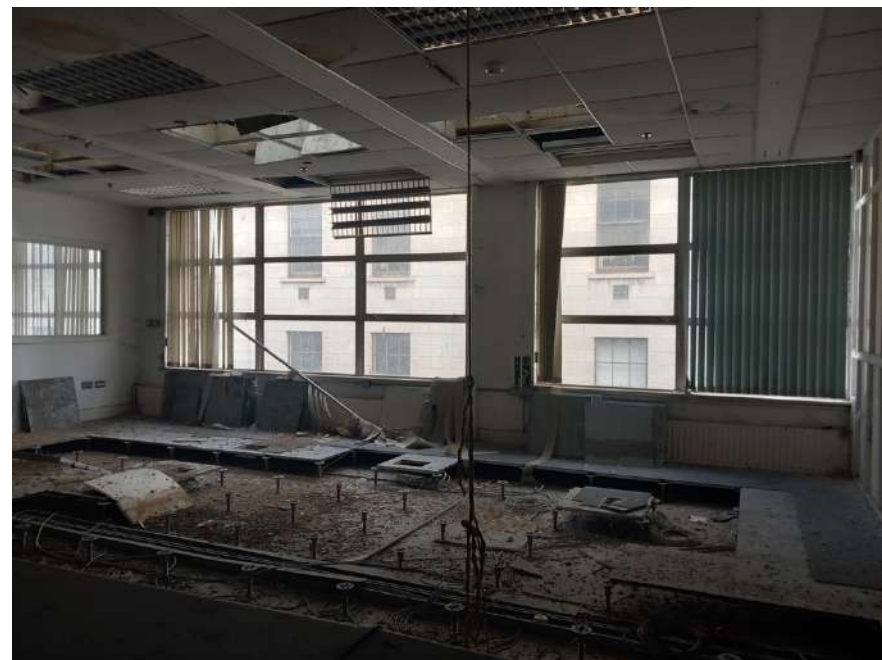
**Plate 265:** Facing north towards GPO on opposite of Prince's Street North. Contemporary finishes throughout; uPVC windows, suspended ceiling, raised access floor.

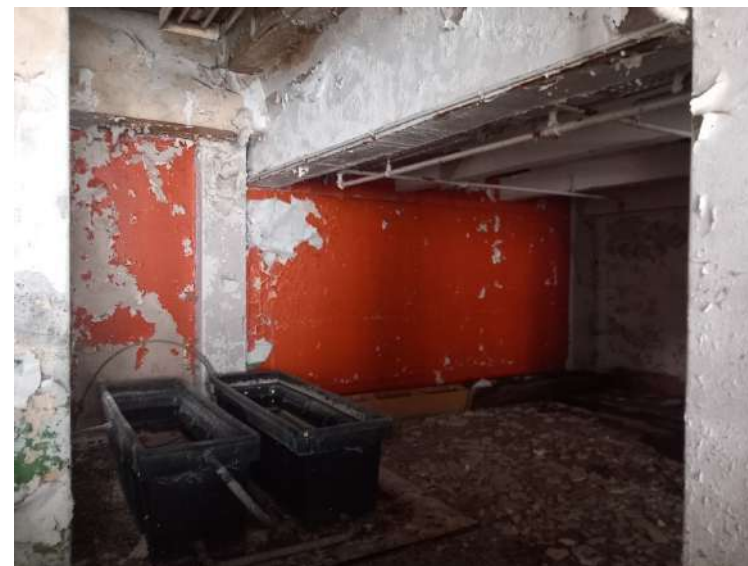
**Plate 266:** Plastic water tanks and debris in north-west corner of top floor. Concrete and steel frame structure.

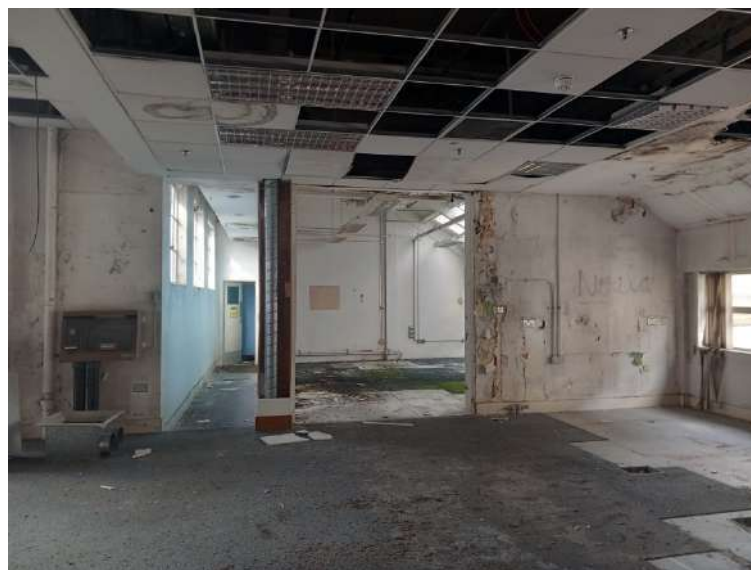
**Plate 267:** View facing west. Contemporary services and raised access floor throughout. Original steel-framed windows to south elevation.

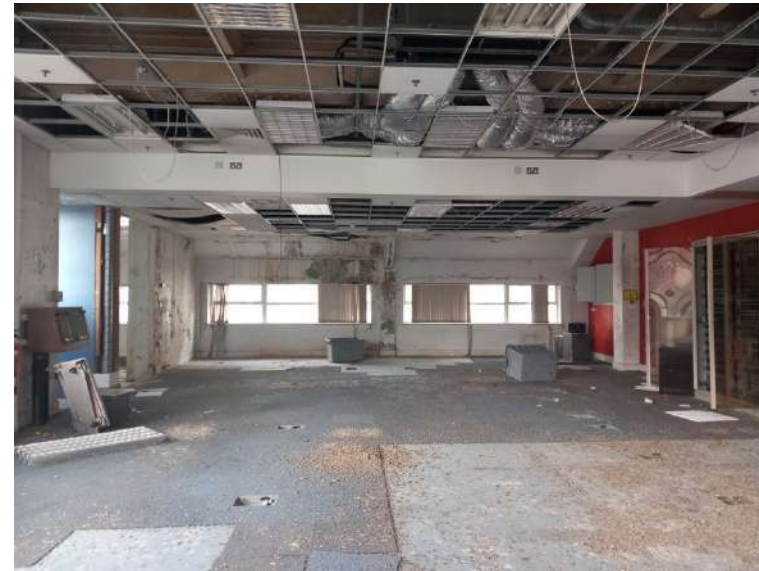
**Plate 269:** View facing south. uPVC windows, raised access floor, contemporary lay-in ceiling tiles. Former open plan office space.

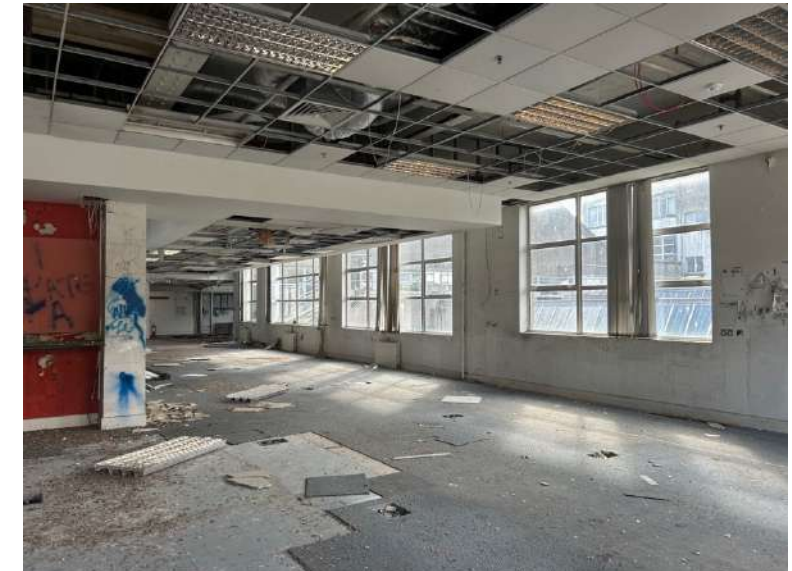
**Plate 270:** View facing northwest. uPVC windows, raised access floor, contemporary lay-in ceiling tiles. Former open plan office space.

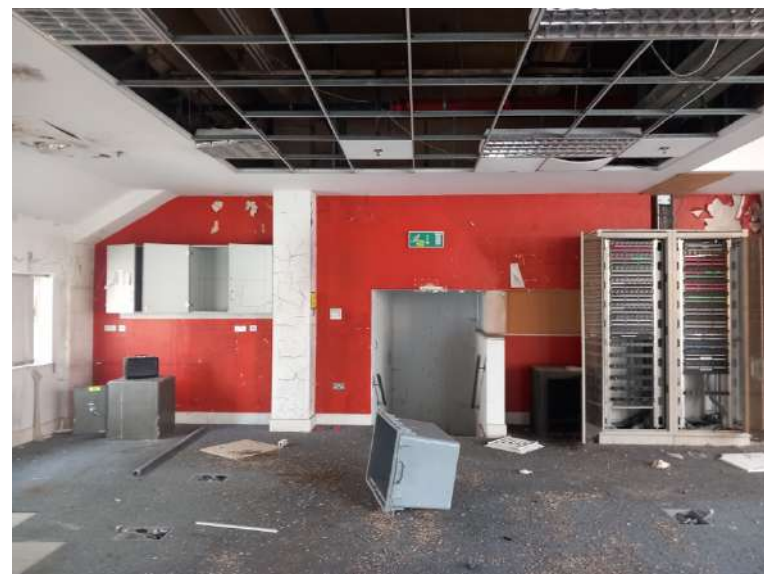
**Plate 271:** View facing east. uPVC windows, raised access floor, contemporary lay-in ceiling tiles. Former open plan office space.

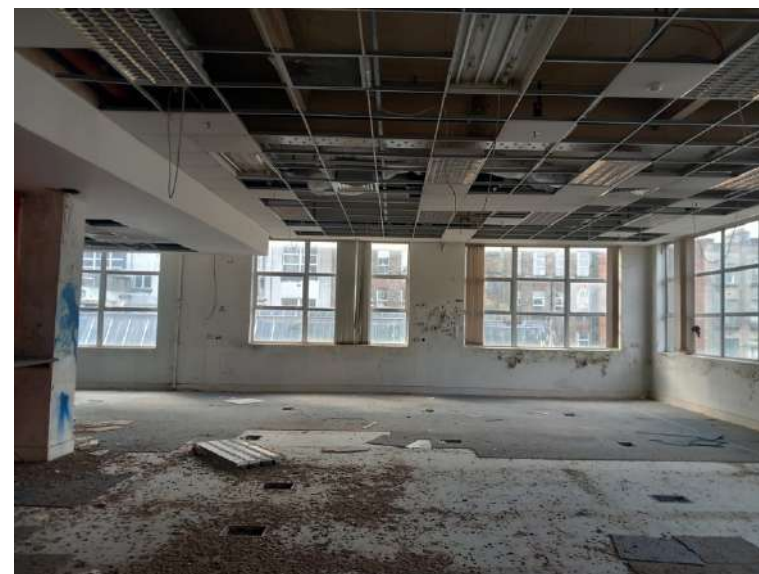
**Plate 272:** View facing south, overlooking roof of former Printing Hall. uPVC windows, raised access floor, contemporary lay-in ceiling tiles. Former open plan office space.

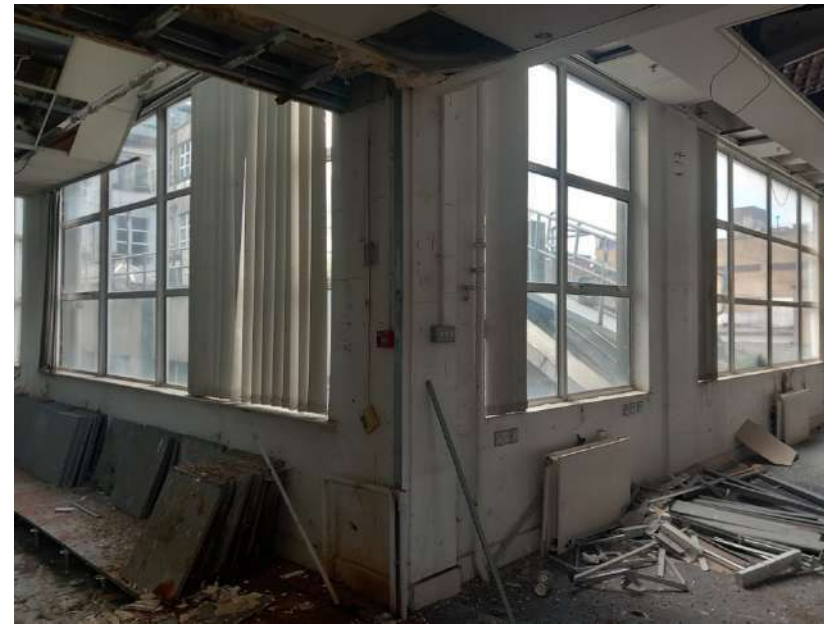
**Plate 273:** View facing south-west. uPVC windows, raised access floor, contemporary lay-in ceiling tiles. Former open plan office space.

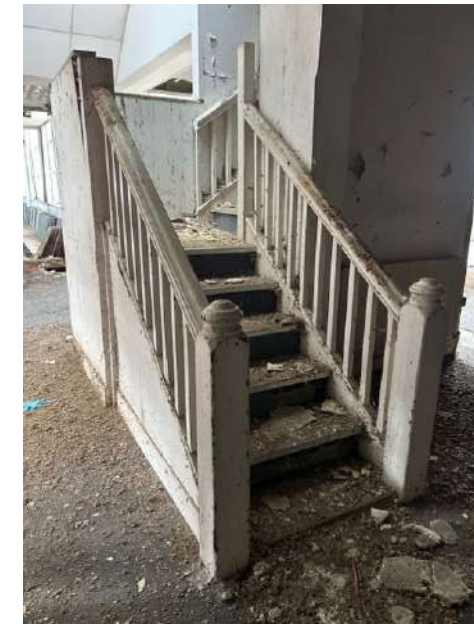
**Plate 274:** Painted timber stair with square plan newel posts to top floor, possible using salvaged elements.

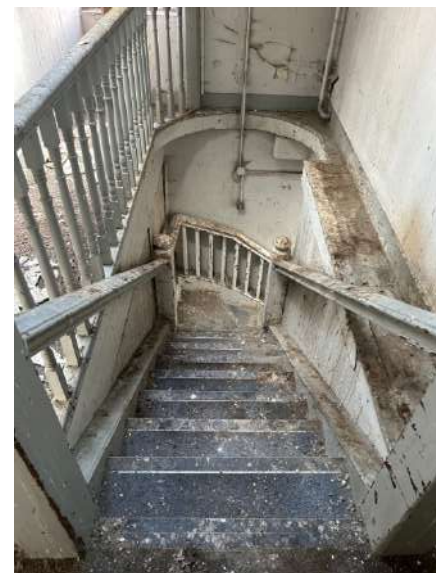
**Plate 275:** Timber stair between second floor and former library on top floor with irregular winders to upper flight. Heavy square plan newel posts with rounded finial. Square plan banisters and painted timber handrail. Stair treads in poor condition. The joinery elements vary in style suggesting the stairs may have been modified or partly replaced with salvaged elements.

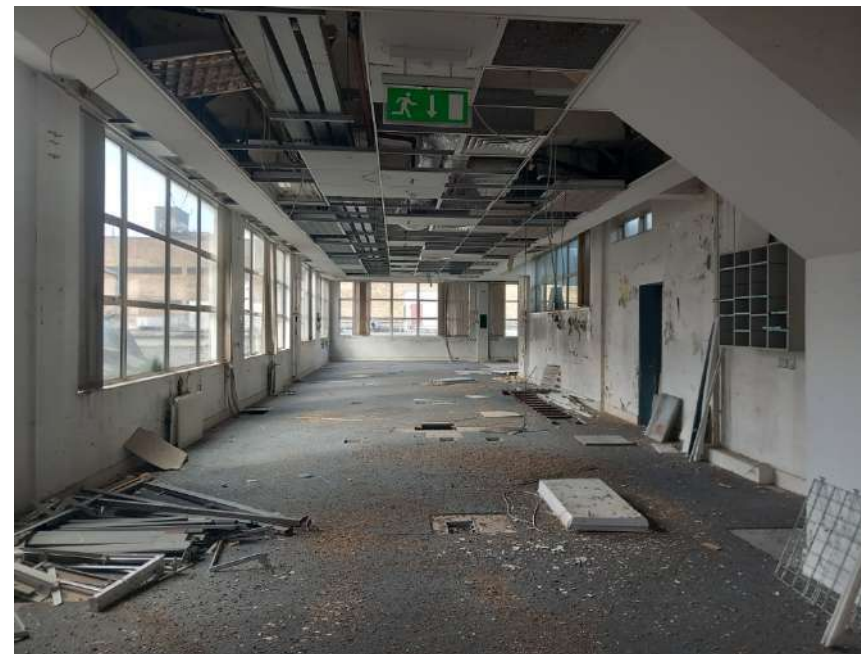
**Plate 276:** View facing west. uPVC windows, raised access floor, contemporary lay-in ceiling tiles.

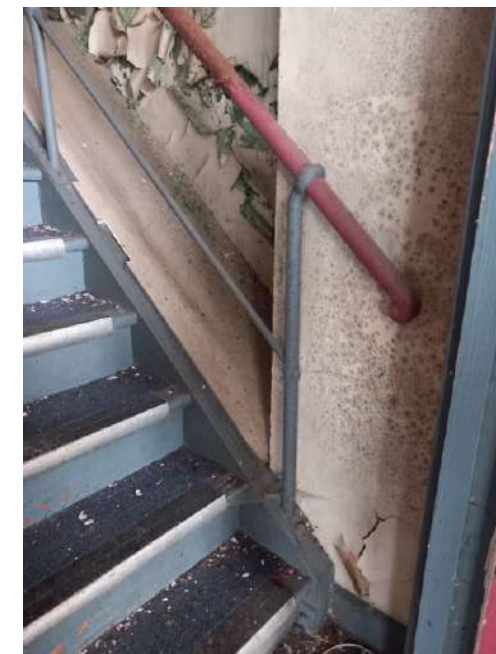
**Plate 277:** Industrial steel balustrade to stairs with ball joints.
